GUIDELINES FOR IN-DEPTH CONDITION ASSESSMENT OF MONUMENTS AT BAGAN

within the framework of the UNESCO Project
“Technical Assistance for the Conservation of Built Heritage in Bagan” funded by Japan

III- 1 Outline of the target monument (No. 1249 Phya-sa-shwe-gu)	63
III- 2 Site preparation and basic documentation	66
III- 3 On-site investigation	69
III- 4 Laboratory testing	89
III- 5 Analysis and assessment	100
III- 6 Recommendation	103

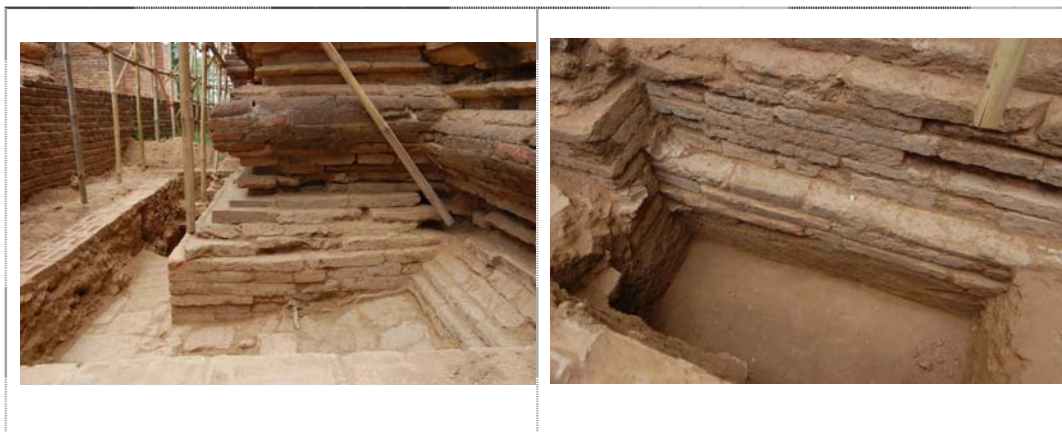
To prevent excavation from making the upper section of the structure further unstable, we dug a L-shaped trench, whose dimensions are in the east-west direction 3.5m and in the north-south direction 2.2m, from the southeast corner of the main body to the connection part attaching to the south wall of the entrance hall, avoiding the part where deformation was obviously found. The survey period was from the 15th June to the 18th of June 2015 and the surveyed area was approximately 4.4m².

Fig. 37 (left), **Fig. 38** (right) The surface excavation of the foundation at temple 1249.

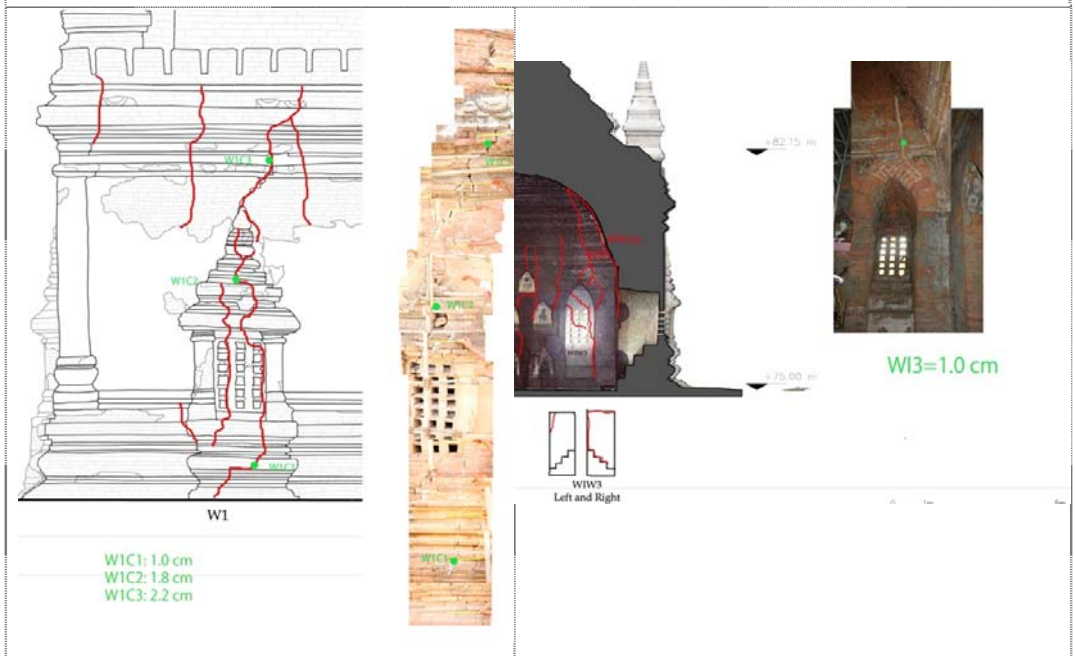
Fig. 40 (left), **Fig. 41** (right) The digital documentation of two corresponding cracks on the exterior and interior wall of a monument.

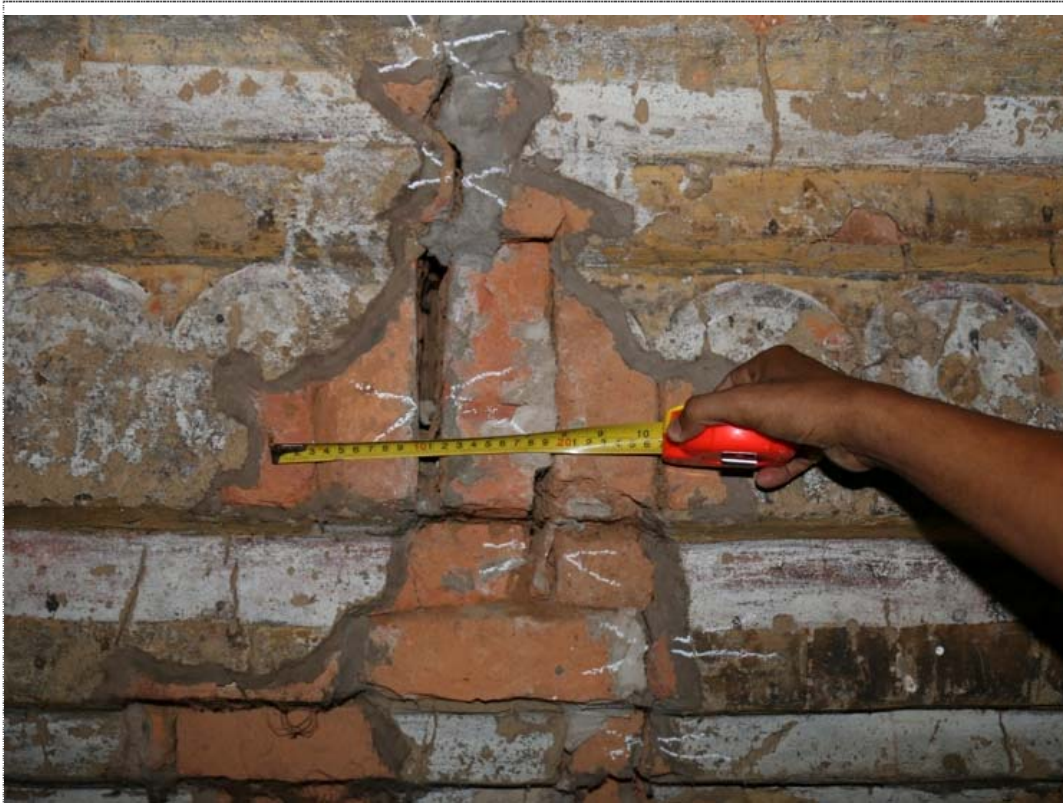
Fig. 42 The cracks were marked with chalk and then documented in detail with a scale bar in the photo to provide information about the width of the crack.

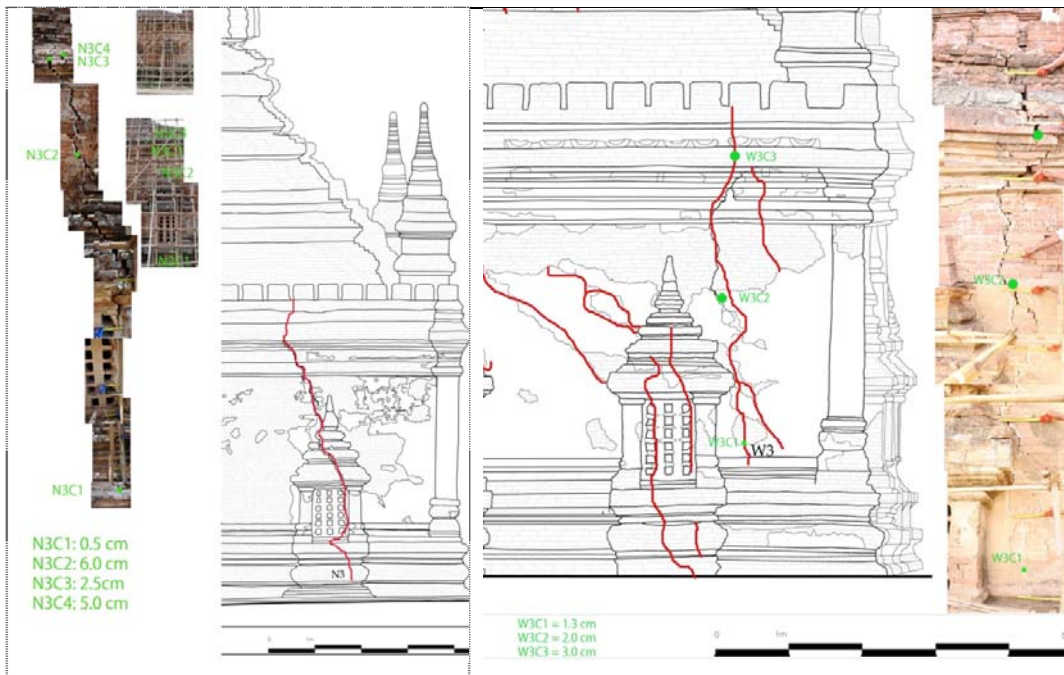
Fig. 43 (left), Fig. 44 (right) The result of the detailed crack pattern documentation of two of the major cracks of PSSG temple on the north and west façades.

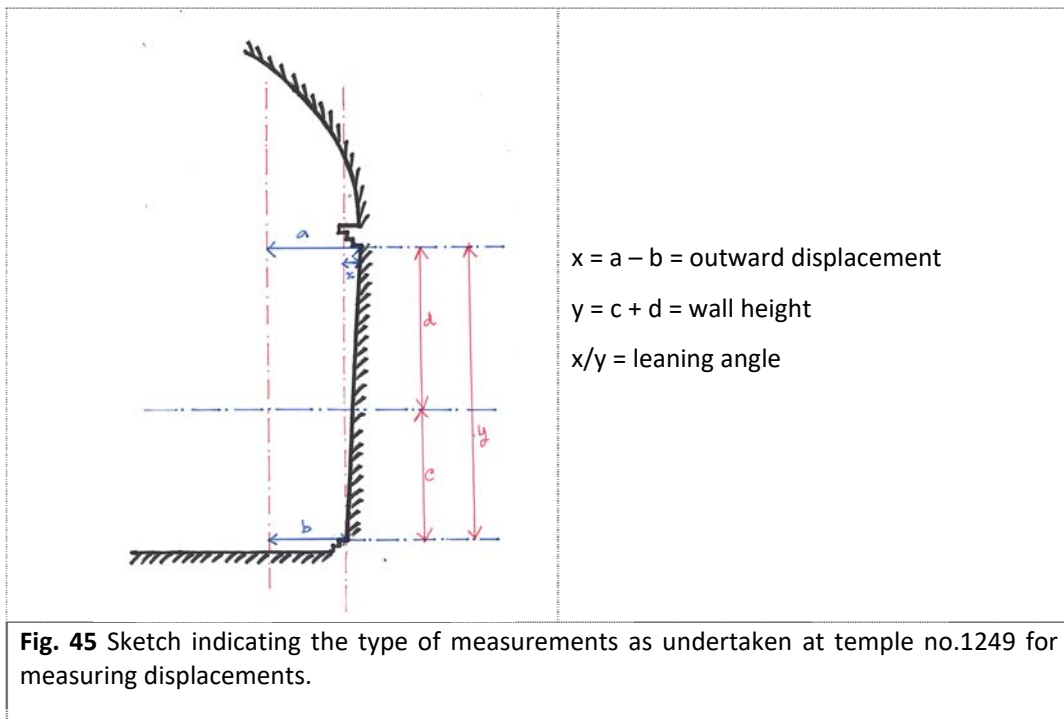
We manually measured the degree of the displacement. We first established on the floor inside the building four base lines crossing at right angles by using a total station, and then measure horizontal distance from the line to the interior wall surface at its bottom and top (directly below the cornice) at approximately equal intervals of one meter. The result was as we expected showing that the west and north walls lean outward in their middle sections significantly, though south wall as a whole lean in an opposite way. The largest amount of displacement was measured at point W6 in the middle of west wall where difference or displacement value was 154mm between the bottom and top of the wall with height of 3700mm.

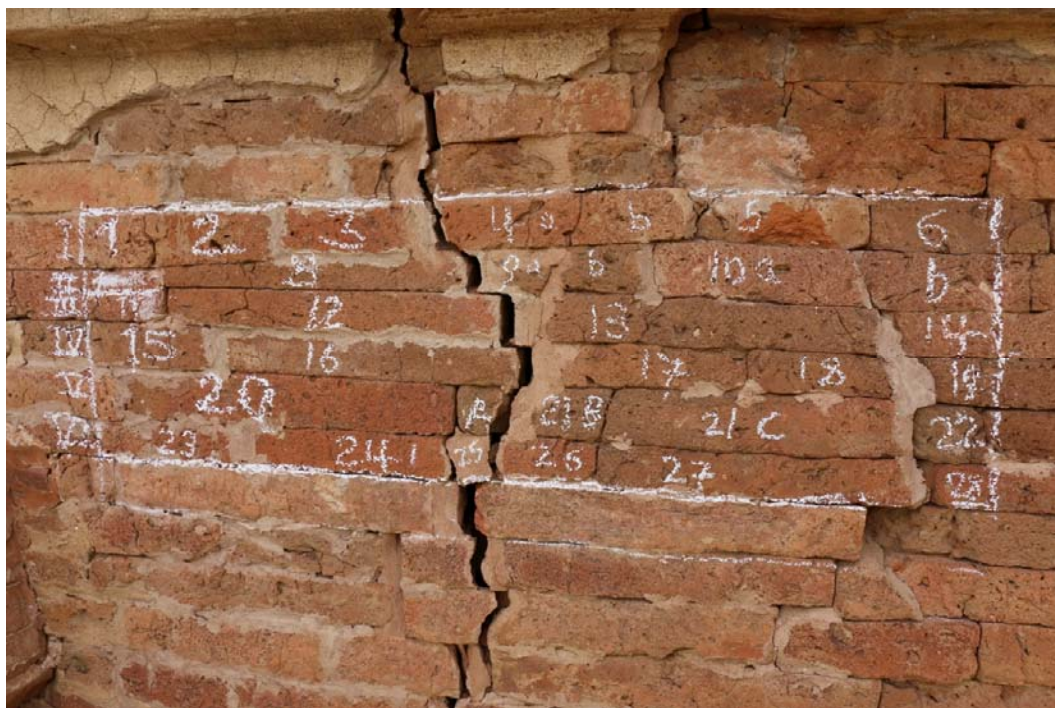
The graph evidences a deep and wide loss of the joint's efficiency between mortar and bricks, both in vertical and horizontal directions. Although the common literature – as indicated in the same graph – requests and defines that acceptable compactness and joint's efficiency must be more than 2000 m/sec in the corresponding value of velocity, the recorded mean value is only around 400 m/sec. Also, all facades of the temple are commonly characterized by very low values of velocity, which means that disaggregation of the joints occurs practically in all the masonry walls investigated. In detail, the worse situation was recorded in the West façade, while the more positive was in the South side. The recorded values identified with “B” symbol, which is related to the single brick, are between 10 to 20 times of the value measured with joints, which also confirms the above general comments. Finally, as expected, the efficiency of the vertical joints is higher than that recorded with horizontal ones which are affected by the dead load. The graph synthesizes the contents of the tables 2-1 to 2-6 in the appendix.

Fig. 48 Test panel no. 4 for which the rebound hammer test was applied three times for each individual brick to test their compression strength, as well as, the ultra-sonic test to determine the compactness of the overall masonry panel.
