# GUIDANCE NOTE IN APPROACHES FOR CONSERVATION OF MURAL PAINTINGS AND ARCHITECTURAL DECORATIVE WORKS AT BAGAN

**Prepared by Rodolfo Luján-Lunsford**  
within the framework of the UNESCO Projects  
“Capacity building for safeguarding cultural heritage in Myanmar” funded by Italy  
“Safeguarding Bagan within the World Heritage Framework” funded by NFUAJ

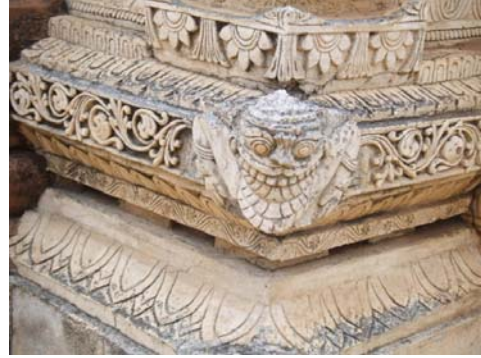
**1825** TEMPLE, DETAIL OF STUCCO MOULDINGS THAT SHOW TRACES OF DECAY WHERE RAIN STRIKES ON HORIZONTAL SURFACES.

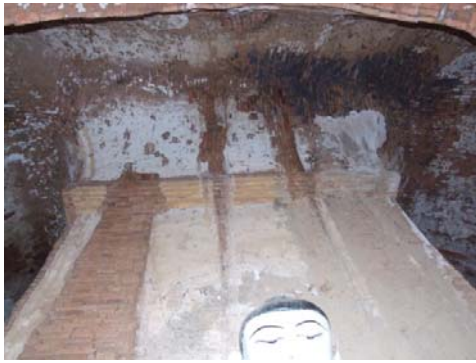
**697** HSIN-BYU-SHIN-HPAYA, SOUTH CORRIDOR, INNER WALL. WATER INFILTRATION FROM ROOF DISSOLVING CONSTITUTIVE MUD MORTAR AND PLASTERS. NOTICE THE STRIPES OF BARE MASONRY.

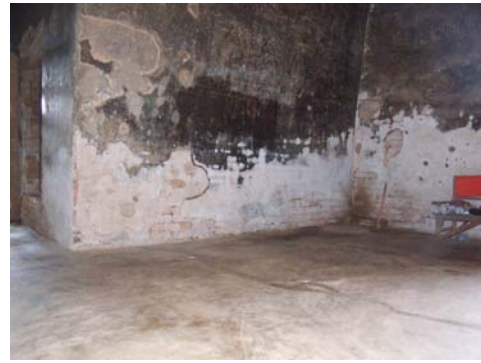
**1605** PATHO-HTA-MYA, VESTIBULE, SOUTHEAST CORNER. RISING WATER DUE TO A POND-LIKE AROUND THE TEMPLE DURING THE RAINY SEASON. THE PROBLEM WOULD OBVIATE IF REMOVING SOME SOIL FROM THE ROAD AT THE NORTH WEST FOR WATER EVACUATION.

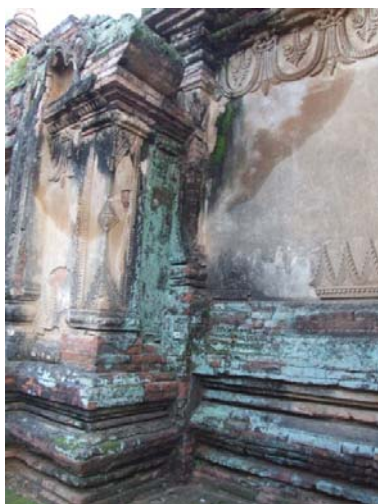
**1323** KUBYAUK-GYI (MYINKABA), NORTH LATERAL FOREPART WITH WINDOW, WEST SIDE. ONGOING WATER INFILTRATION FROM UPPER PARTS GIVEN BY THE DARKER AREAS ON THE PLASTER, NOTICE THE DEVELOPMENT OF MICRO-ORGANISMS ON THE SURFACES.

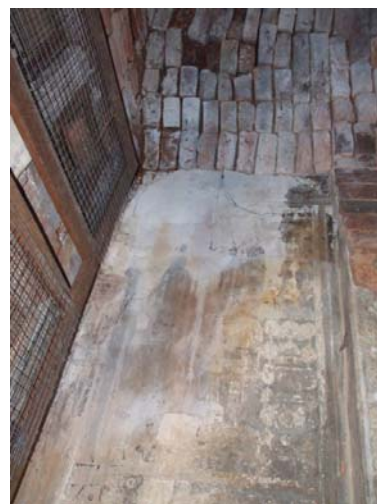
**1323** KUBYAUK-GYI (MYINKABA), NORTH LATERAL FOREPART WITH WINDOW, EAST SIDE, INDOORS. WATER INFILTRATING HAS OBLITERATED THE UPPER SECTION OF MURAL PAINTING. THE WHITE AREAS CORRESPOND TO DRY MASONRY WITH RE-CRYSTALLISED SALT.

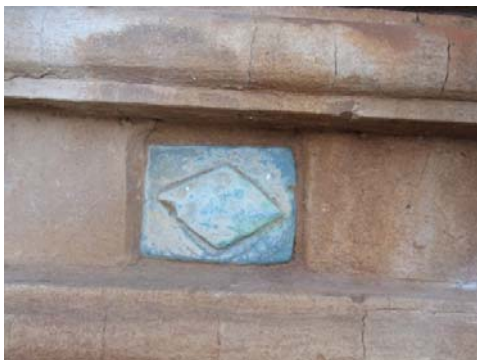
**539** TAYOK-PYI-HPAYA-GYI. GLAZED PLAQUE WITH DEPOSITION OF CALCIUM CARBONATE MIXED WITH DUST ON THE SURFACE, THIS IS THE YELLOWISH FILM ON THE GREEN GLAZE.

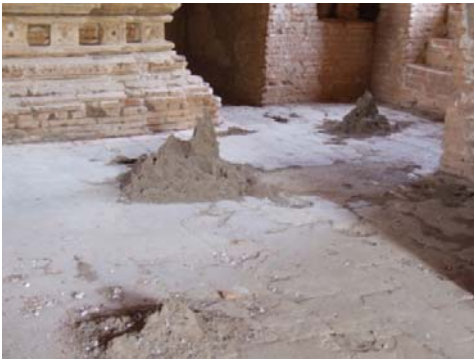
**2128** TEMPLE. TERMITE NESTS IN THE ORIGINAL SANDSTONE SLABS FLOORING.

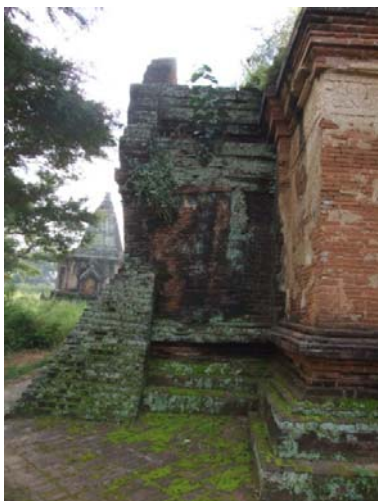
**263** TEMPLE. DEVELOPMENT OF MICRO-ORGANISMS AND GROWTH OF HIGHER PLANTS ON THE WALLS AND UPPER PARTS.

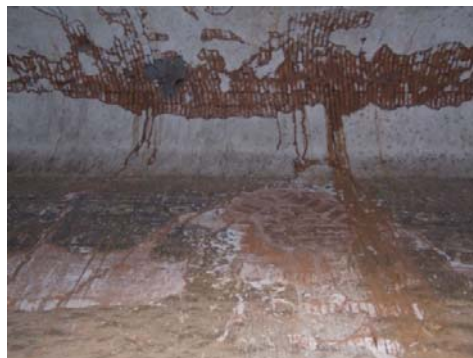
**1499** MIN-NYEIN-KON. SWALLOWS' NESTS (UPPER LEFT SIDE OF PHOTOGRAPH) AND MUD RUN-OFF (RIGHT SIDE) DUE TO WATER INFILTRATION DISSOLVING CONSTITUTIVE MUD-BASED MORTAR AND DEPOSITING ELSEWHERE.

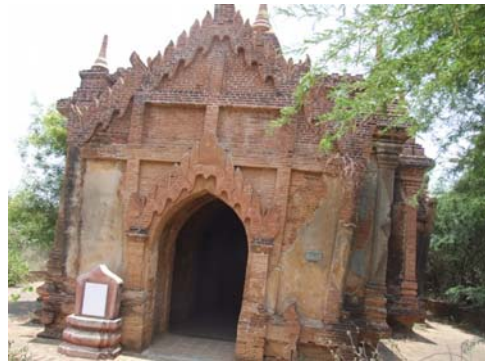
**1160** TEMPLE AS IN 2017. LARGE SECTIONS OF MASONRY & STUCCO MOULDINGS WERE DESTROYED; THE PROPORTIONS OF THE ELEMENTS WERE HEAVILY ADULTERATED AS WELL AS THE SHAPE OF THE PEDIMENT OVER THE FOREPART. THE TEMPLE IS INSIDE A POOL MADE BY THE RETENTIVE WALL CONSTRUCTED ALL AROUND WITHOUT AN OUTLET FOR WATER EVACUATION DURING THE RAINY SEASON.

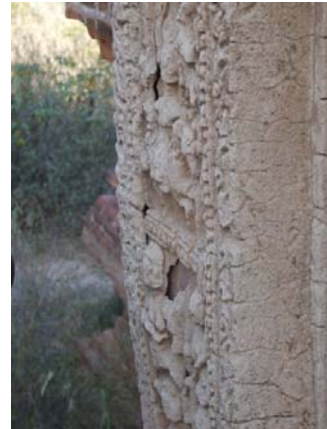
**698** MONASTERY, HSIN-BYU-SHIN MONASTIC COMPLEX, FOREPART, WEST FACE, NORTH SIDE. STUCCO MOULDINGS SEPARATED FROM SUPPORT WITH STRONG DEFORMATION (BULGING).

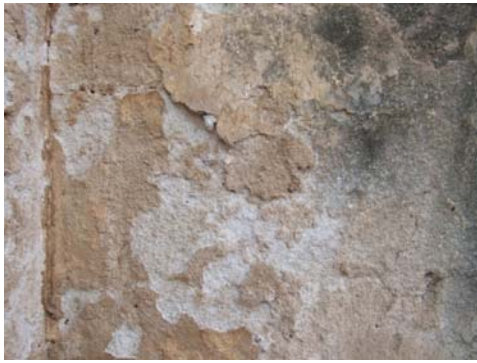
**2162** ANANDA-OK-KYAUNG MONASTERY, PLATFORM RETAINING WALL, NORTH FACE, EAST SIDE. PLASTER LACKING COHESION (POWDERY) AND THIN LAYER OF WHITEWASH LACKING ADHESION.

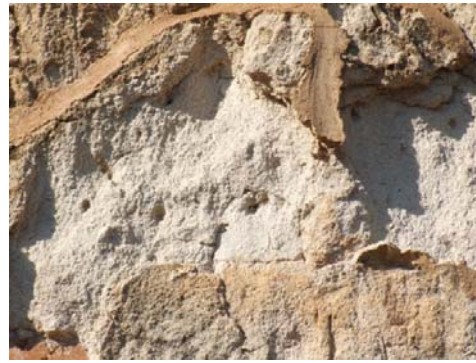
**2162** ANANDA-OK-KYAUNG MONASTERY, UPPER STOREY, SOUTH FACE, PEDIMENT OF WESTERN DOOR. POWDERING STUCCO MOULDINGS DUE TO SALT RE-CRYSTALLISATION DUE TO WET-DRY CYCLES.

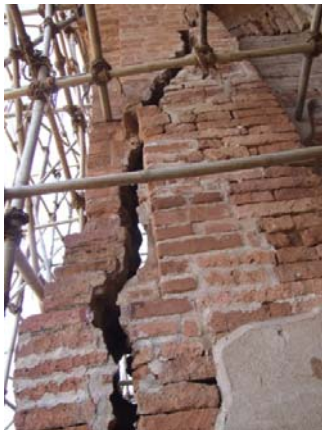
**539** TAYOK-PYI-HPAYA-GYI, 1<sup>ST</sup> FLOOR, WEST PORCH, CROSSING CRACKS THROUGHOUT THE MASONRY.

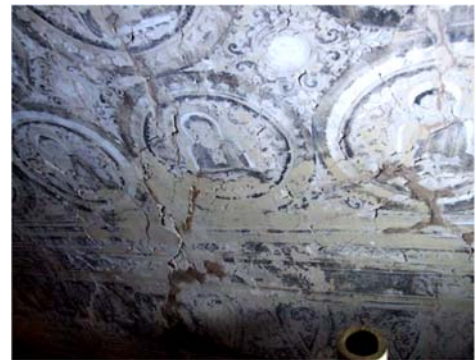
**1847** (HPAYA-NGA-ZU GROUP), CROSSING CRACKS ON PLASTER, PROBABLY FROM DISLODGED BRICKWORK BENEATH.

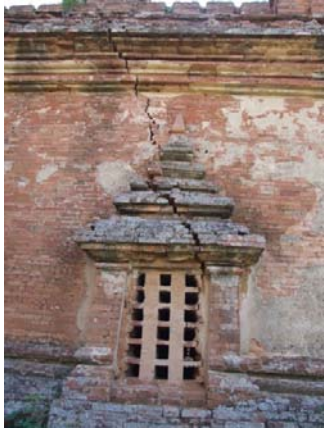
**1249** PHYA-SA-SHWE-GU, CROSSING CRACK ALONG AND THROUGHOUT THE STRUCTURE.

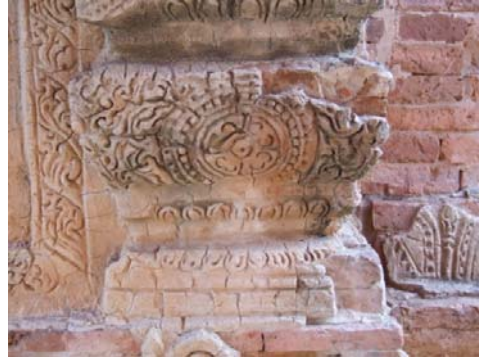
**698** MONASTERY, HSIN-BYU-SHIN MONASTIC COMPLEX, FOREPART, WEST FACE, SOUTH SIDE. DRYING CRACKS OF STUCCO MOULDINGS. THESE ARE ALWAYS DIVIDED IN THREE LINES, CHARACTERISTIC TO LIME-BASED PLASTERS WHEN SETTING/DRYING.

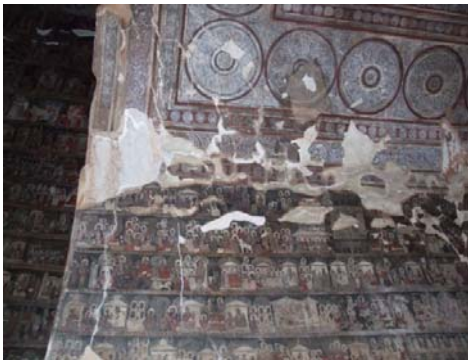
**1580** LOKA-HTEIK-PAN. SUPERFICIAL LACUNAE THAT INTERRUPT THE LEGIBILITY OF THE PICTORIAL TEXT.

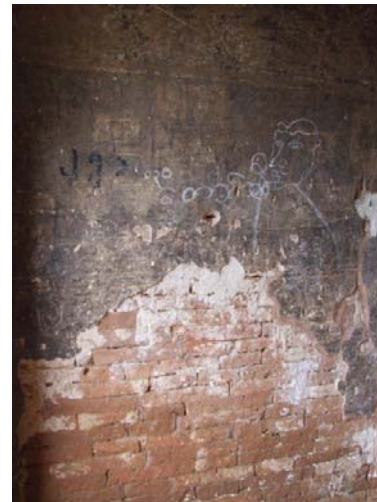
**433** PYWAN-TAN-HSA-HPAYA. LACUNAE OF PLASTER IN-DEPTH SHOWING THE BRICKWORK, COMBINED WITH SUPERFICIAL ONES THAT ARE THE REMAINING WHITE PLASTER.

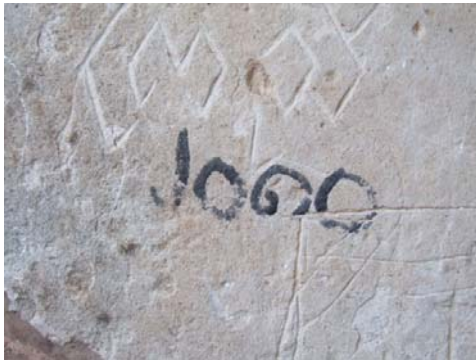
**2080** TEMPLE, INCISIONS CONSCIOUSLY CAUSED WITH A POINTED TOOL.

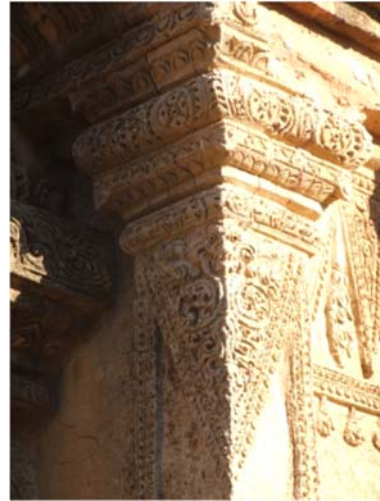
**1152** TEMPLE. ERODED SURFACE DUE TO SLIGHTLY ACIDIC WATER RUN-OFF DISSOLVING CONSTITUTIVE MATERIALS.

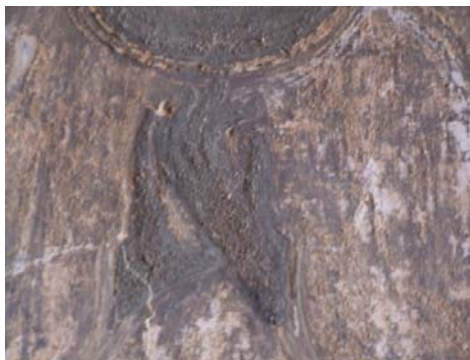
**539** TAYOK-PYI-HPAYA-GYL. MICRO-SCALING OF PAINT LAYER, PERHAPS DUE TO THE SHRINKAGE OF A PREVIOUS FIXATIVE THAT WAS APPLIED.

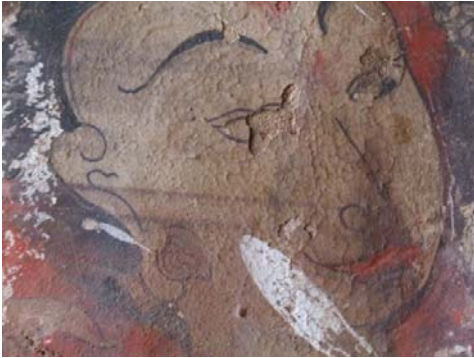
**2007** SHWE-KYAUNG-U-HPAYA. DRYING CRACKS FORMED ON THE PRIMING AND PAINT LAYERS. NOTICE THE DRIP OF LIME-WASH EMPLOYED FOR THE OUTSIDE.

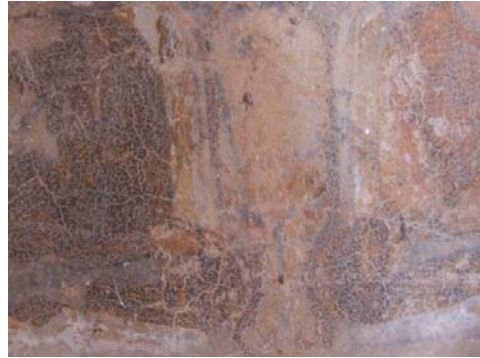
**539** TAYOK-PYI-HPAYA-GYI, UPPER STOREY TEMPLE, VESTIBULE, NORTH WALL. DETAIL OF PAINTING, PROBABLY A PURPLE LAKE, WITH EVIDENT CRAZING DUE TO EXCESSIVE WEATHERING.

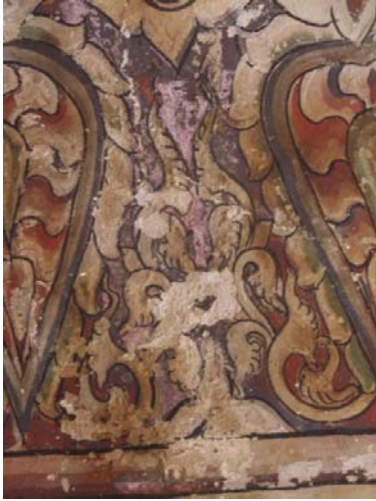
**2007** SHWE-KYAUNG-U-HPAYA. THE ABRASIONS OF PAINT LAYER LEAVE A SLIGHT TRACE OF PIGMENT ON THE SURFACE.

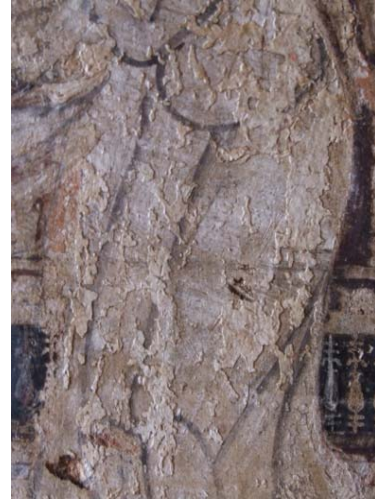
**539** TAYOK-PYI-HPAYA-GYI, GROUND FLOOR, LACUNAE IN-DEPTH OF PAINT LAYER.

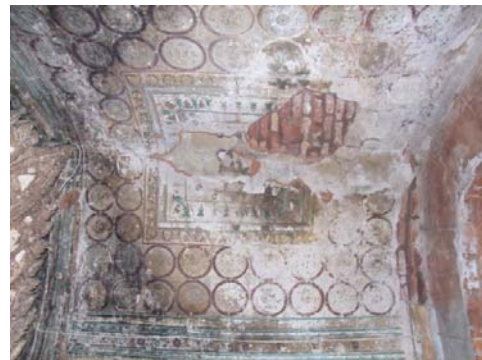
**1336** TEMPLE, VESTIBULE VAULT. ALTERATION OF RED VERMILION INTO BLACK ON THOSE AREAS HIT BY REFLECTED SUNLIGHT WHEREAS, THE AREAS THAT ARE NOT UNDER THE SUNLIGHT REFLECTION ARE LESS ALTERED. WATER INFILTRATING HAS WASHED AWAY A GREAT DEAL OF PAINTING.

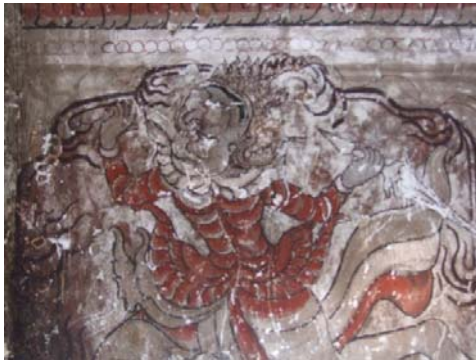
**2162** ANANDA-OK-KYAUNG, DOORWAY SPLAY. THE ORGANIC PIGMENTS HAVE DISCOLOURED INTO A GREYISH FILM, WHEREAS THE INORGANIC PIGMENTS (RED, BLACK AND WHITE) HAVE REMAINED UNCHANGED UNDER THE REFLECTED SUNLIGHT.

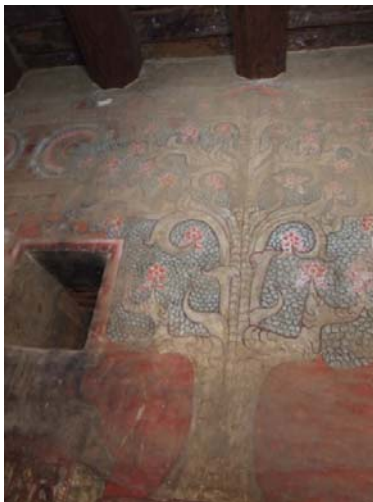
**2162** ANANDA-OK-KYAUNG MONASTERY, SHRINE, EAST WALL. MURAL PAINTINGS COVERED AT THE TOPMOST WITH A THICK LAYER OF DUST WHEREAS THE LOWER SECTION SHOWS HEAVY DEPOSITS OF SOOT.

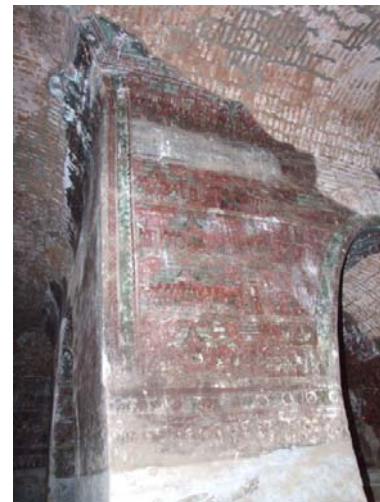
**1969** PITAKAT-HPAYA, DUST DEPOSITS ON PROTRUDING SURFACES AS WELL AS DEVELOPMENT OF MICRO-ORGANISMS PERHAPS DUE TO WATER INFILTRATION FROM THE ROOF (THE BLACKISH UPPER SECTIONS).

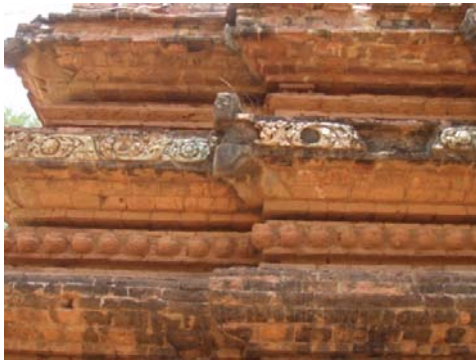
**1145** SO-MIN-GYI-HPAYA, EAST SIDE. CALCIUM CARBONATE DEPOSITIONS ON GLAZED PLAQUES AS WELL AS BLACK DEPOSITS FROM ALGAE ON THE ROUGH SECTIONS WITHOUT GLAZING THAT DEVELOP DURING THE RAINY SEASON.

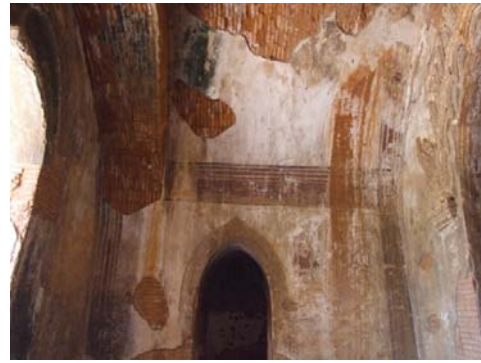
**1457** MAHA-GU-GYI, VESTIBULE, SOUTH WALL MUD RUN-OFF THE SURFACE DUE TO INFILTRATION INTO THE MASONRY WASHING AWAY CONSTITUTIVE MUD-BASED MORTAR, AT THE LEFT GROWTH OF MICRO-ORGANISMS (ALGAE).

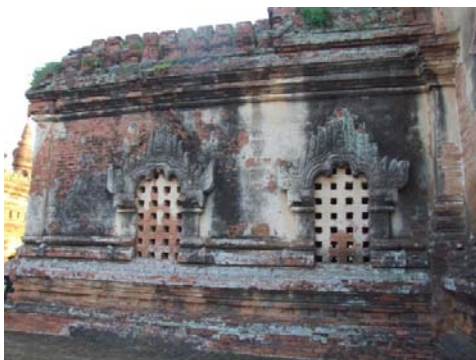
**1085** SEIN-NYET-AMA, VESTIBULE EXTERNAL NORTH WALL. MICRO-ORGANISMS (FUNGI, ALGAE, LICHENS) DEVELOP ON DAMPENED

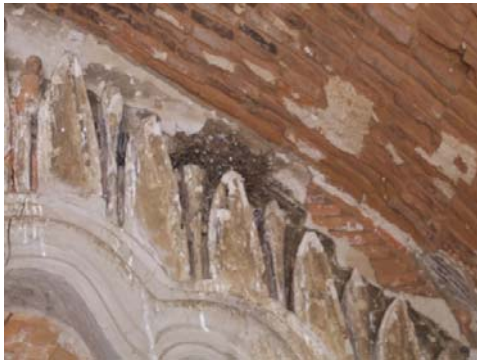
**2128** TEMPLE, VESTIBULE. PIGEON'S NEST ON STUCCO FLAME PEDIMENT.

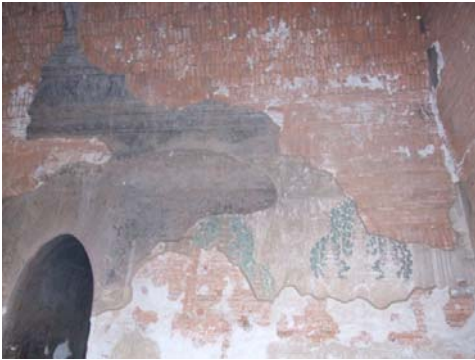
**537** TAYOK-PYI-HPAYA-GYI, VESTIBULE, NORTH WALL. THE DARK BROWNISH AREA ABOVE THE ARCH IS A FORMER FILLING WITH MUD-BASED PLASTER AND THEN PAINTED FOR COMPLETING THE LOST DECORATION.

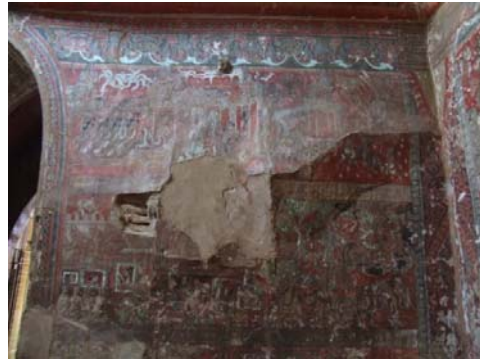
**2007** SHWE-KYAUNG-U-HPAYA, WEST WALL, NORTH SIDE. DEFORMATION CAUSED TO THE ORIGINAL PLASTERS BY THE HARD FILLING IN CEMENT THAT DID NOT ALLOW ADJUSTMENT.

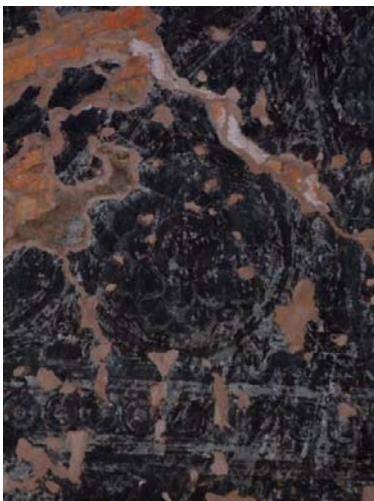
**1600** NAT-HLAUNG-KYAUNG. SMOKE DEPOSITS FIXED WITH PVAc COATING(S).

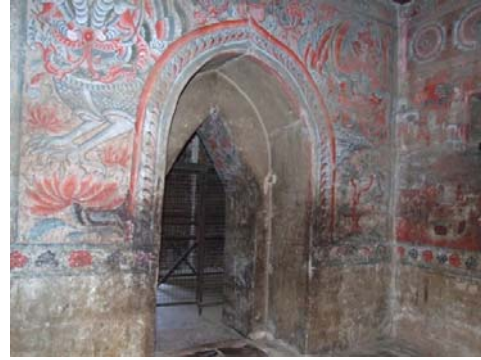
**2162** ANANDA-OK-KYAUNG. GRIME AT HAND REACH AND FIXATIVES OBLITERATE THE PAINTED SURFACE AND CAUSED DETACHMENT OF PAINT (THE WHITE POINTS).

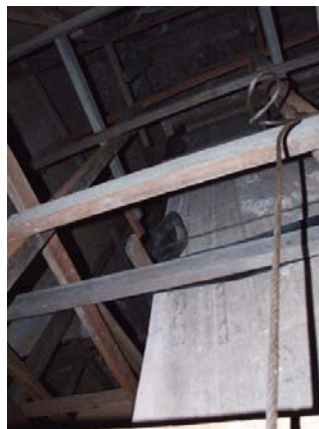
**539** TAYOK-PYI-HPAYA-GYL, UPPER STOREY, SHRINE, SOUTH EAST CORNER OF CENTRAL CORE. THE STAINLESS STEEL BELT WAS INSTALLED ON A THIN BLACK RUBBER SHEET DIRECTLY SET ON THE PAINTINGS. THIS WILL CAUSE DAMAGE TO THE PAINTED PLASTER AT THE CORNER.

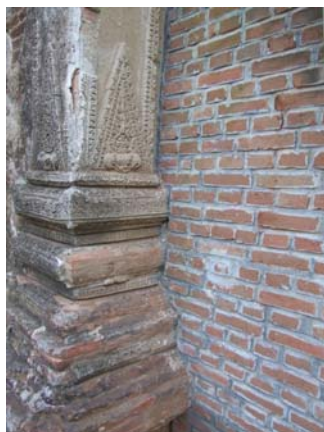
**997 KYAUNG-GYI-NIMA (AMA), WEST PORCH, NORTH. THE BUTTRESS FOR SUPPORTING THE PORCH WAS BUILT WITH STRONG CEMENT DIRECTLY ON THE STUCCO MOULDINGS WITHOUT ANY PROTECTION OR BUFFER. ATTENTION TO STRUCTURAL WORKS BE AWARE!!!**

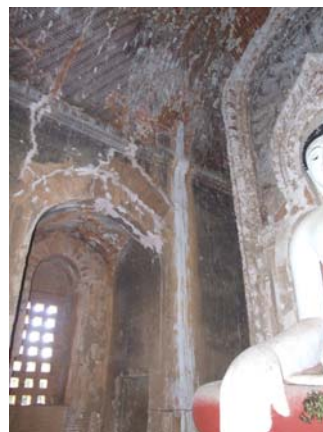
**997 KYAUNG-GYI-NIMA (AMA). SHRINE, SOUTH WALL. THE WHITE LEAKAGE OF GROUT CORRESPOND TO A FORMER LEAKAGE OF MUD MORTAR. THE MASONRY REPAIR TEAM WAS UNAWARE OF THE PROBLEM SO NOT UNDERTOOK THE NECESSARY MEASURES TO PUT REMEDY.**

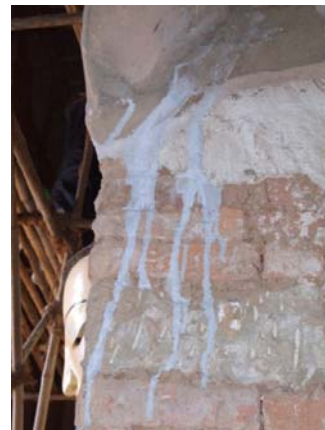
**539** TAYOK-PYI-HPAYA-GYI, FIRST STOREY TEMPLE, SOUTHEAST CORNER OF CENTRAL CORE IN SHRINE. GROUTING MATERIAL RUN-OFF OVER THE SURFACE THAT WAS NOT REMOVED SO THIS WILL SHOW FOREVER A WHITE INDELIBLE STAIN. IT IS IMPORTANT TO BE ATTENTIVE.

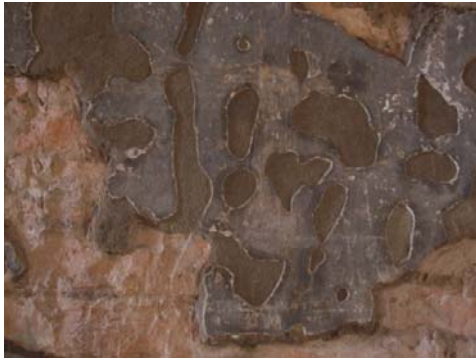
**1600** NAT-HLAUNG-KYAUNG, EXTERNAL WEST WALL OF CIRCUMAMBULATORY CORRIDOR. THE LACUNAE WERE FORMERLY EDGED WITH STRONG CEMENT PLASTER BUT THE PLASTERS WERE NOT FIXED/CONSOLIDATED. THE CEMENT WAS REMOVED AND THE SMALL LACUNAE FILLED WITH SIMILAR COMPATIBLE MATERIAL AS THE ORIGINAL AT THE SAME LEVEL AS PER THE ORIGINAL STRATIGRAPHY. IT IS PENDING THE REMOVAL OF THE PVAC AND SMOKE LAYERS FROM THE SURFACE THEN, EVERYTHING WILL BLEND WITH THE CLEANED PAINTED SURFACE.

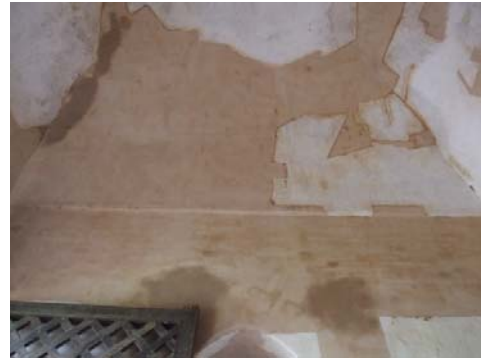
**2171** ANANDA-GU-HPAYA-GYI, ENTRANCE PASSAGEWAY. THE APPROACH FOR THE TREATMENT OF LACUNAE AS WELL AS FOR THE ORIGINAL PLASTERS IS INCORRECT. THE PLASTERS MUST BE FIXED/CONSOLIDATED, THE LACUNAE CLEANED AND FILLED WITH SIMILAR MATERIALS TO THE ORIGINAL, NOT CHOPPING OUT THE LOOSENED SECTIONS AND FILLING WITH NON-SIMILAR MATERIALS. THE WATER INFILTRATION PROBLEMS HAVE NOT BEEN SOLVED, NOTICE THE DARKER AREAS THAT CORRESPOND TO WET PLASTER.

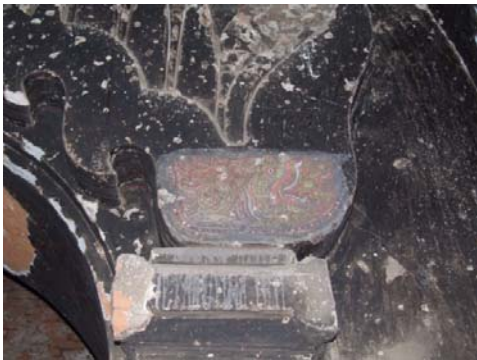
**1668** SHWE-THI-HSAUNG, VESTIBULE, NORTH SIDE OF ARCH. CLEANING TEST WITH HEAVY DRIPPING BELOW. IT IS DIFFICULT TO GET RID OF THE LINES PRODUCED SINCE SOME ARE STILL DIRTY AND OTHERS OVER-CLEANED THUS, AN UNEVEN SURFACE IS CREATED.

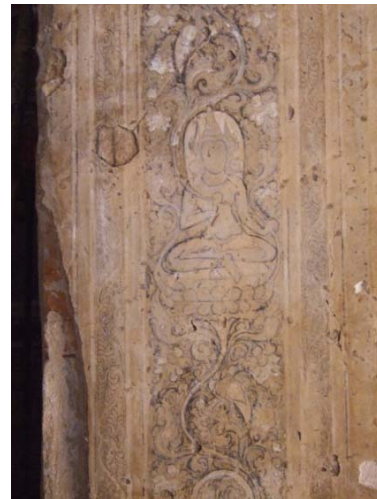
**534** SA-PWE-TIN, CIRCUMAMBULATORY CORRIDOR. HEAVY OVER-CLEANING IN WHICH, THE PREPARATORY DRAWING OF THE CENTRAL FIGURE WAS REVEALED HAVING DELETED FOREVER THE PAINTING.

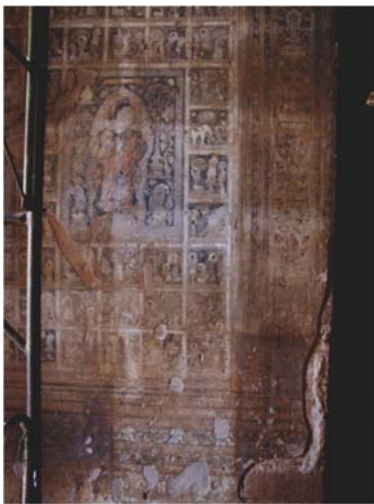
**534** SA-PWE-TIN, CENTRAL CORE, SOUTH WALL, EAST SIDE. IRREVERSIBLE DAMAGE TO

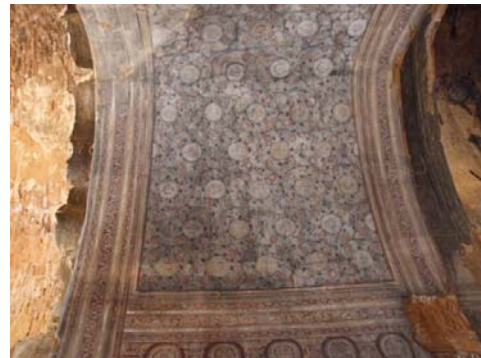
**571** TEMPLE, SOUTH VESTIBULE, VAULT. THE CLEANING OF THE PAINTED SURFACE SHOWS NON HOMOGENEOUS APPLICATION OF SOLVENTS AND PERHAPS WITH DIFFERENT TIMING. DARK AND LIGHT PATCHES RENDER THE APPRECIATION DIFFICULT.

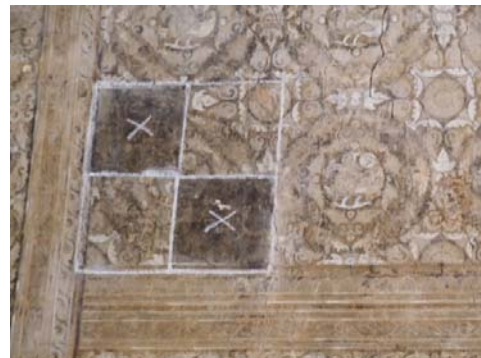
**534** SA-PWE-TIN, CIRCUMAMBULATORY CORRIDOR. THIS MUST NEVER BE DONE, IT IS A BRILLIANT DEMONSTRATION OF INCAPACITY.

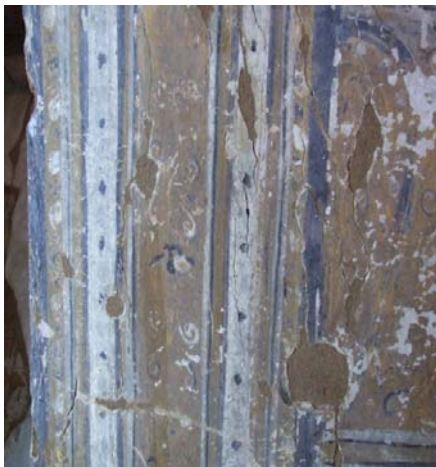
**262** SHWE-LEIK-PYI, VESTIBULE, NORTH WALL. AREA OF PAINTING BEFORE INTEGRATION WITH WATERCOLOUR GLAZES. NOTICE THE WHITE LOSSES ON UPPER SECTION.

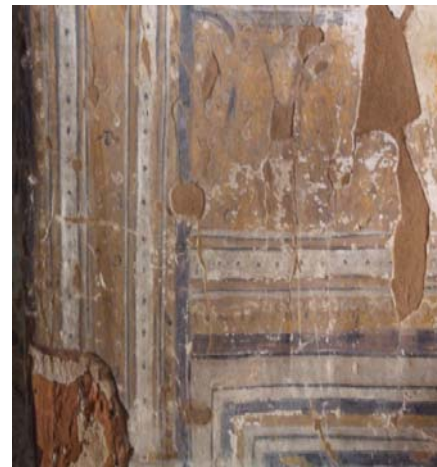
**262** SHWE-LEIK-PYI, VESTIBULE, NORTH WALL. AREA OF PAINTING AFTER TONING DOWN THE WHITE LOSSES OF UPPER SECTION WITH WATERCOLOUR GLAZES.
