HERITAGE FOR MYANMAR

Earthquake, Heritage and Conservation

Assessment of Earthquake-Damaged Heritage

Prepared by HFM

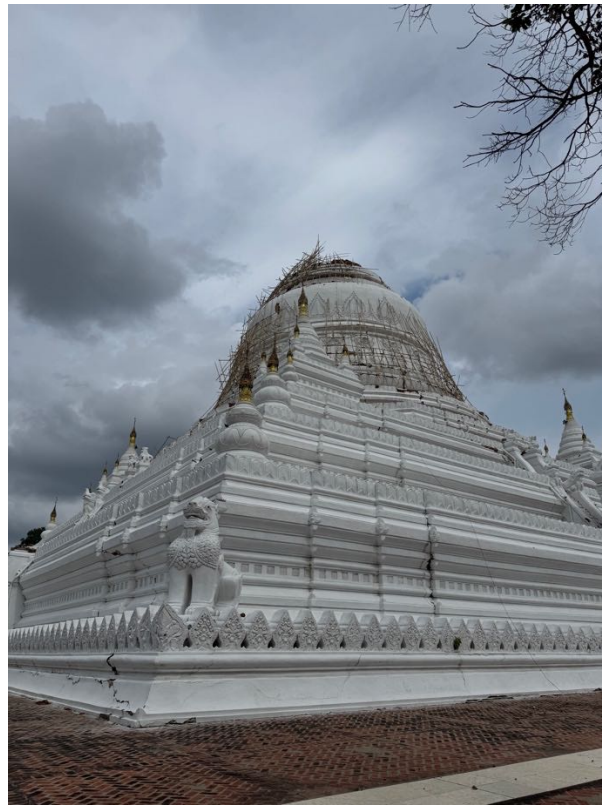
Stupas: As the most damaged category, the primary failure point was the upper spires (Figure 1). Spires previously "restored" using reinforced concrete and heavy cement mortars suffered the most. When these heavy upper sections collapsed, they frequently crushed the original ancient bell-shaped body and the base below. It has been observed that stupas maintained with original brickwork and traditional lime mortar proved more

stable while monuments previously subjected to maintenance using incompatible replacement materials and bell-shaped domed structures on top of stepped terraces exhibited heightened vulnerability and sustained more extensive structural impact during the seismic event.

Figure 1 – Pahtotawgyi, Amarapura (17 July 2025)

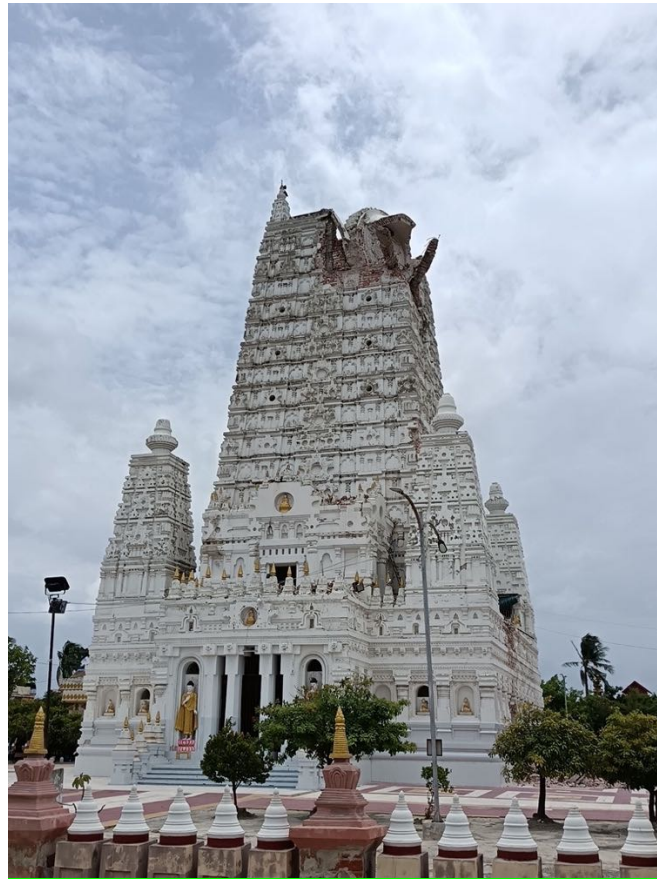
Temples: Heavy brick structures with numerous load-bearing walls suffered severe structural failure (Figure 2). Previous conservation interventions—which involved the injection of reinforced concrete (RC) or the application of cement mortars into the original masonry fabric—have proven detrimental. During seismic excitation, these incompatible materials underwent brittle fracture and delamination, causing significant physical damage to the original historic masonry. While a natural earthquake might only cause partial damage to an ancient monument, the presence of inappropriate restorations led to total structural collapse in some cases.

Figure 2 – Upper part of Mahabodhi damaged by the earthquake (8 July 2025)

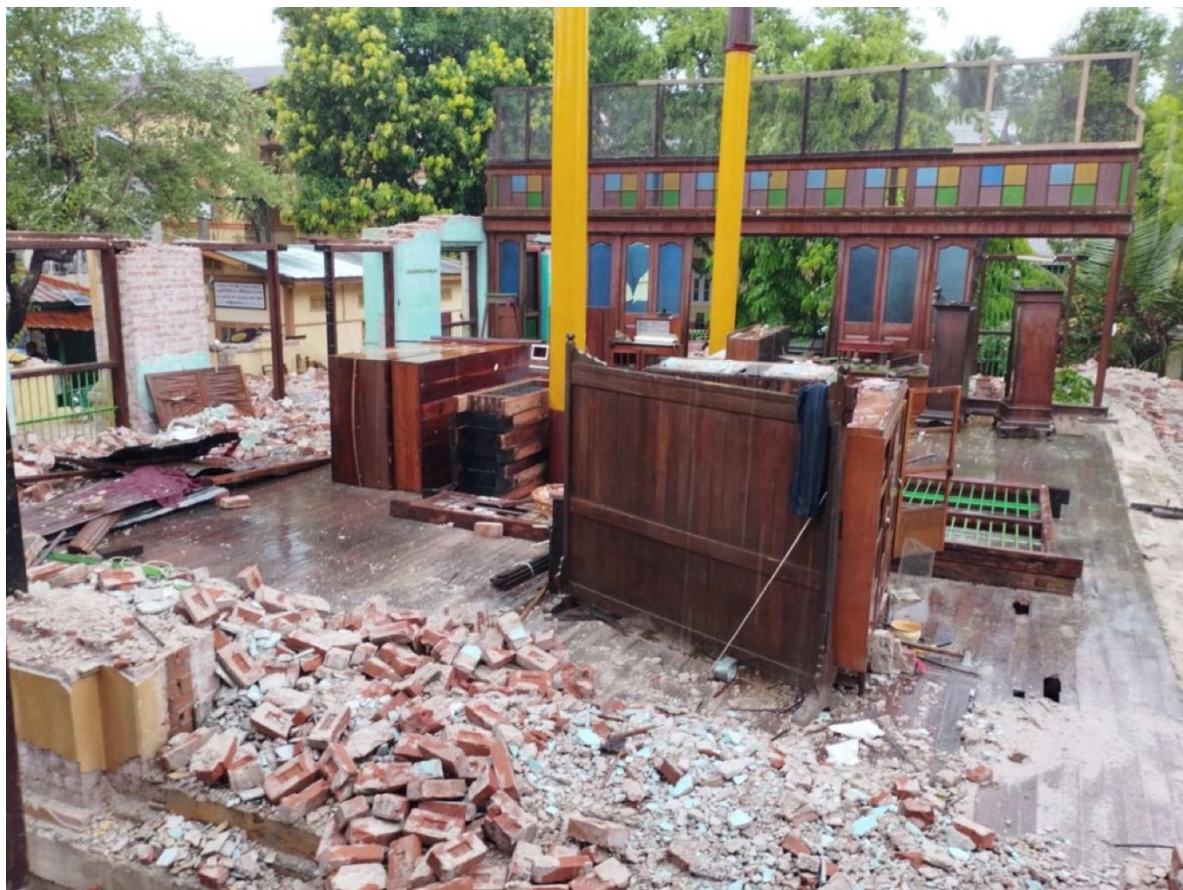
Brick and Timber Monasteries: Hybrid two-story monasteries constructed with load-bearing masonry exterior walls and internal timber framing (columns and beams) (Figure 3) exhibit higher seismic resilience compared to purely masonry structures. However, these buildings frequently sustain extensive out-of-plane failure in their two-story high masonry walls, a vulnerability primarily attributed to inadequate horizontal tying (diaphragm connectivity) between the timber floor systems and the masonry shell. When well-maintained, the internal timber skeleton allowed the building to sway with the seismic waves, reducing the overall force on the structure. However, due to the presence of earthquake-vulnerable structural elements—such as staircases, high-elevation entrance canopies, masonry walls with insufficient lateral bracing, and masonry wall corners—these buildings remain at a high risk of collapse during seismic events.

Figure 3 – Sasana Vithudi Monastery, Mandalay (31 May 2025)

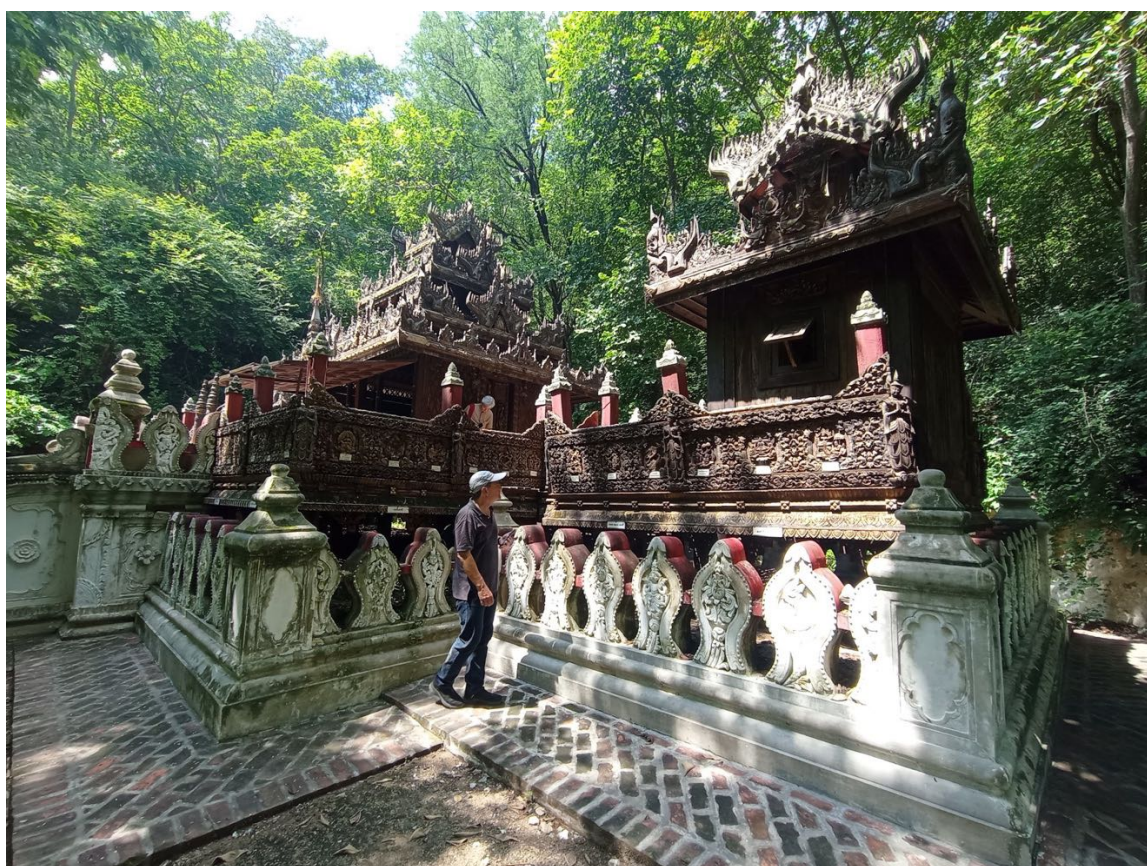
Timber Monasteries: Traditional timber monasteries constructed on stone plinths (Figure 4) sustained negligible structural damage, despite their proximity to the earthquake epicenter. This resilience is attributed to the traditional Myanmar

construction technique, in which timber columns are placed directly upon stone footings. This configuration allows the columns to move independently during seismic activity, while the inherent flexibility of the timber significantly dissipates seismic energy. Consequently, these structures exhibit high levels of earthquake resistance. This observation constitutes a critical lesson that should inform future heritage conservation and restoration policies.

Figure 4 – Ariyawuntha wooden monastery, Sagaing (31 August 2025)

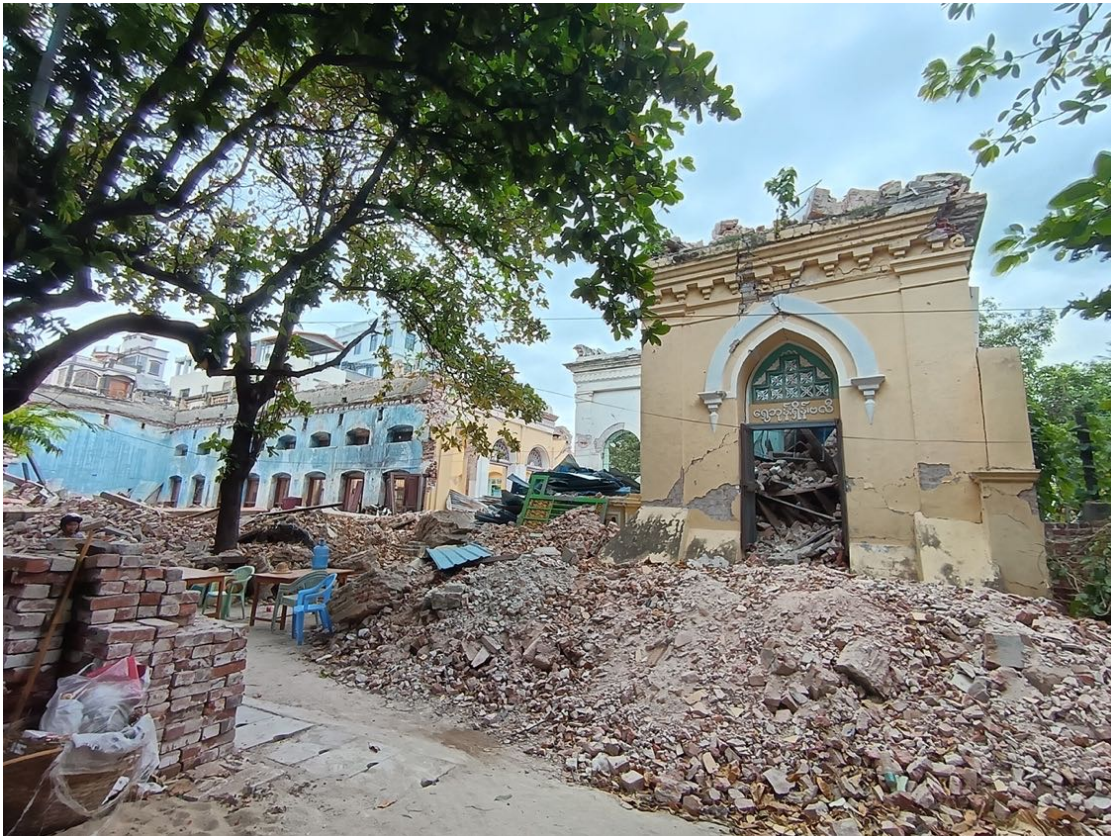
6 – Shwe Phone Shein mosque, Mandalay (8 July 2025)

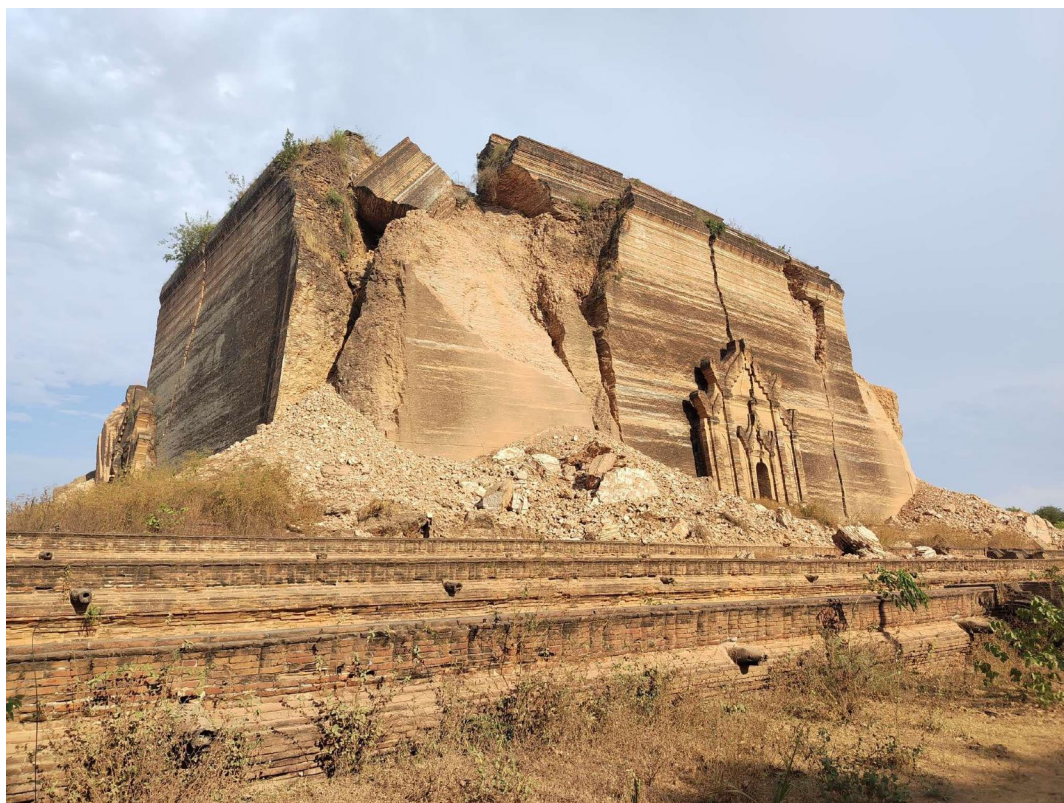
Figure 11 – Mingun Pahtotawgyi [VL], Mingun (14 April 2025)

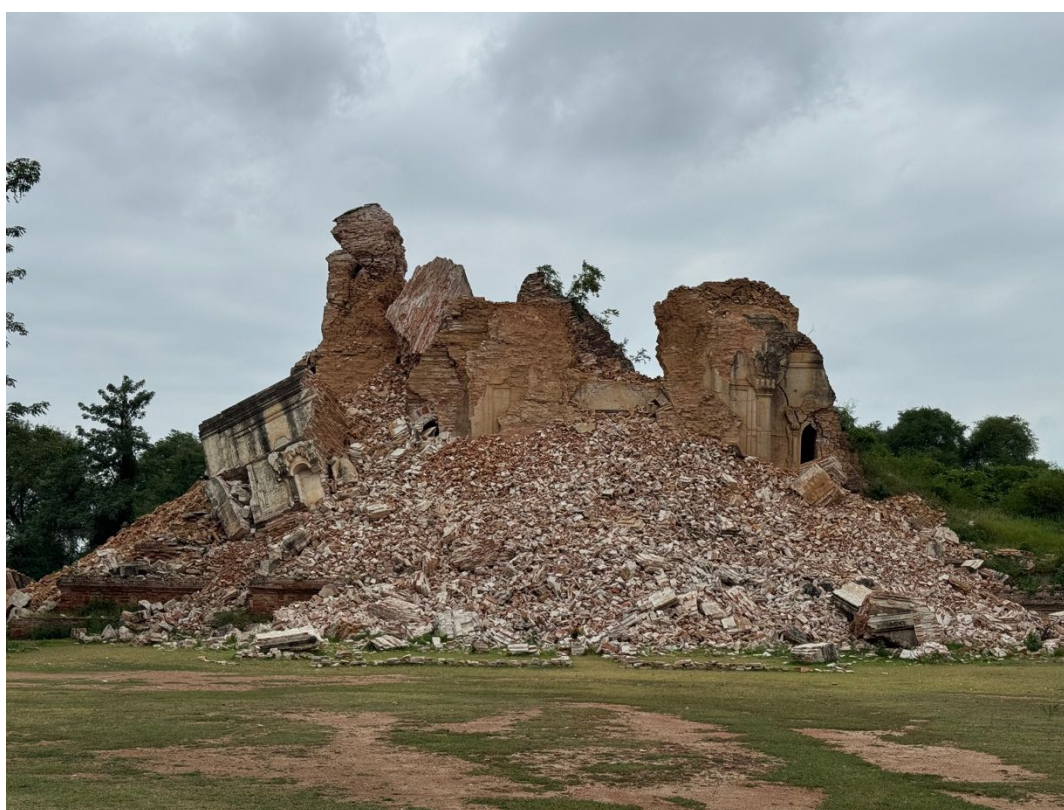
Figure 12 – Layhtetgyi Monastery [L], Inwa (16 July 2025)

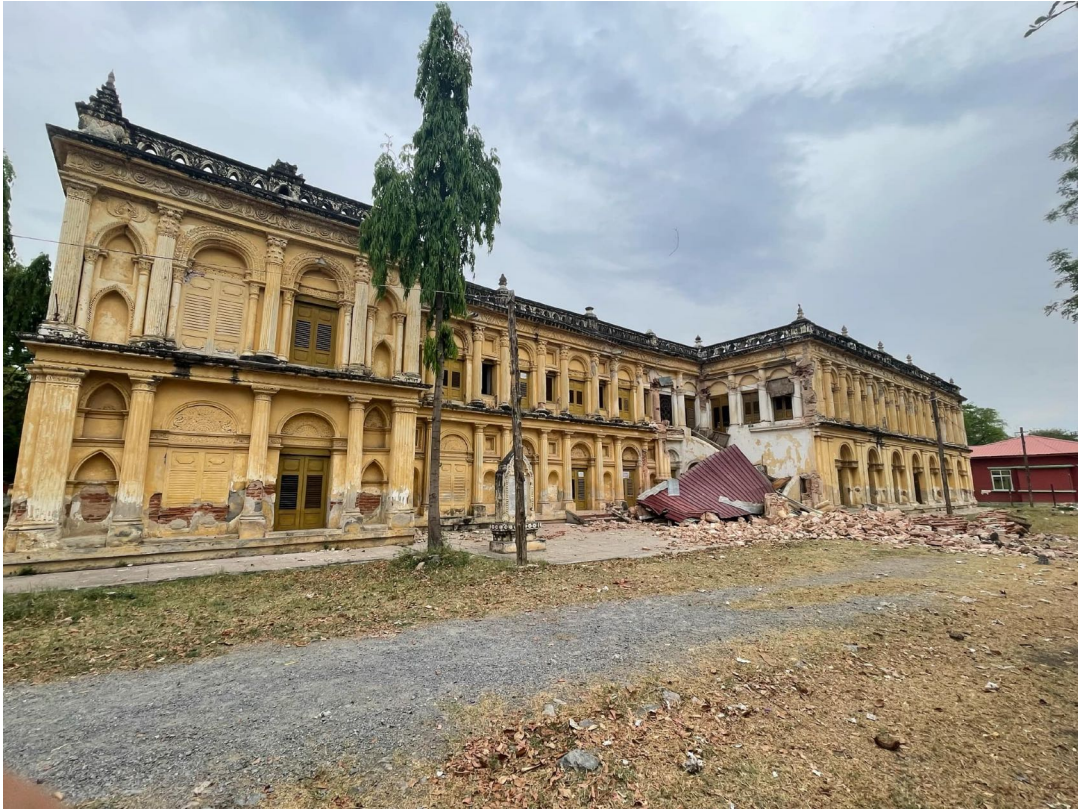
Figure 13 – Yawmingyi Monastery [L], Mandalay (12 April 2025)

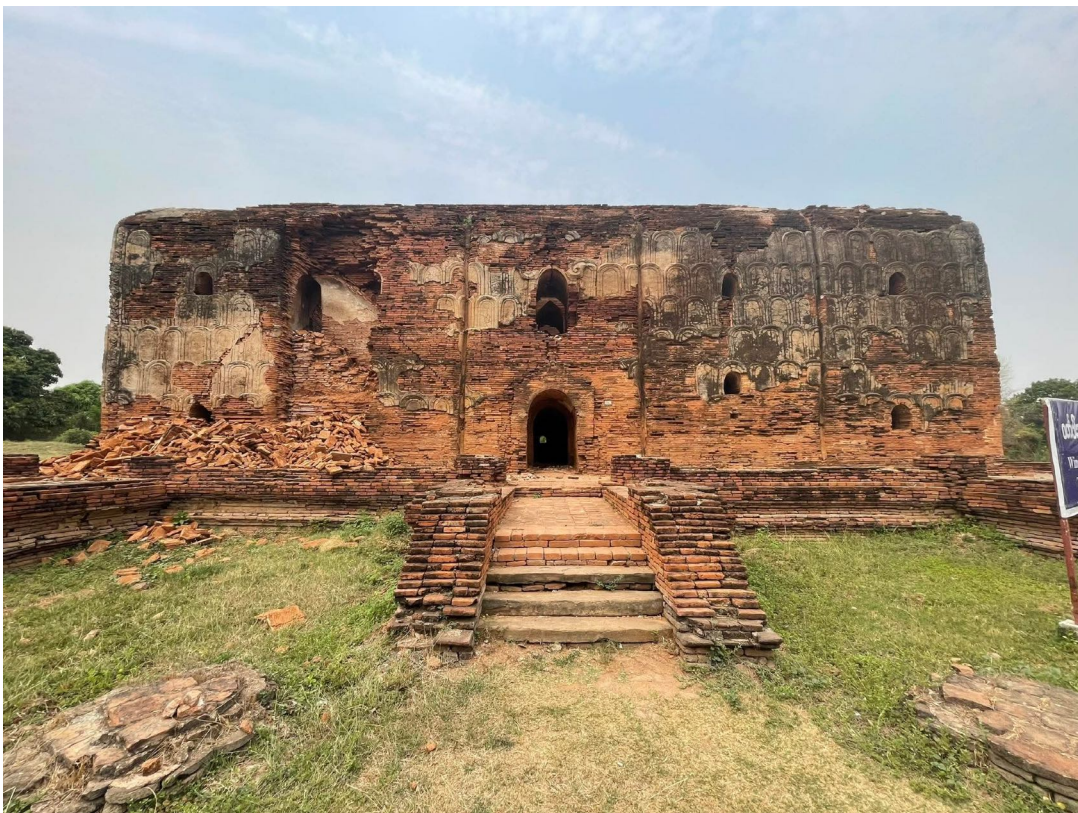
Figure 14 – Wingaba pagoda [M], Inwa (6 April 2025)

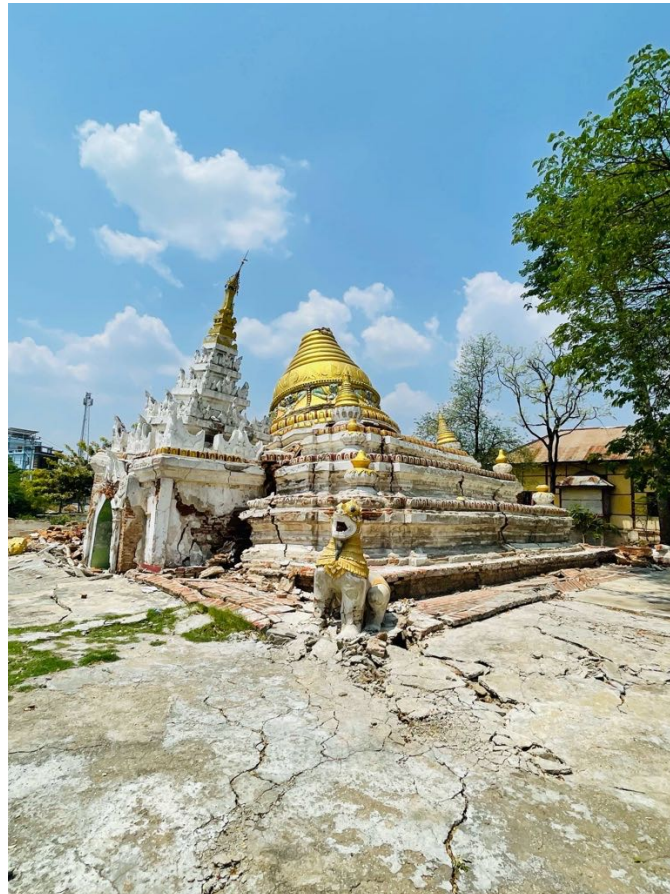
Figure 15 – Aung Chan Tha Pagoda [S], Sagaing (20 April 2025)

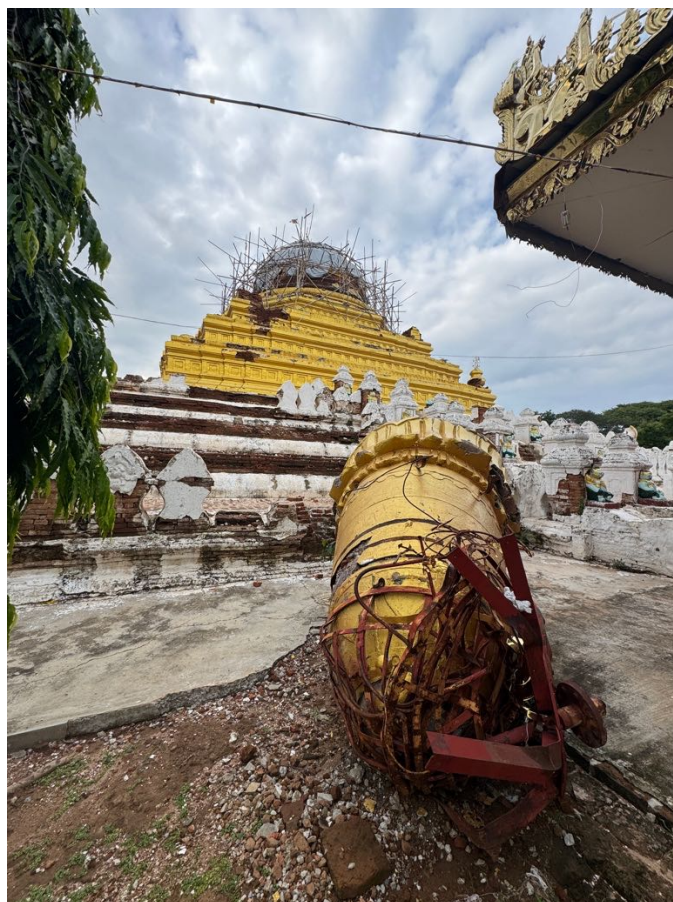
Figure 16 – Collapsed spire of Sandamuni Zedi, Amarapura (17 July 2025)

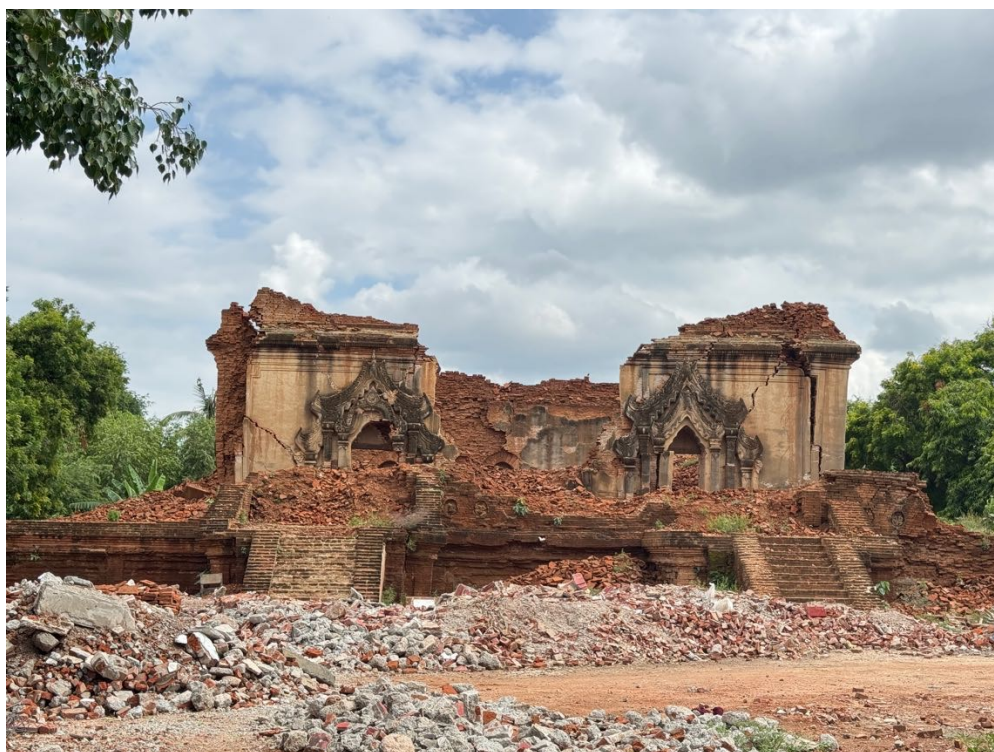
Figure 17 – Walls of Shweguyi Monastery damaged by the earthquake, Amarapura (17 July 2025)

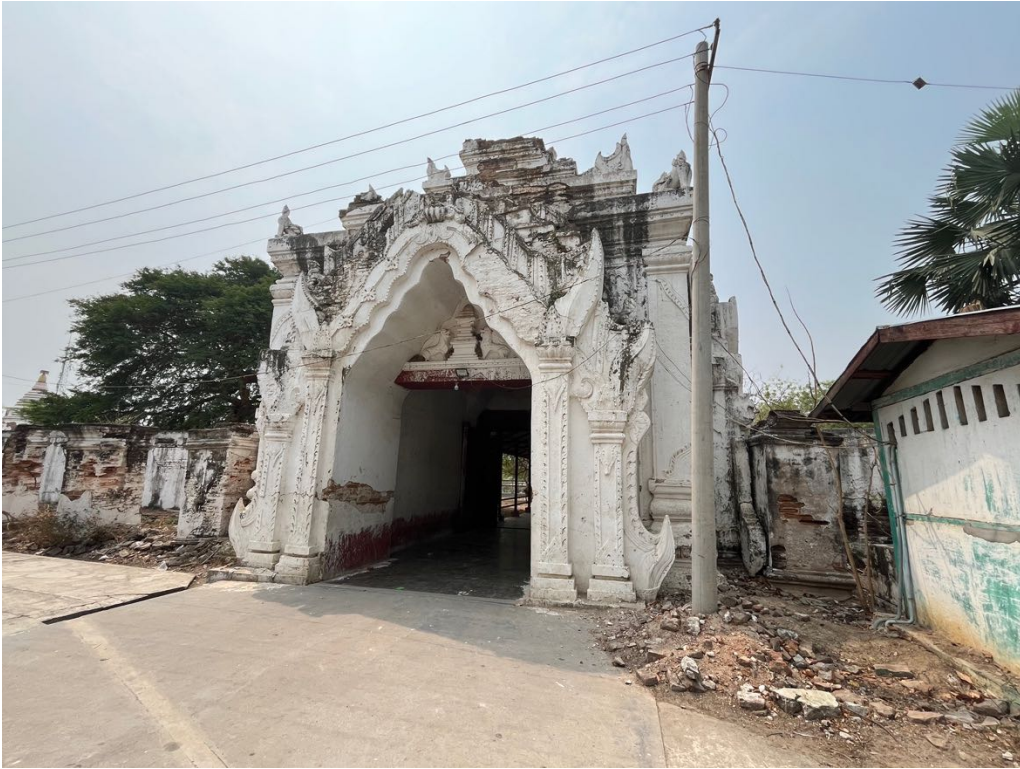
Figure 18 – Upper part of the entrance of Lawka Manisular pagoda damaged by the earthquake, Mandalay (1 April 2026)

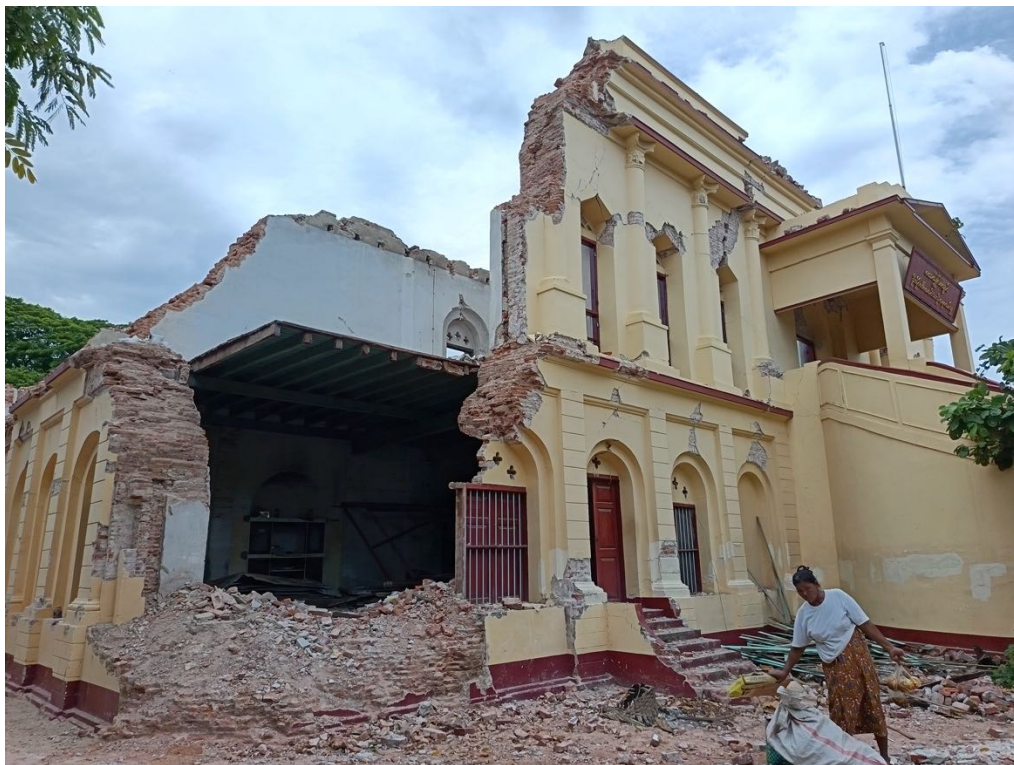
Figure 19 – Roof and walls of Maha Bandoola Monastery damaged by the earthquake, Mandalay (8 July 2025)

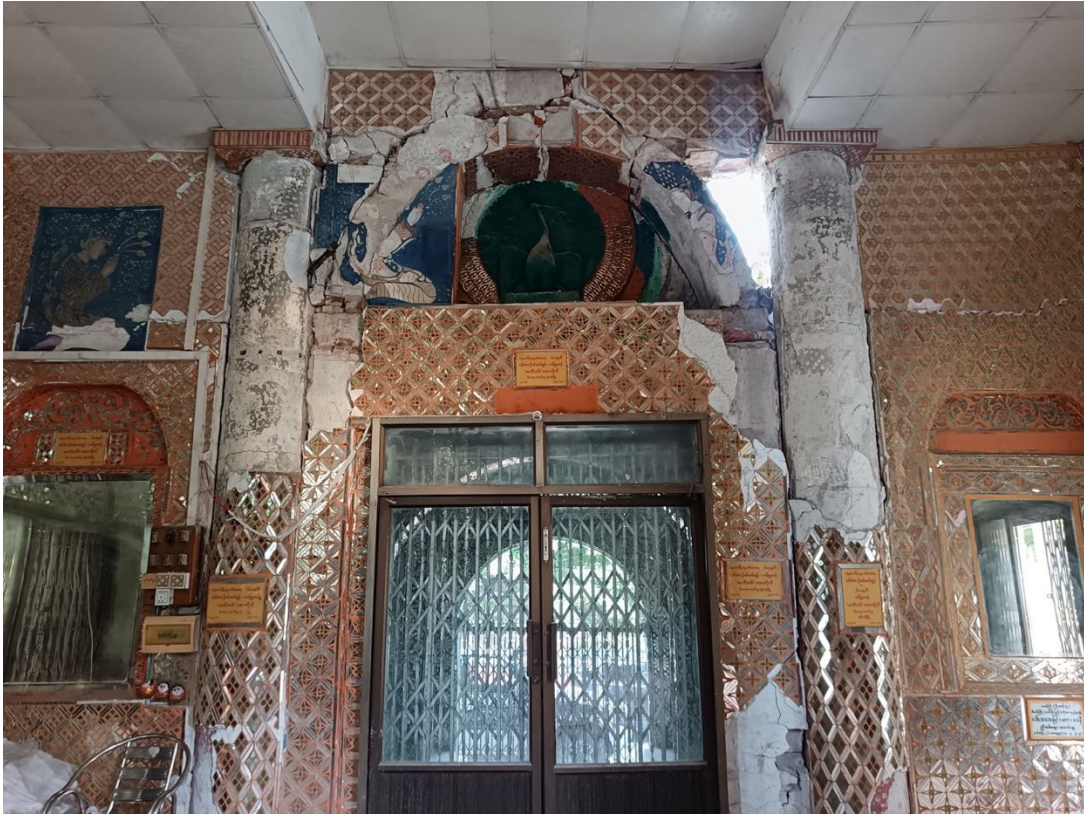
Figure 25 – Damage of glass mosaic, Shwe Yinye’ pagoda, Amarapura (15 July 2025)

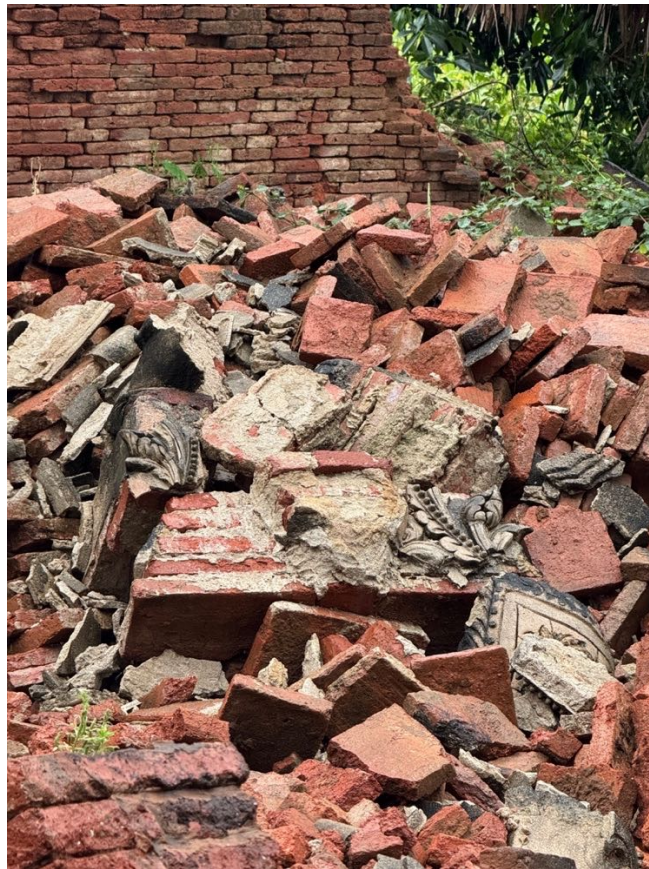
Figure 26 – Fragments of stucco, Yadana Semi complex, Inwa (16 July 2025)

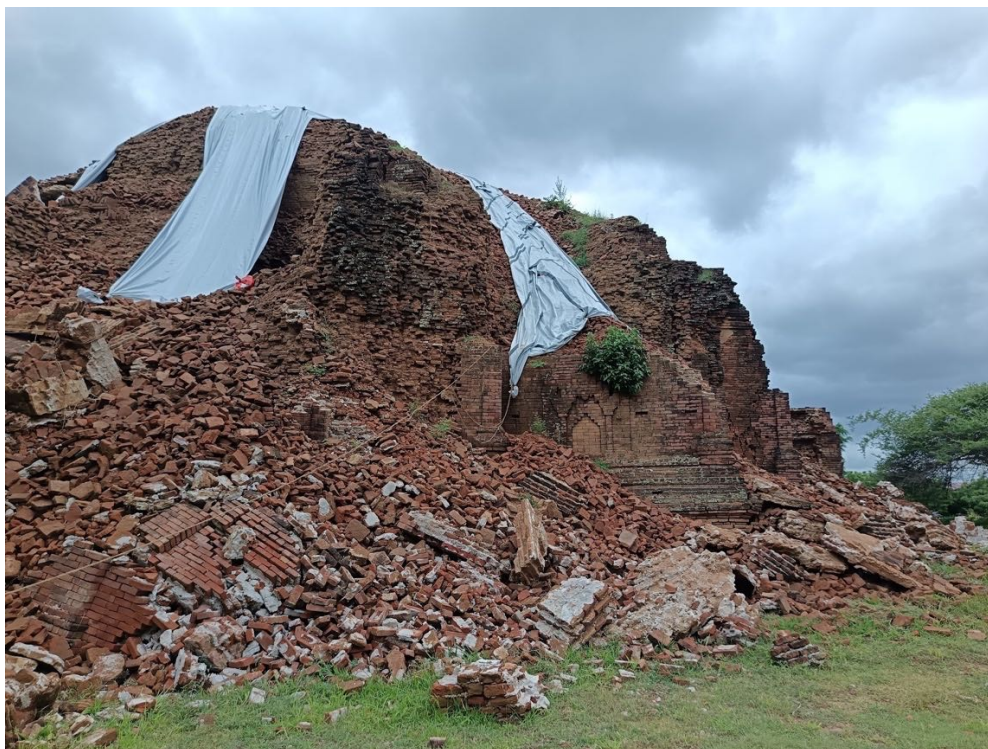
The existing protective measures at most sites (Figures 27-28) have been found to be largely ineffective. As previously noted, tarpaulin covers are frequently displaced by wind, failing to protect the underlying masonry from rainfall. This exposure allows rainwater to seep into the structures, endangering interior walls and delicate murals. Furthermore, the moisture encourages the growth of invasive plants within the debris, which poses a secondary threat to the structural integrity of the heritage assets. At sites where a risk of further collapse exists, the current use of physical barriers and warning signs is also insufficient to ensure public safety or prevent further damage.

Figure 27 – Pagoda no.233, Pinya (18 July 2025)

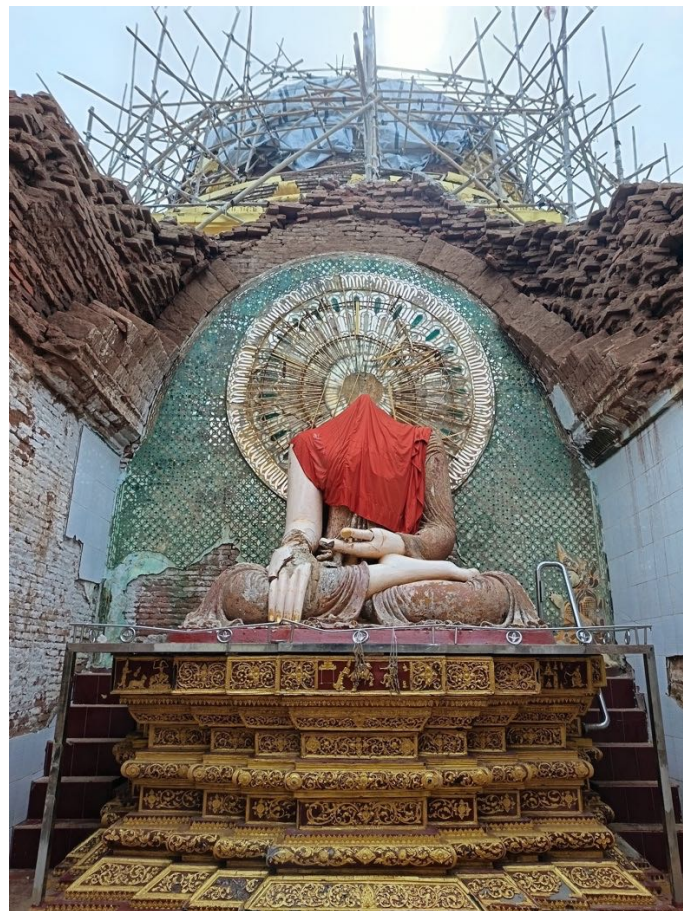
Figure 28 – Sandamuni and Buddha image, Amarapura (15 July 2025)

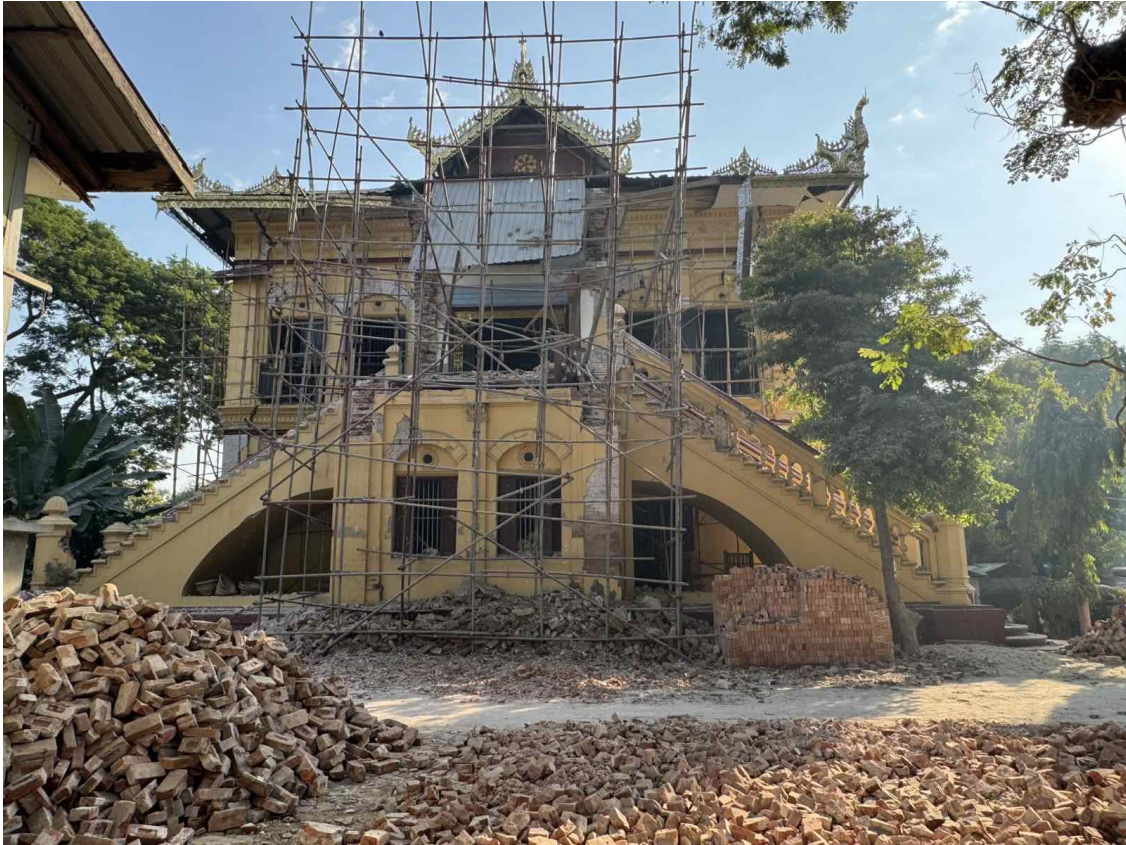
failure were the insufficient connectivity between the timber floors and roofs and the structural walls. Furthermore, the lack of robust ring beams (wall plates) to provide lateral confinement contributed significantly to the severity of the damage.

Figure 29 – Damage of the rear veranda of Abayarama monastery

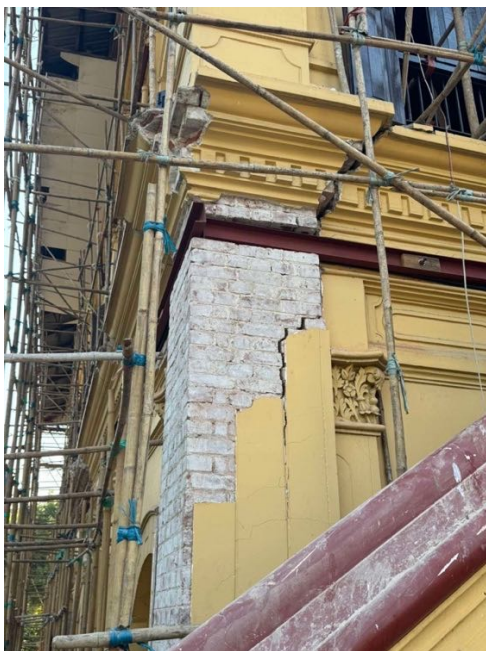
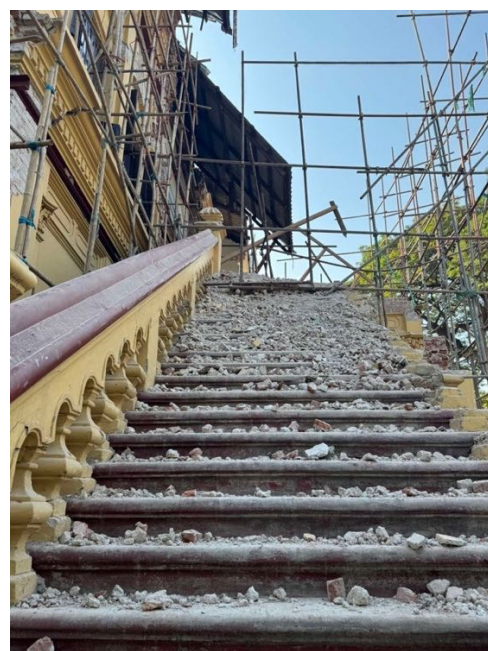
Figure 30 – Damage of corner (left) and staircase (right)

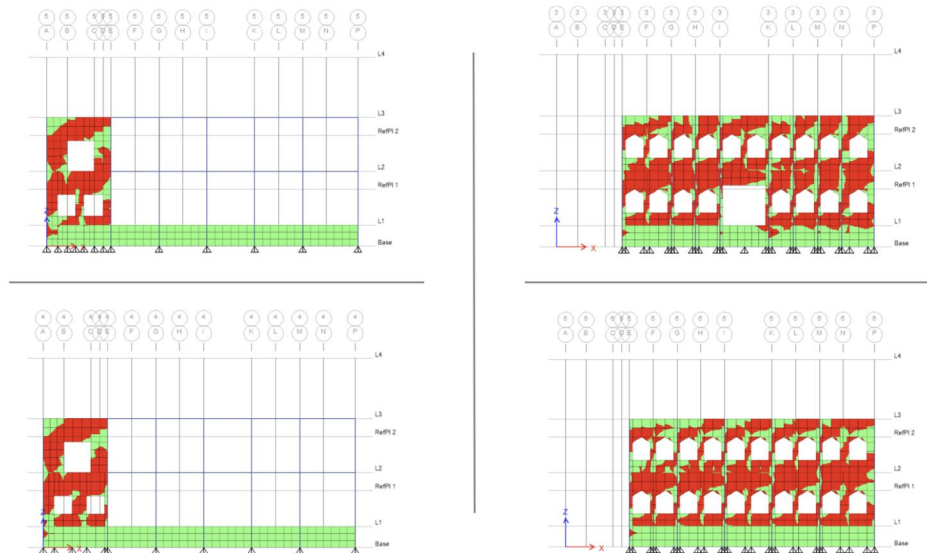
Figures 29 and 30 summarize the ETABS-based demand screening for (a) URM in-plane shear demand and (b) out-of-plane wall demand. Green indicates demand within the adopted allowable limit; red indicates demand higher than the allowable limit and therefore requires retrofit attention.

IN PLANE Shear – Green is OK , Red is Higher than allowable

Figure 33 – Model showing damage caused by inward force impact on the surface of the load-bearing walls of the building

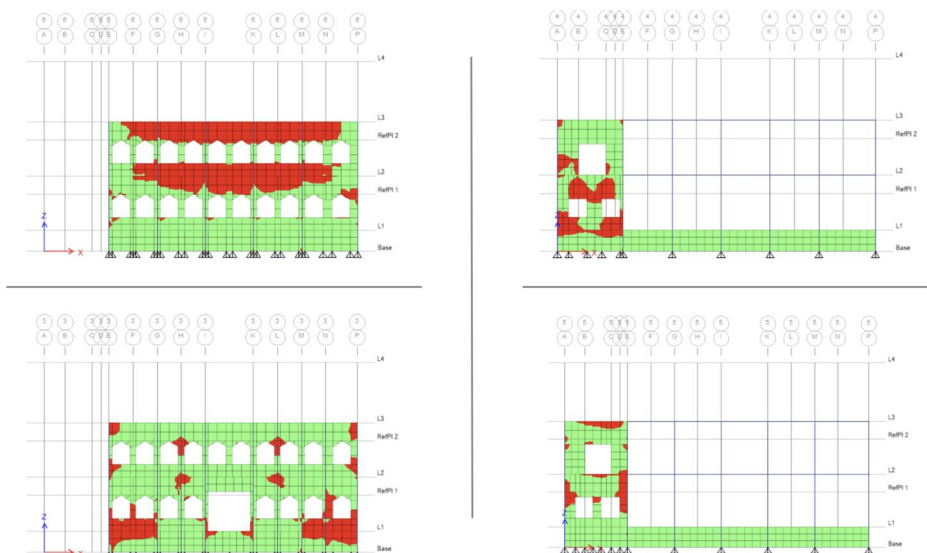
OUT OF PLANE – Green is OK , Red is Higher than allowable

Figure 34 – Model showing damage caused by outward force impact on the exterior surface of the load-bearing walls of the building
