**Emergency
measures and
damage
assessment
after an
earthquake**

Pierre Pichard

CLT/84/WS/14

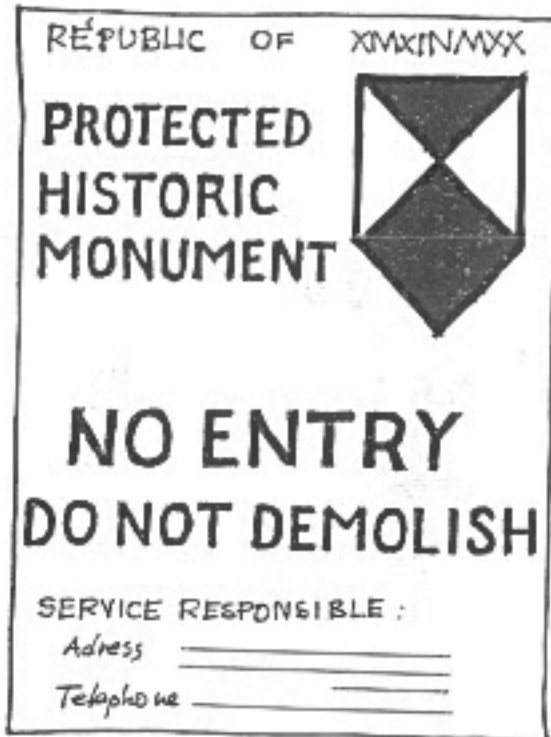
Figure 2

Another solution - provided that advance preparations have been made (see chapter 10, section (d), paragraph 5) is to affix to the walls of monuments printed stickers prominently displaying the same emblem (fig. 2) with a warning message in the local language or languages. It is recommended that any such stickers should show the address and telephone number of the service responsible for each monument.

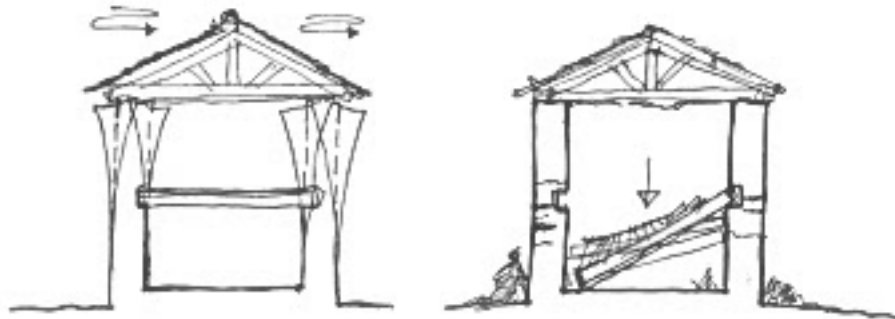
When the floor beams and joists are not deeply set into or anchored in the walls, the temporary separation of the walls during certain phases of the vibration can cause the collapse of the floors (fig. 9).

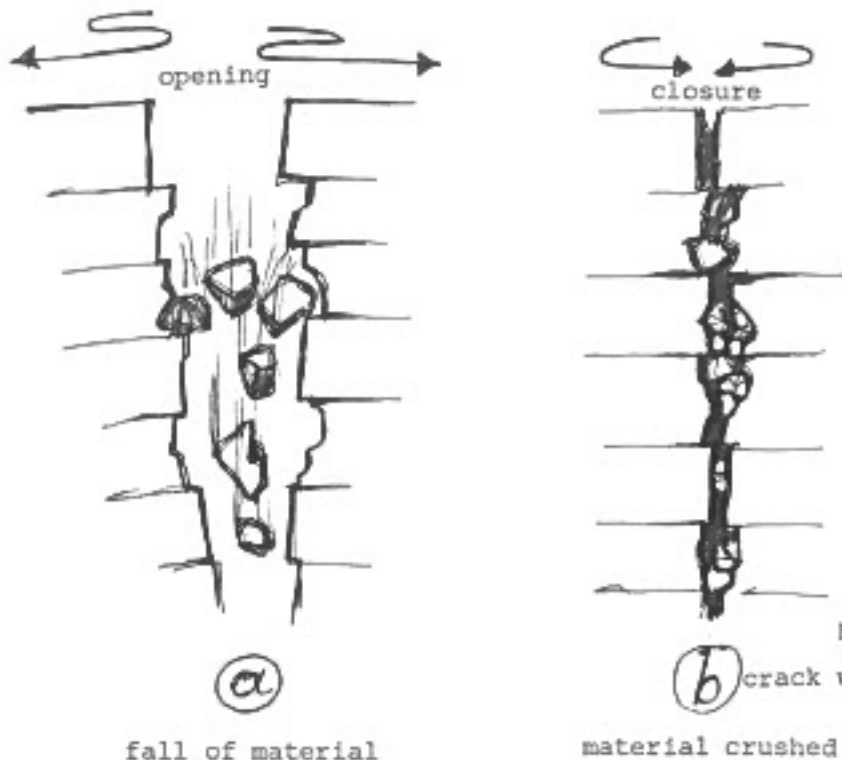
(c) Deep cracks with crushing of material. The presence of crushed building material (stone or brick) inside the cracks shows that, at certain phases of the vibration period, the crack has opened wide between two parts which vibrated differently from each other. There has thus been an actual dislocation, even if the crack closed up again when the vibration stopped, crushing the imprisoned material (fig. 16).

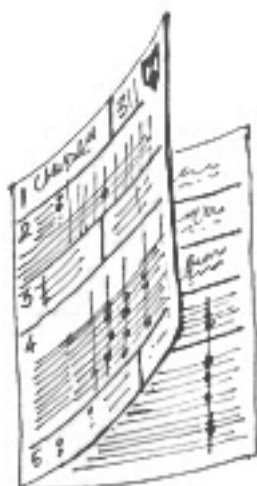
Figure 18

This set of sketches, or simplified drawings, can be included in a standardized damage-assessment form (one form per monument or building); the use of these forms is the best method of obtaining accurate and consistent results. The forms specially designed for assessing the damage to the historic monuments of Montenegro, Yugoslavia, after the earthquake of 15 April 1979 have proved their worth. They comprise four pages, 210 mm by 297 mm (fig. 18 and annex 1).

Damage assessment form
(see Annex 1)

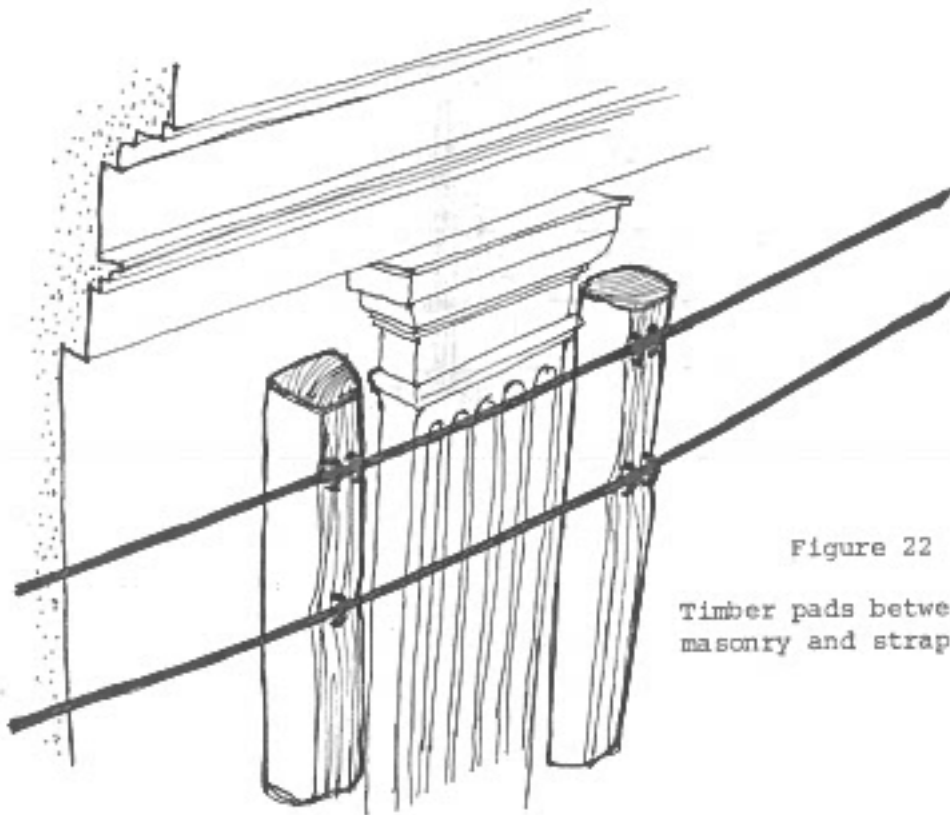
In order to provide a better seating on the masonry and to protect the architectural decoration (mouldings, pilasters, plastering, etc.) it will often be essential to insert barks of timber between the straps and the building (fig. 22).

Figure 22
Timber pads between
masonry and straps

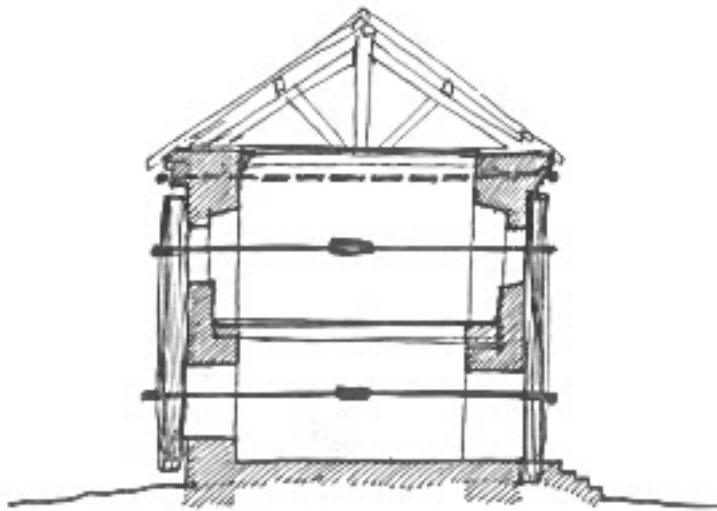
Figure 23

Where the building is of some size and, more especially, if it is elongated, strapping alone is not enough. Cross ties must be added. The simplest solution is to use the windows, but this is generally risky because the level at which the ties are positioned is unsatisfactory. It is accordingly necessary to place vertical pads between the walls and the ties and to position the ties symmetrically in relation to the floors (fig. 23). Wherever possible, the aim will be to place the cross ties symmetrically in relation to the compressible components that divide up the structure: floors, cross-walls, diaphragm arches, etc.

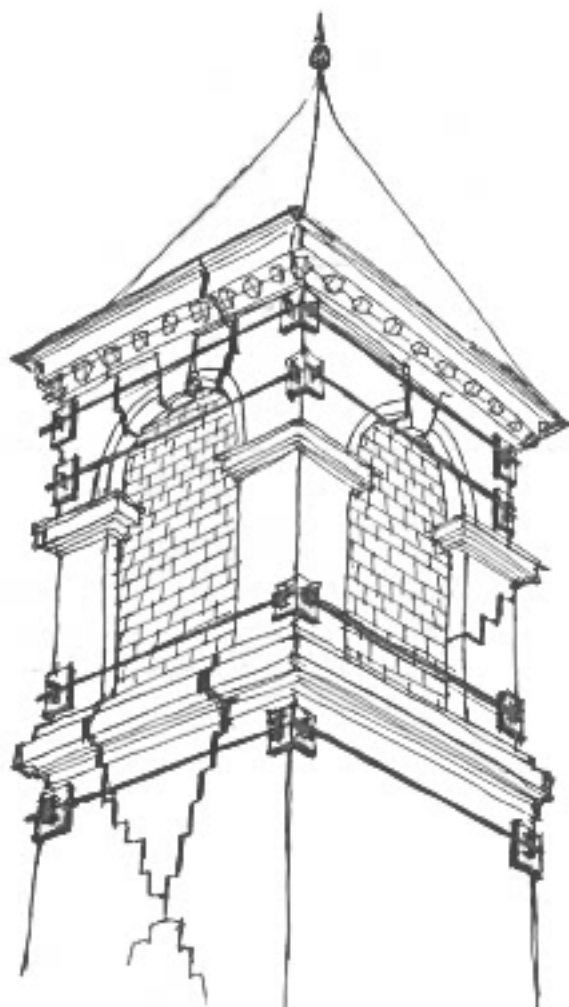
By a combination of walling up openings and fitting straps, even structures pierced by many openings can be stabilized (fig. 27).

Walling up of openings and strapping

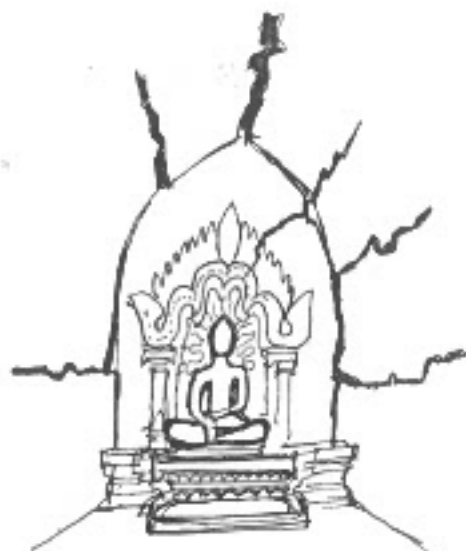
Figure 29

Temporary protection must sometimes be provided for non-transportable items of exceptional value (altars, tombs, statues or groups of sculpture, etc.). In the initial (critical) period, sandbag protection is an acceptable measure. Thereafter effective protection against falls of overhanging masonry may be provided by a shelter stoutly built of timber or metal with adequate bracing and designed to resist crushing (fig. 29) covered with boards, at least 25 mm thick.

Protection of a non-transportable statue

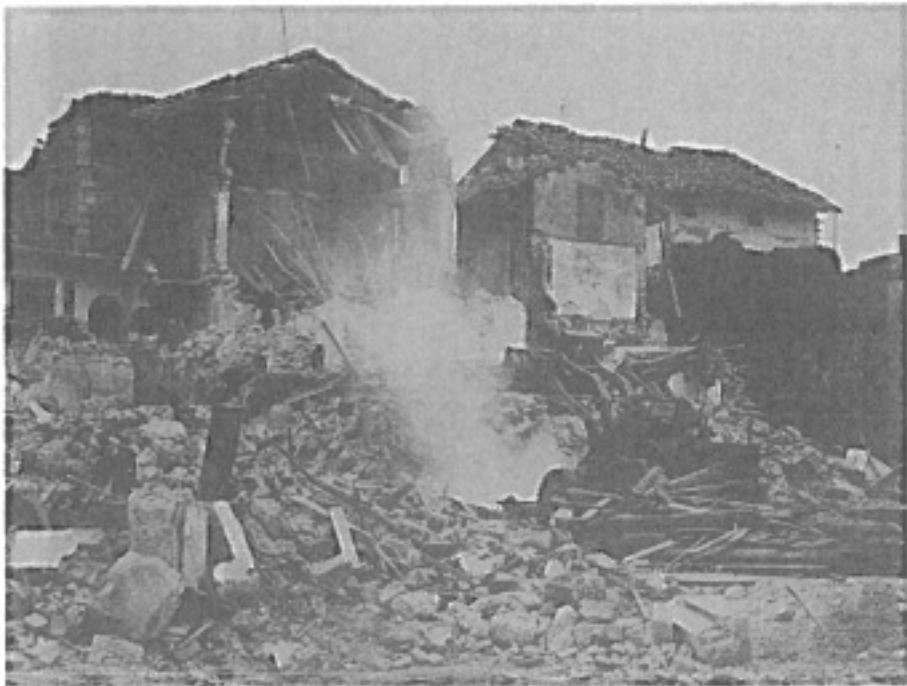
Photo 1

Friuli (northern Italy). Systematic demolition of ancient houses in a village damaged by the earthquake of 6 May 1976.

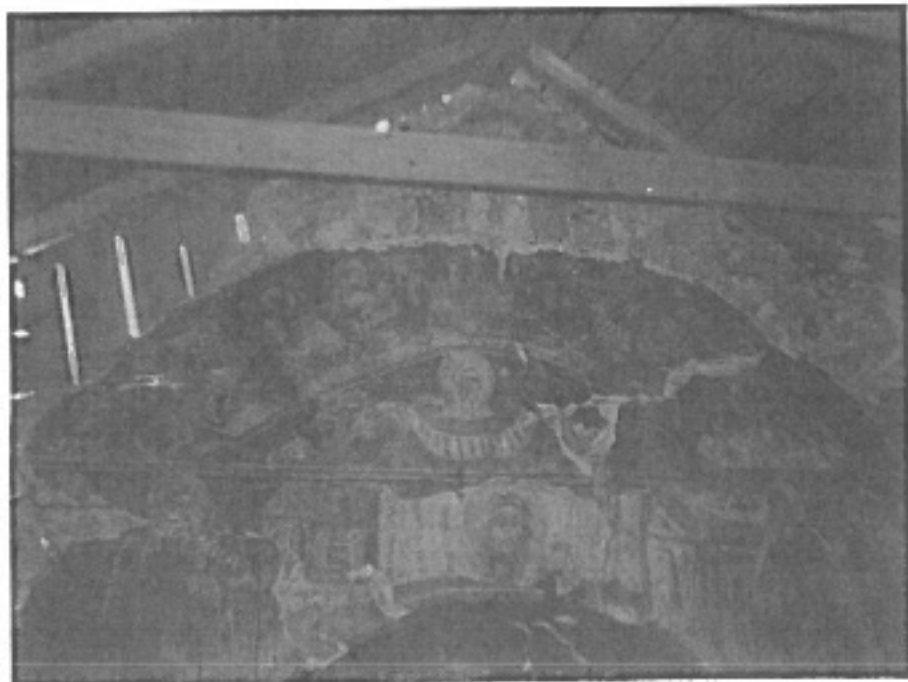
Photo 3

Podlastva monastery, interior of the church and frescoes on apse wall under temporary roofing.

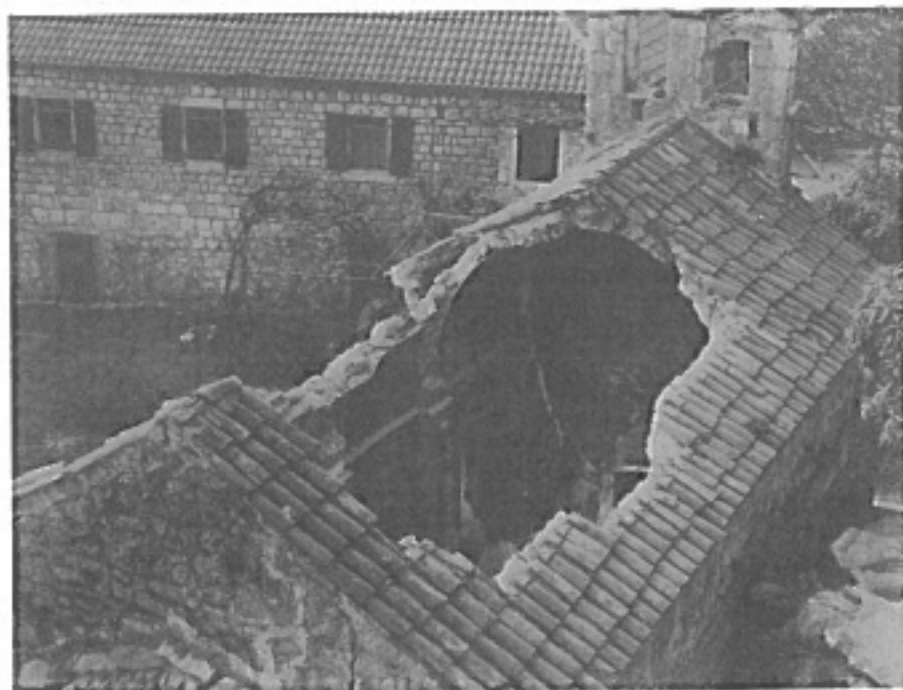
Photo 4

Gradiste monastery (Montenegro), church of St Nicholas: part-collapse of vault, dangerously exposing frescoes of 1620 AD.

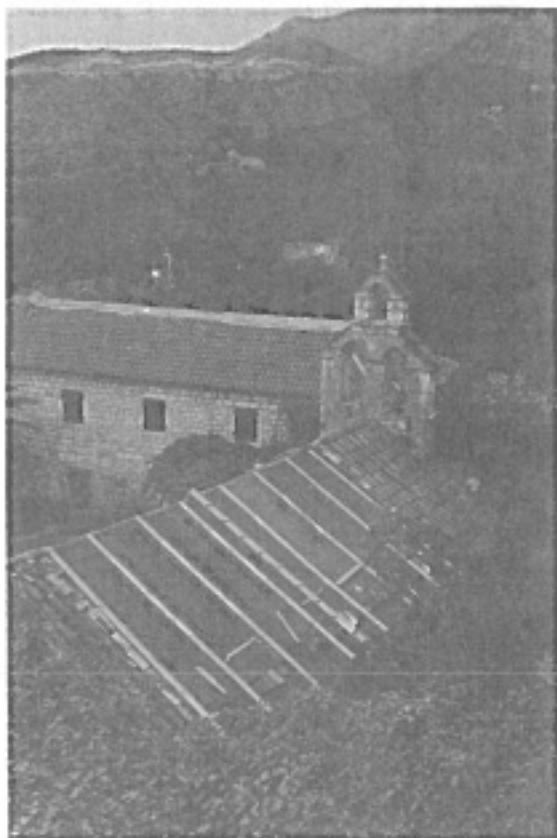
Photo 5

Gradiste monastery: temporary protective roofing.

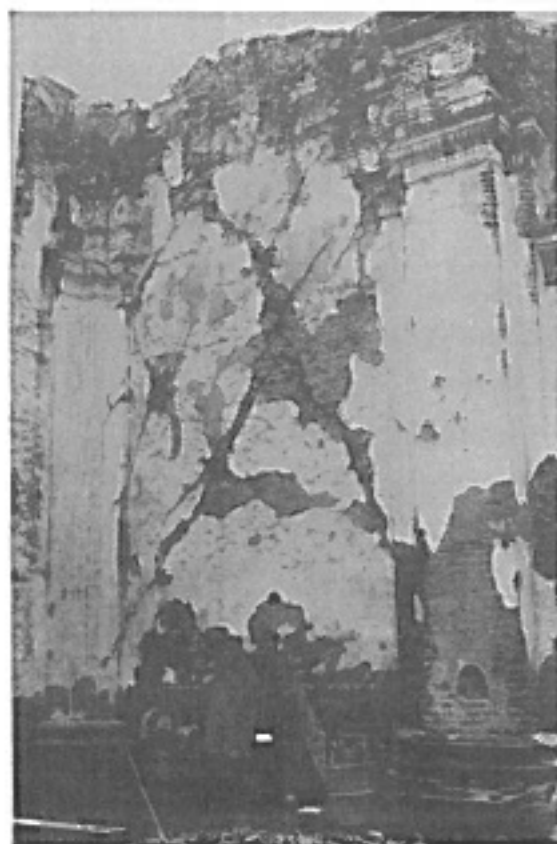
Photo 6

Antigua Guatemala: cathedral damaged by the earthquakes of July 1773 and 4 February 1976. Diagonal x-shaped cracks evidencing lengthwise oscillation of wall.

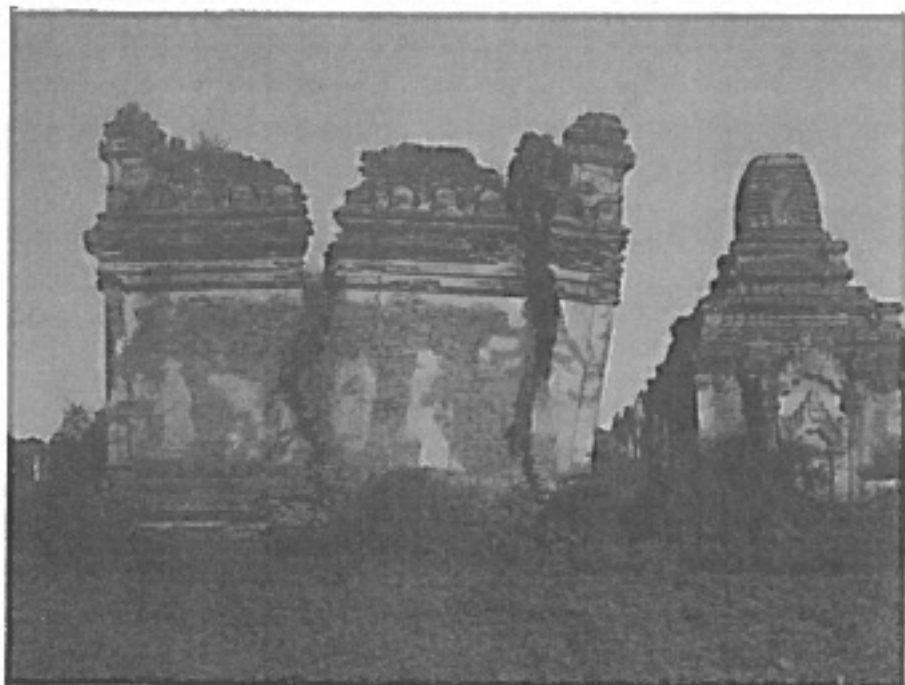
Photo 8

Pagan, temple No. 1828. West wall split into three. Crushing of the base and subsidence of the foundations evidenced by the tilt of the south wall (on the right) and of the central fragment.

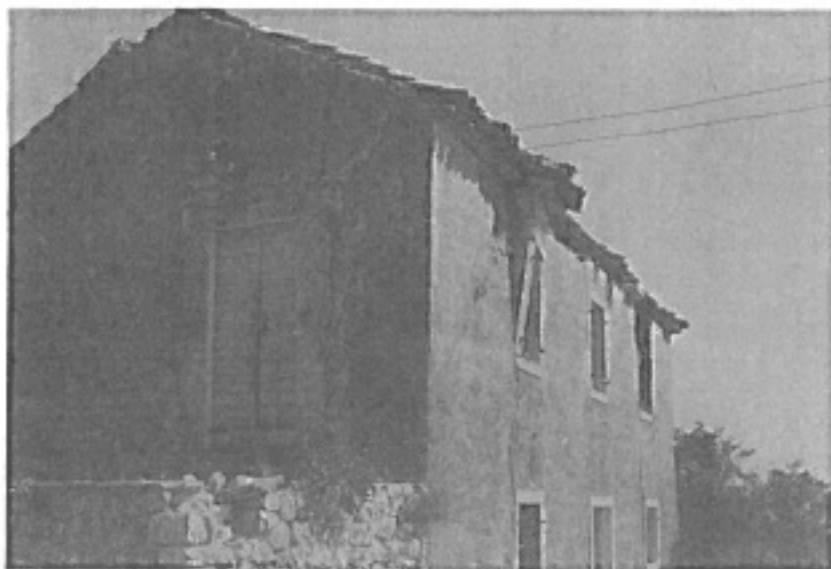
Photo 9

Brajici (Montenegro): Dislocation of the walls of a house by cracks that follow the openings.

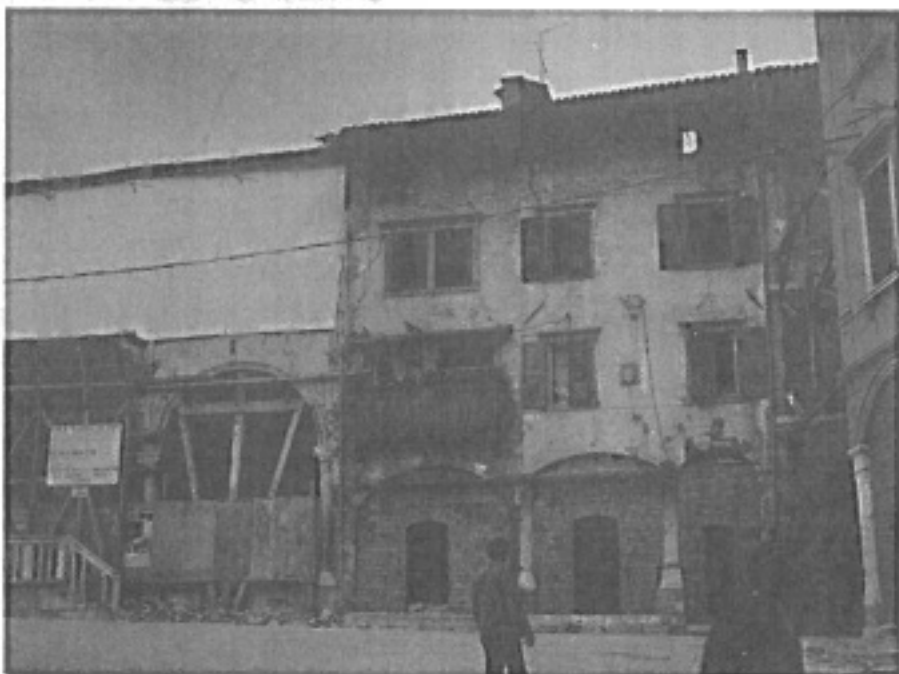
Photo 16

Gemona (Friuli): to the left, bracing of arches and temporary covering on town hall. To the right, the arcades of the houses have been bricked up.

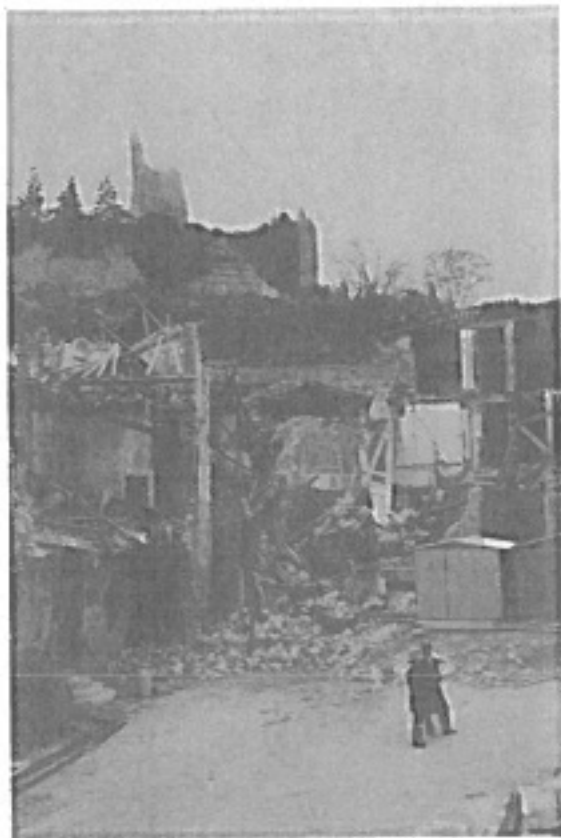
Photo 19

Gemona (Friuli), Palazzo Gurigatti:
same view after the aftershock of 15 September 1976.
The monument has fallen in on itself completely,
behind the props. The neighbouring buildings are
partly destroyed.

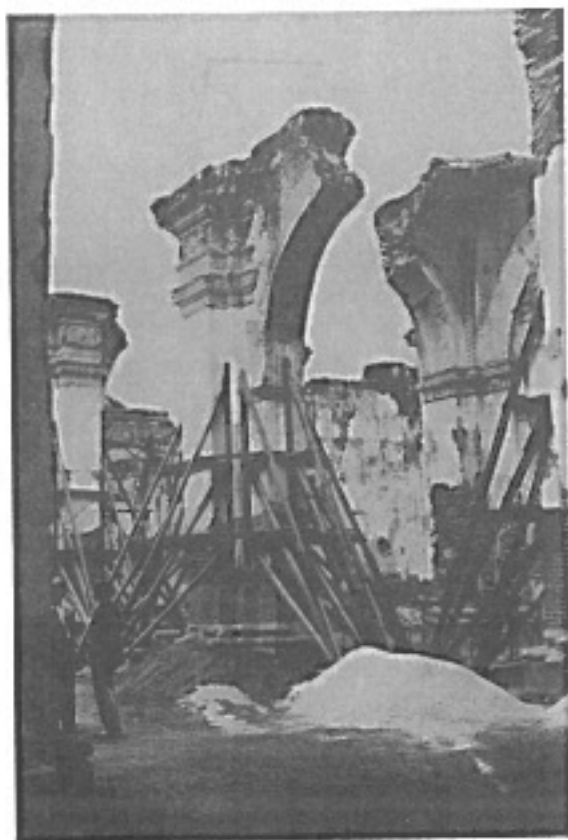
Photo 20

Antigua Guatemala, cathedral:
shoring of a single pillar in the ruins left by
the earthquakes of 1773 and 1976.

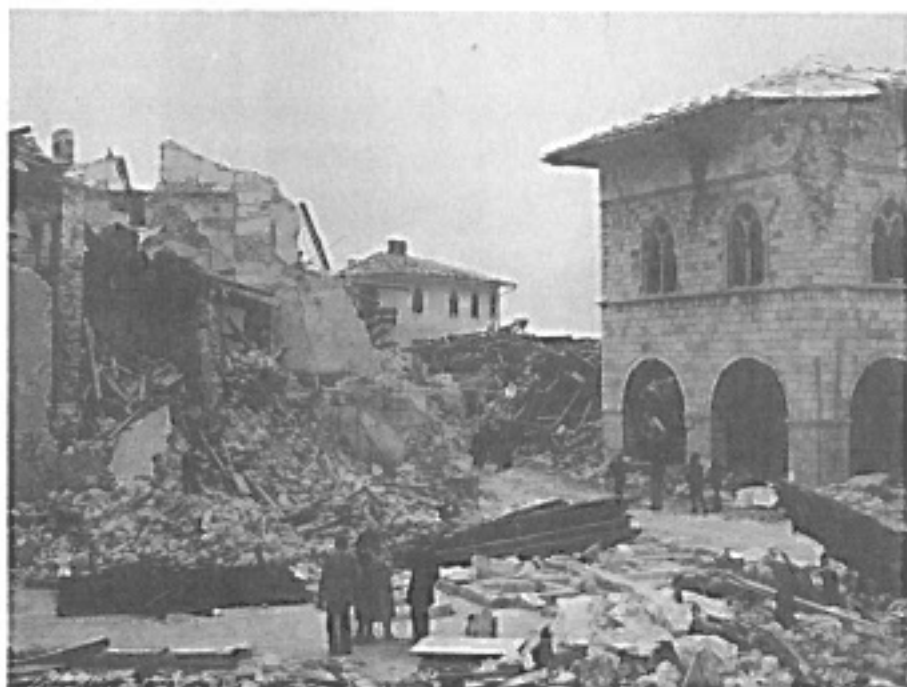
Photo 22

Venzona (Friuli): Debris of old houses destroyed around the town hall, which was severely damaged.

As a general rule, however, in the interests of workers' safety, no removal of debris should be allowed until the stability of all large masonry features still standing has been improved (photo 22).

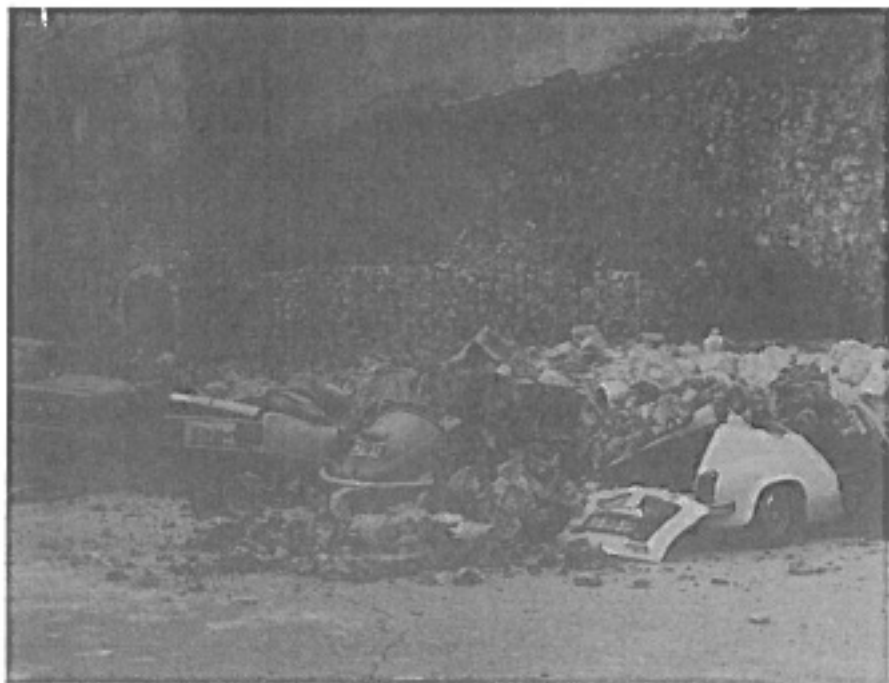
Photo 23

Budva (Montenegro): The ramparts of the medieval town collapsed, crushing several parked cars including a vehicle belonging to the Service for the Protection of Historic Monuments of Montenegro.
