GUIDELINES FOR IN-DEPTH CONDITION ASSESSMENT OF MONUMENTS AT BAGAN

within the framework of the UNESCO Project
“Technical Assistance for the Conservation of Built Heritage in Bagan” funded by Japan

III- 1 Outline of the target monument (No. 1249 Phya-sa-shwe-gu)	63
III- 2 Site preparation and basic documentation	66
III- 3 On-site investigation	69
III- 4 Laboratory testing	89
III- 5 Analysis and assessment	100
III- 6 Recommendation	103

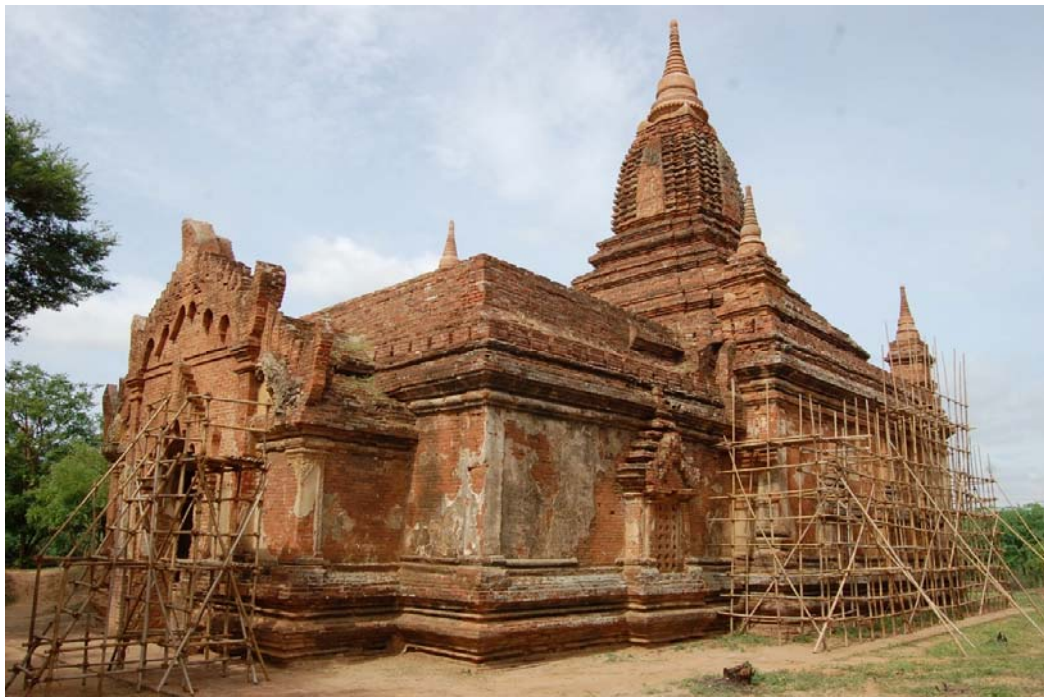
Fig. 35 Phaya-shwe-gu Temple with scaffolding installed for the areas that needed to be inspected, plus a moveable scaffold that can be used for accessing different parts of the exterior building.

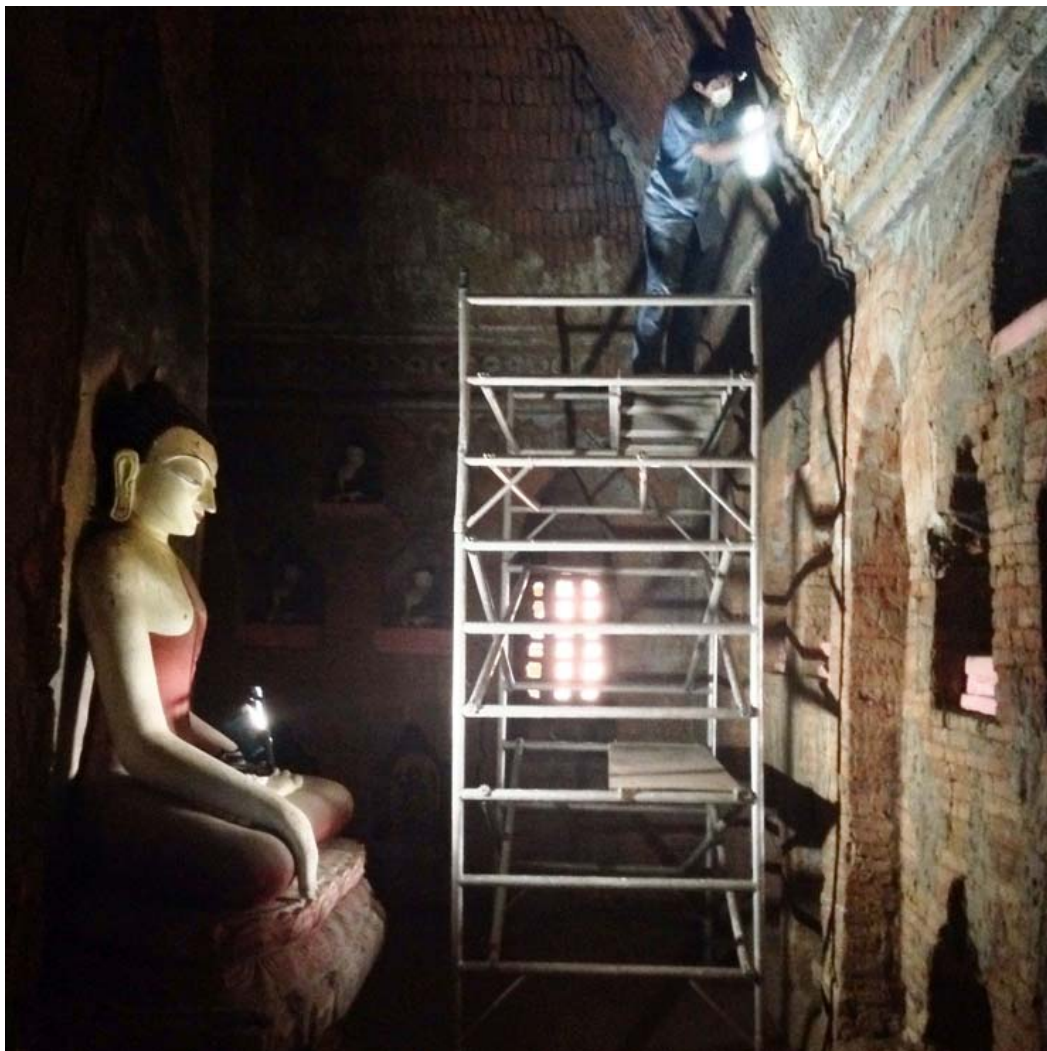
Fig. 36 The moveable rolling tower that was used inside of the building together with aluminum scaffolding.

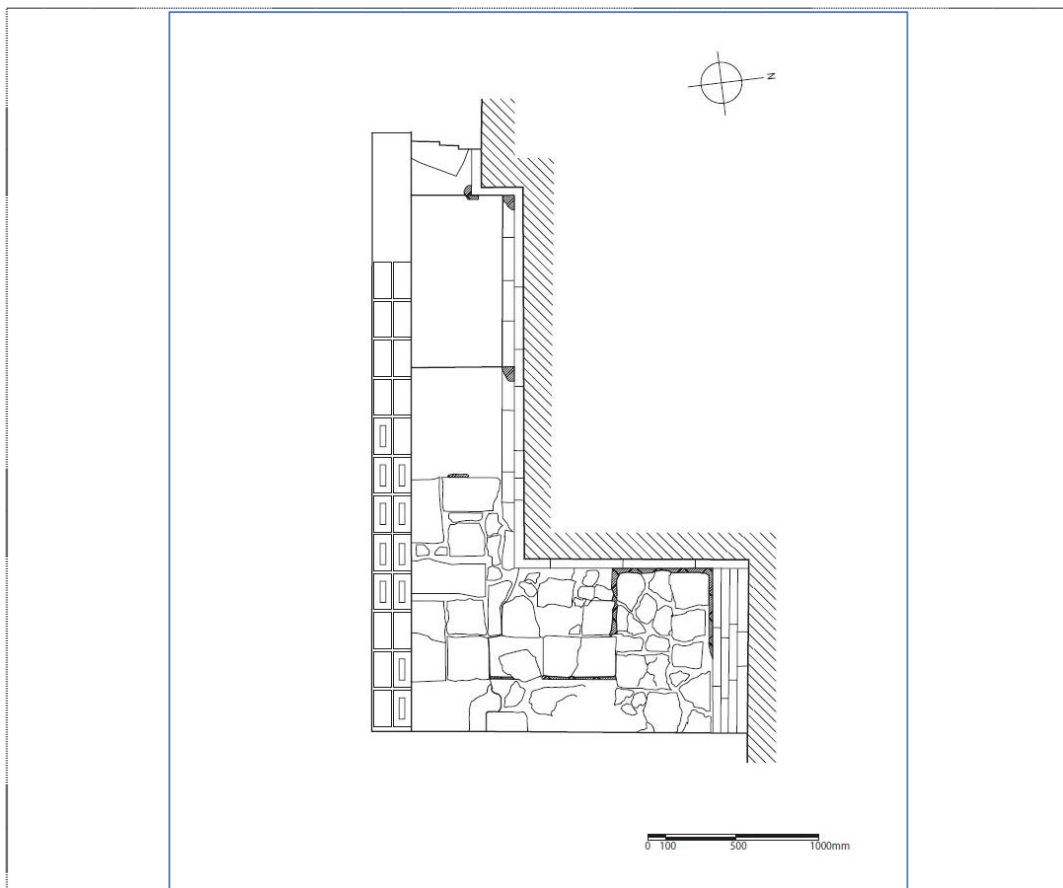
Meanwhile, there is a gap on the brick wall above the top face of the fifth layer at around the southeast corner of the main body. From the observation, it can be noticed that the gap stretches in a stepped pattern into an internal corner where the entrance hall is attached to. From the measurement results of the ninth layer shows that there is approximately 15 mm difference in level between two points separated from each other by 60 cm, which is possibly caused by an uneven settlement of the ground.

- 3) At least in the area we investigated, no foundation work was found at the bottom. A building structure was directly constructed on the leveled ground layer.
- 4) The outer peripheral part of the building has had a brick paved surface since it was originally constructed.
- 5) Uneven settlement occurred at the foundation, which possibly relates to the deformation of its upper structure.

Fig. 39 Plan of the excavation trench.

After the excavation, the trench was refilled with sandbags in preparation for a possible additional survey to be conducted in the future. All excavated pieces of earthenware and stucco among other articles are kept at the DOA Bagan branch office.

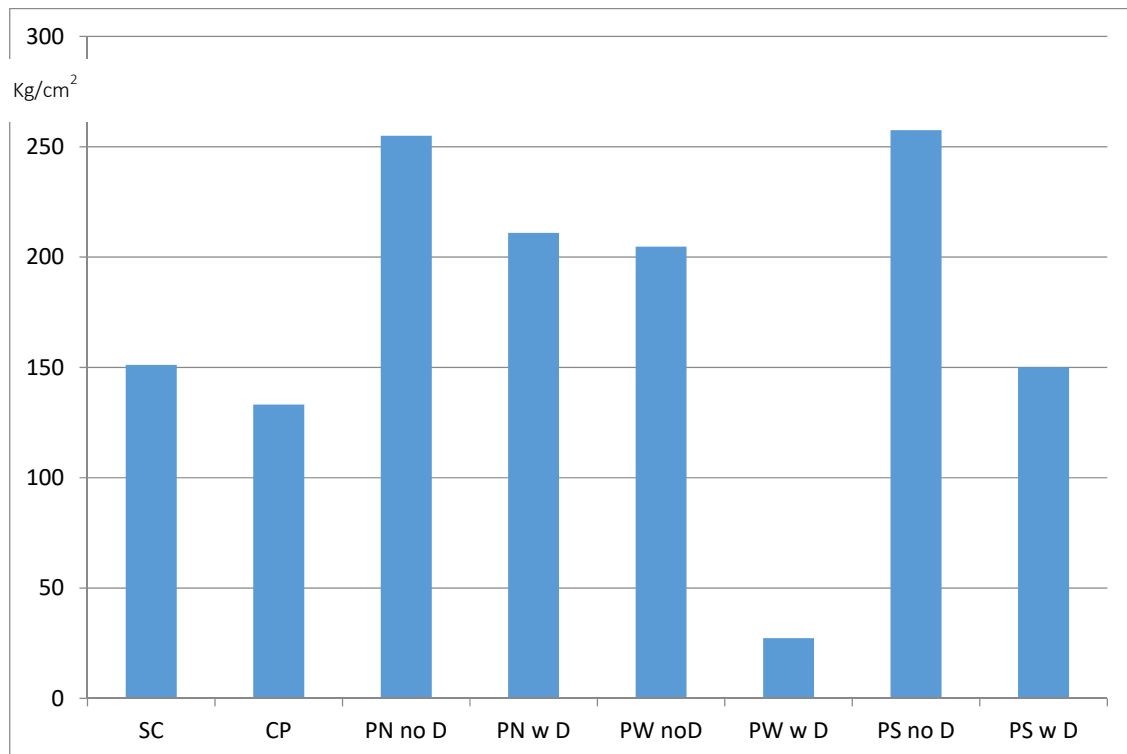
After deduction by using a conversion table, the obtained mean value of the compression strength of the bricks in each testing area is shown on the bar graph below.

<Tendency of compression strength value of the bricks>

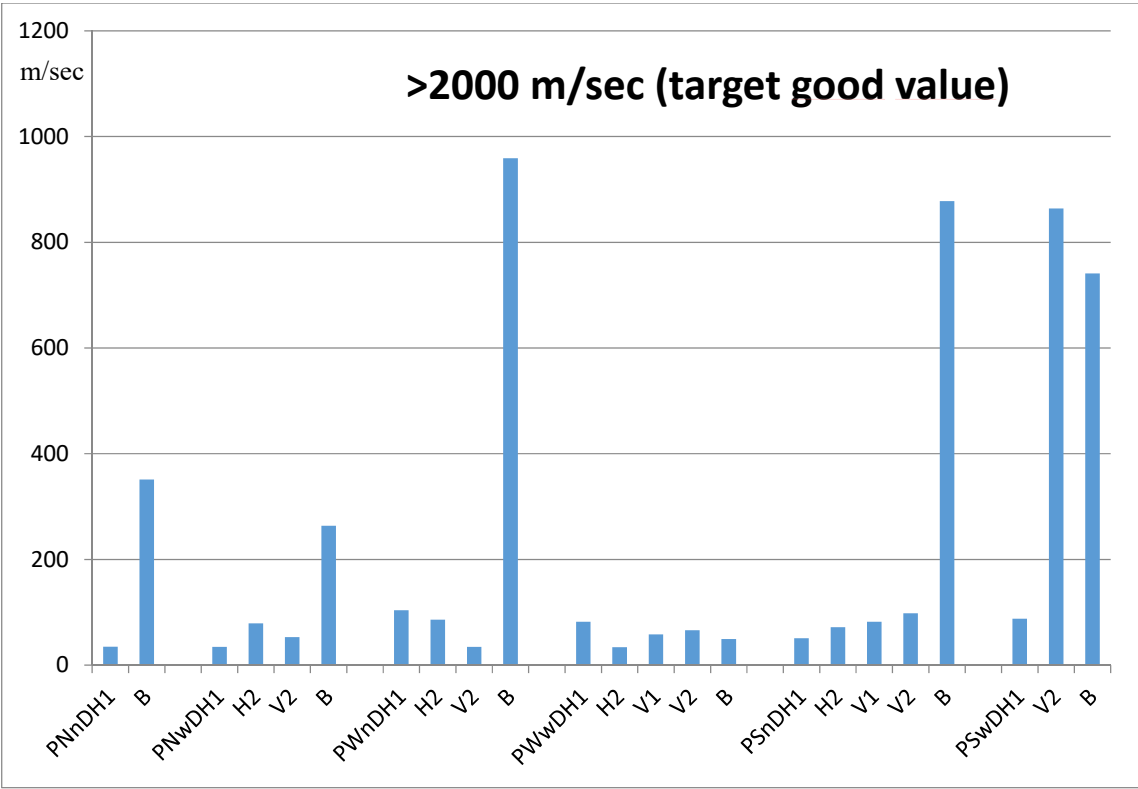
The following bar graph indicates the detected velocity through the object brick and joints in each case. Higher velocity means that the target section has better compactness.

<Tendency of velocity around joints and in the brick>

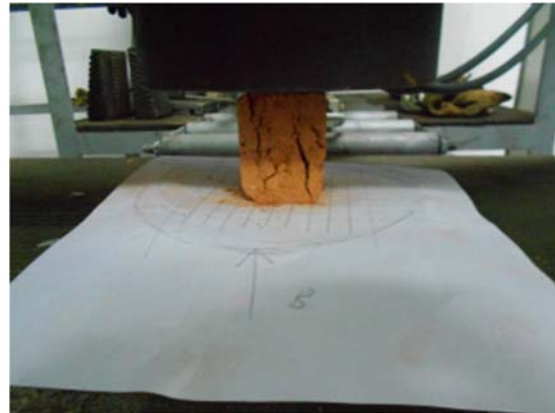
Fig. 61 (below) Compression Test Report showing the load displacement chart test of a brick sample, provenance “EN”.

All of the experimental load displacement curves appear, unfortunately, to be influenced by the inaccuracy in producing a cube-sample. The maximum levels of loads are not corresponding to the final values of displacement, which is another confirmation of the too much heterogeneity of the results derived from the insufficient accuracy and the decay of the bricks. Some good and positive results are shown in **Fig. 56** to **Fig. 59**, but curves in **Fig. 62** to **Fig. 67** are characterized by unexpected steps of charge and sudden loss of charge before reaching the final phase of softening. **Fig. 60** and **Fig. 61** shows a too low value of load.
