# GUIDANCE NOTE IN APPROACHES FOR CONSERVATION OF MURAL PAINTINGS AND ARCHITECTURAL DECORATIVE WORKS AT BAGAN

**Prepared by Rodolfo Luján-Lunsford**  
within the framework of the UNESCO Projects  
“Capacity building for safeguarding cultural heritage in Myanmar” funded by Italy  
“Safeguarding Bagan within the World Heritage Framework” funded by NFUAJ

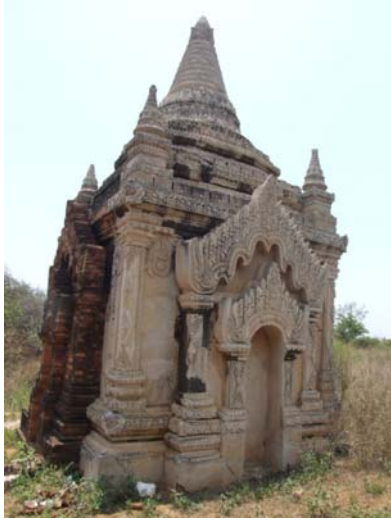
**1825** TEMPLE, FROM NORTH-WEST. STUCCO MOULDINGS ACCORDING TO THE INSCRIPTION IN TEMPLE N° 15 IN SALÉ WERE APPLIED IN THE 1960'S.

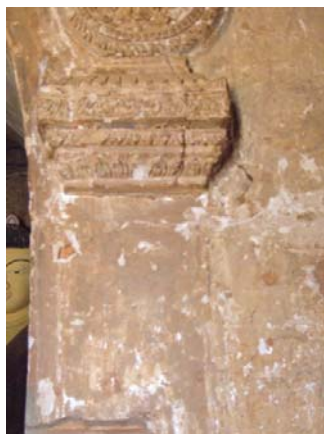
Generally the render/plaster layer(s) were spread homogeneously all over the masonry surfaces and eventually stucco mouldings were applied on the polished surface as in **1457** Maha-gu-gyi where the stucco mouldings, corresponding to the pilasters, have collapsed and the flat plastering can be noted.

**1457** MAHA-GU-GYI, VESTIBULE, WEST WALL, SOUTH SIDE. THE COLLAPSED PILASTER'S STUCCO PUT IN EVIDENCE THE FLAT FINISHING OF THE PLASTERING, THENCE NO PROPER ADHESION BETWEEN LAYERS.

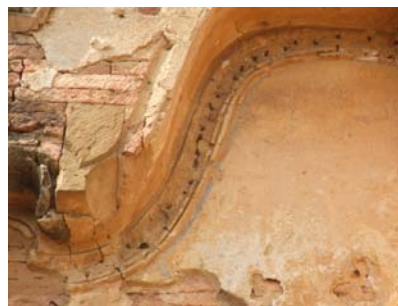
**1812** HTI-LO-MIN-LO TEMPLE, EAST FACE, SOUTH SIDE. WOODEN PEGS INSERTED INTO THE MASONRY AND RENDERING THAT SUPPORTED DISAPPEARED STUCCO MOULDINGS. NOTICE THE PAINTED BANDS THAT MIGHT HAVE FORMED PART OF A LOST DECORATIVE CYCLE.

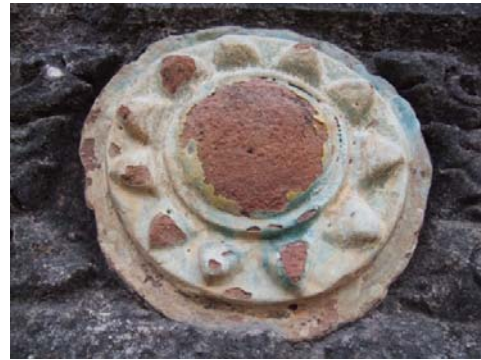
**748 SULA-MANI-GU-HPAYA.** GLAZED SANDSTONE ELEMENT. THE GLAZING, HAS DETACHED DUE TO ENVIRONMENTAL FACTORS AND LACK OF MAINTENANCE.

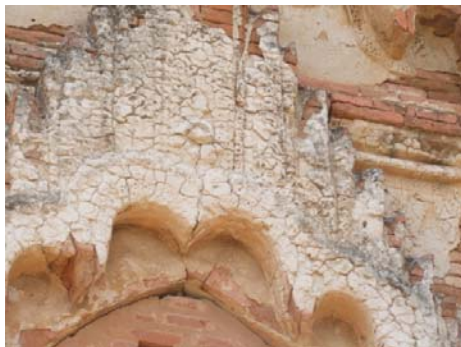
**1498** NYA-PYA-GU, NORTH PORCH, PEDIMENT. WATER PERCOLATION ON SURFACE HAS

COMPLETELY ERODED THE ANCIENT STUCCO MOULDINGS.

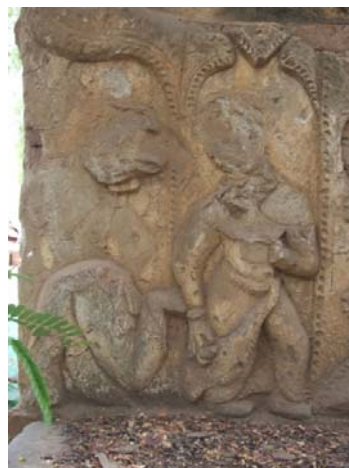
**2162** Ananda-ok-kyaung Monastery. Yellow-brownish deposition on stuccoes as formation of a mixture of Calcium carbonate and dust.

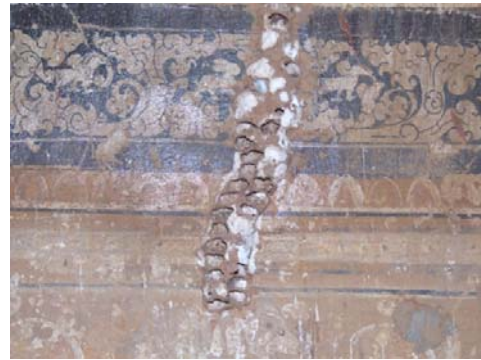
**1846** TEMPLE, HPAYA-NGA-ZU GROUP. COLEOPTERANS MUD NEST ON PAINTINGS, DIFFICULT TO SAFELY REMOVE.

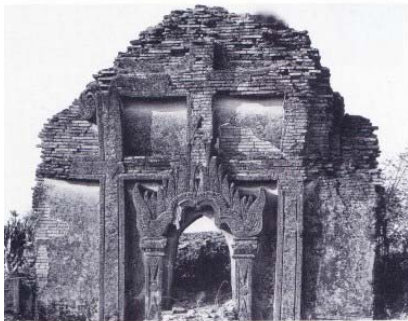
1160 d - South face, south forepart

**1160** TEMPLE AS APPEARS IN VOLUME FIVE OF P. PICHARD *INVENTORY OF MONUMENTS AT BAGAN* BEFORE 1995.

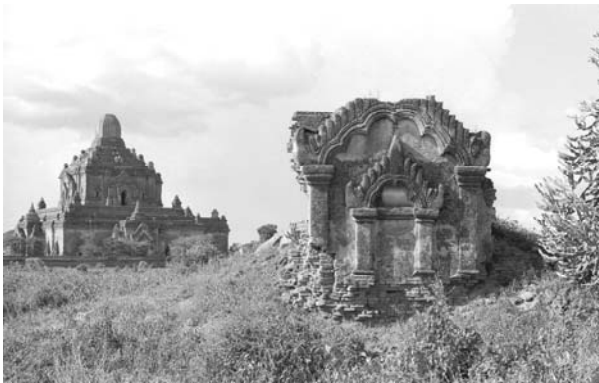
Another, as many other examples of transformation by uncontrolled reconstruction is **1810** Temple in which, the porch at the south face was completely destroyed and substituted by a plain wall that was easier to build rather than to preserve the ancient work.

**1810** Temple at the southern side of **1812** Hti-lo-min-lo, south face as appears in 1995. (courtesy P. Pichard, 2017).

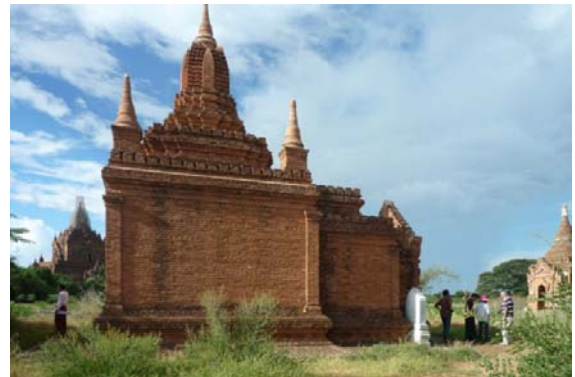
**1810** Temple at the southern side of **1812** Hti-lo-min-lo, south face as appears in 2017. (courtesy P. Pichard, 2017).

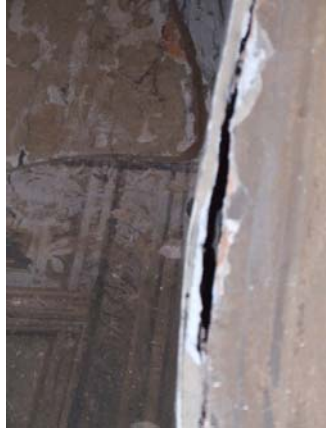
**1460** TEMPLE, SHRINE, NORTH WALL, WEST SIDE. DETACHMENT WITH DEFORMATION OF PAINTED PLASTER.

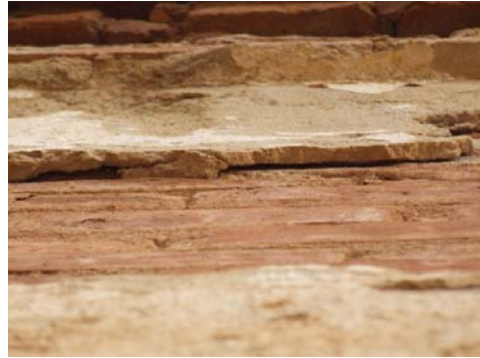
**2162** ANANDA-OK-KYAUNG MONASTERY, NORTH FACE, SEPARATED RENDERING FROM THE WALL

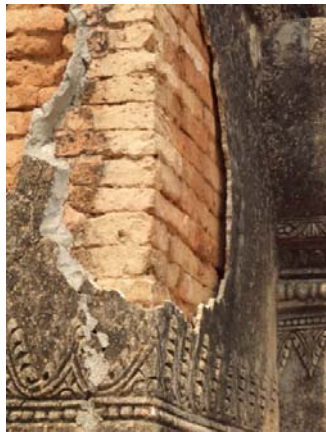
**1467** LOKA-OK-SHAUNG, UPPER STOREY, PORCH, SOUTHEAST CORNER. DEFORMED RENDERING DUE TO THERMAL EXPANSION & CONTRACTION.

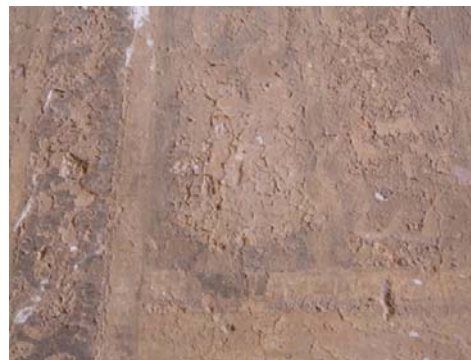
**482** THAMBULA-HPAYA. MICRO-SCALING OF PAINT LAYER DUE PERHAPS TO EXCESSIVE BINDING MEDIUM. HOWEVER, THIS OCCURS WHEN DIFFERENT BINDING MEDIA ARE EMPLOYED.

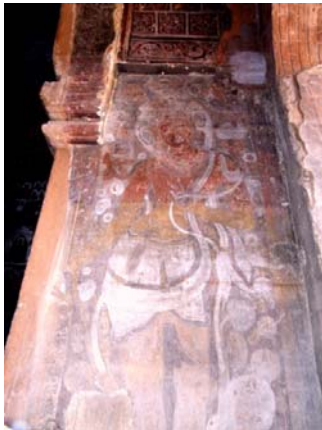
**1323** KUBYAUK-GYI (MYINKABA), PASSAGE FROM VESTIBULE TO CORRIDOR, NORTH WALL. ALTERATION OF YELLOW OCHRE INTO RED OCHRE DUE TO HIGH TEMPERATURE ON UPPER PARTS.

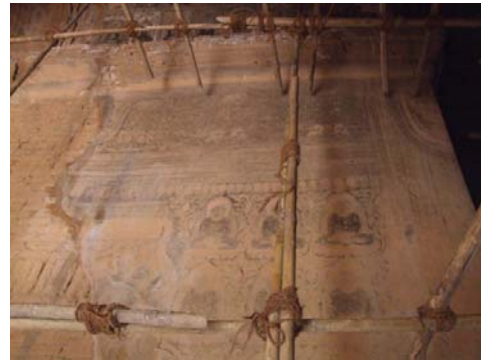
**539** TAYOK-PYI-HPAYA-GYI, UPPER STOREY TEMPLE, SOUTH WALL OF CENTRAL CORE. SOME ORGANIC PIGMENTS HAVE FADED BY SUNLIGHT BUT OTHERS SUCH AS THE PURPLE LAKE HAVE REMAINED.

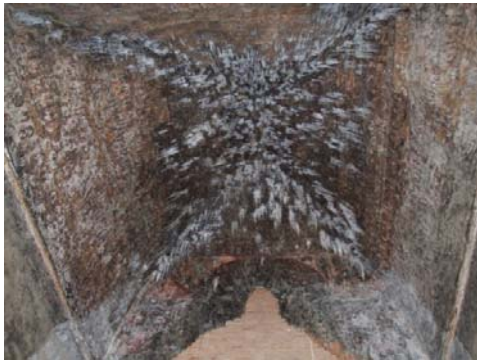
**1202** ABEYA-DA-NA, CELLA, VAULT. BAT DROPPINGS ON THE VAULTING SURFACE.

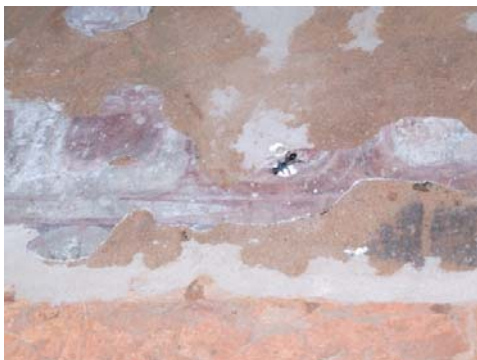
**1323** KUBYAUK-GYI (MYINKABA), VESTIBULE, SOUTH WALL. INSECT EATER OF ACRYLIC RESINS

EMPLOYED IN FORMER INTERVENTIONS, BURROW TUNNELS INTO THE MUD-BASED PLASTERS SEARCHING FOR THESE.

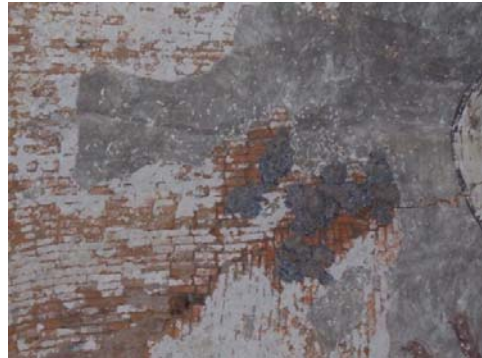
**1219** KYA-ZIN-HPAYA, SWALLOW'S NESTS UNDER THE VAULTING OF THE SHRINE.

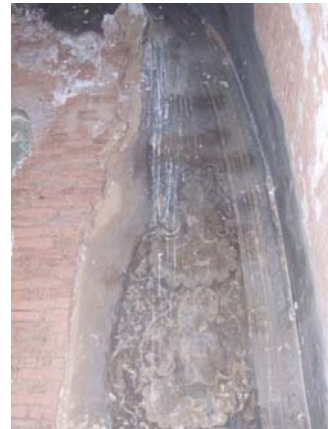
**1487** TEMPLE, BIRD'S DROPPINGS ON MURAL PAINTINGS.

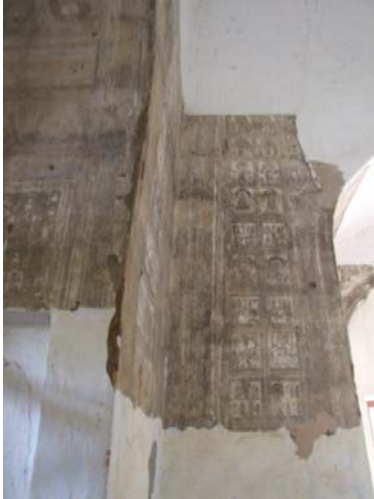
**85** THEIN-MAZI. MURAL PAINTINGS BEING DISCOVERED UNDER WHITEWASH LAYERS OF LIME.

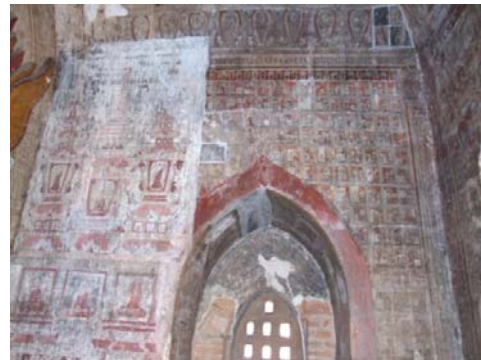
**1404** SHWE-BON-THA. OVER-PAINTING IN LATER PERIODS WAS A COMMON PRACTICE, THIS MEANS THAT THE BUILDINGS WERE IN USE.

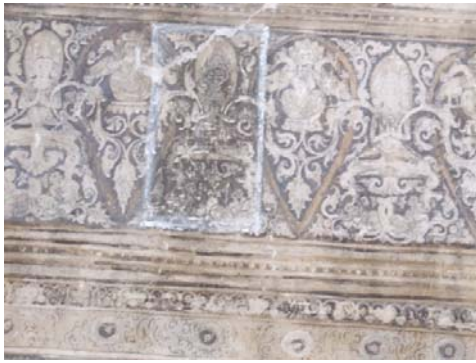
**1846** TEMPLE, PENATHA-GU GROUP, PORCH, NORTH WALL. THE PAINTINGS WERE CLEANED AT A POINT THAT FINAL OUTLINES AND DETAILS WERE REMOVED BY USING INAPPROPRIATE TECHNIQUES AND MATERIALS (NOT SUITABLE STRONG SOLVENTS). THE EXTANT NOT CLEANED AREA WITH THE RECTANGLE, IS PRACTICALLY INTACT, IT WAS NECESSARY TO ONLY REMOVE DUST BY DRY CLEANING.

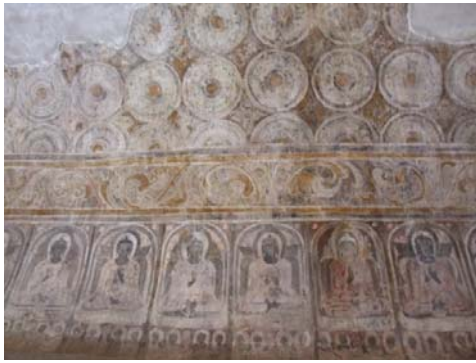
**2171** ANANDA-GU-HPAYA-GYI. THE MURAL PAINTINGS WERE CLEARED FROM WHITEWASHES, THE LACUNAE FILLED WITH PLASTER OF PARIS AND PICTORIALY INTEGRATED. A COATING OF NON SUITABLE PVAC WAS APPLIED AS A PROTECTIVE COATING.

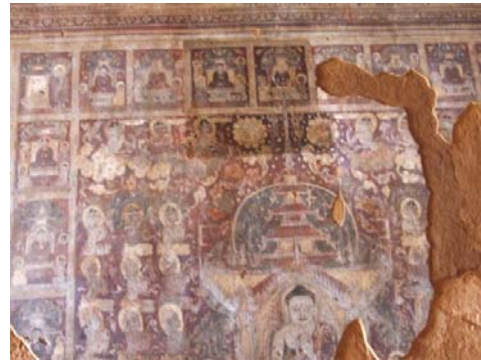
**571** TEMPLE. DURING THE RESTORATION WORKS OF THE MURAL PAINTINGS, A COATING WITH NEEM GLUE WAS DONE ALL OVER THE SURFACE WITH THE EXCEPTION OF THE DARKER SQUARE AREA THAT WAS COATED WITH AN ACRYLIC RESIN (PARALOID B72).
