# GUIDELINES FOR POST-EARTHQUAKE TEMPORARY STRUCTURAL STABILISATION OF MONUMENTS OF BAGAN

Prepared by Dr Arun Menon  
Associate Professor, Structural Engineering Laboratory,  
Dept. of Civil Engineering, IIT Madras, Chennai, INDIA  
National Centre for Safety of Heritage Structures (NCSHS)

within support from the UNESCO Heritage Emergency Fund and within the framework  
of the UNESCO Projects

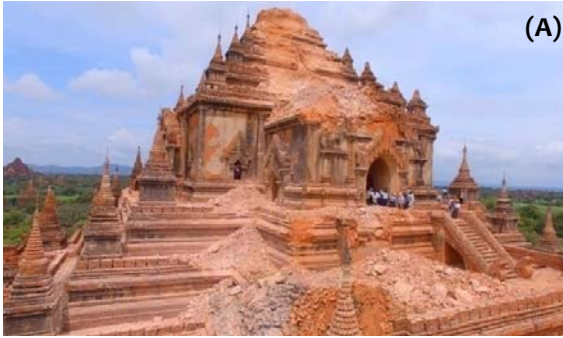
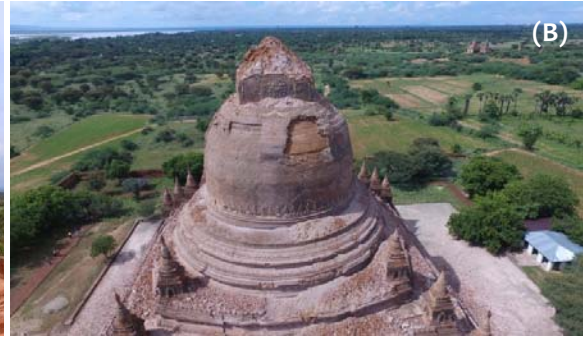
Figure 3.1: Collapse of spire

1. **Damage to spires:** Damage is caused due to amplified accelerations and displacements at higher elevations in the structure (see Fig. 3.1). Sliding failure has been observed in smaller spires (see Fig. 3.2B), whereas heavier and larger spires show evidence of shear cracking (diagonal tension cracks) as seen in Fig. 3.3 A and flexural crushing or compression failure due to rocking as seen in Fig. 3.2 A.
2. **Damage to pediments at entrance gateway to vestibules:** Overturning and partial collapse of free-standing elements such as pediments at entrance gateway to vestibules is a recurrent damage mechanism (see Fig. 3.3 B, 3.4 A and 3.5 A).
3. **Damage to parapets:** Overturning and partial collapse of free-standing elements such as parapets walls is a recurrent damage mechanism (see Fig. 3.4 B and 3.5 B).

4. **Damage due to pounding from falling debris:** Significant damage has also been observed due to the impact of massive brick masonry blocks of the spire or other free-standing structural elements (e.g. pediments) on other roof structures such as vaults (see Fig. 3.1).
5. **Overturning of facade:** Detachment and partial or total overturning of the facade wall at the entrance to the vestibule (see Fig. 3.6 A). This is primarily due to poor connection of the facade of the vestibule to the rest of the structure.

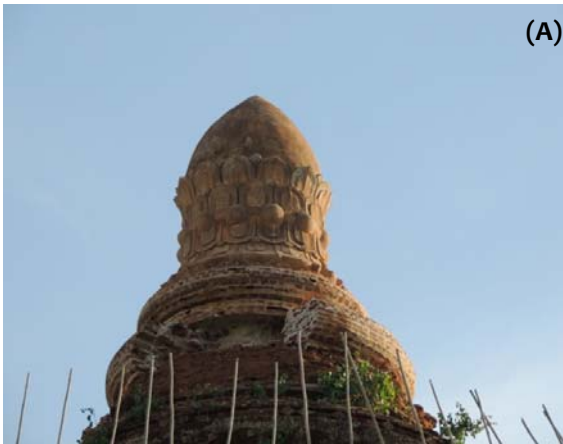
Figure 3.2: (A) Crushing of masonry due to flexural rocking at the base of the pinnacle; (B) Shear sliding of the pinnacle of the spire

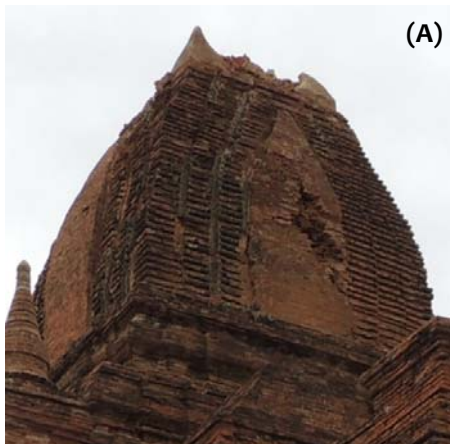
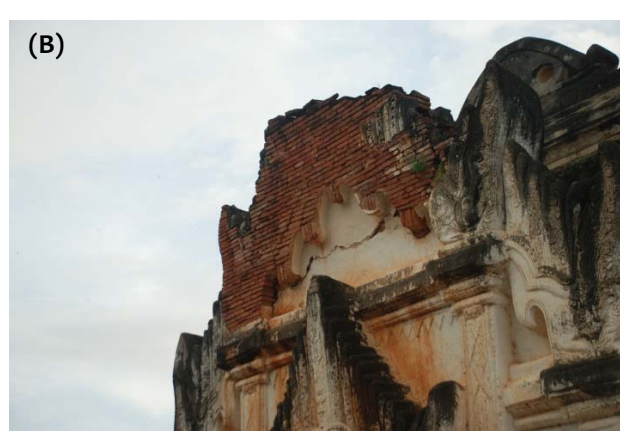
Figure 3.3: (A) Shear damage to the base of the spire; (B) Detachment and overturning of the free-standing pediment

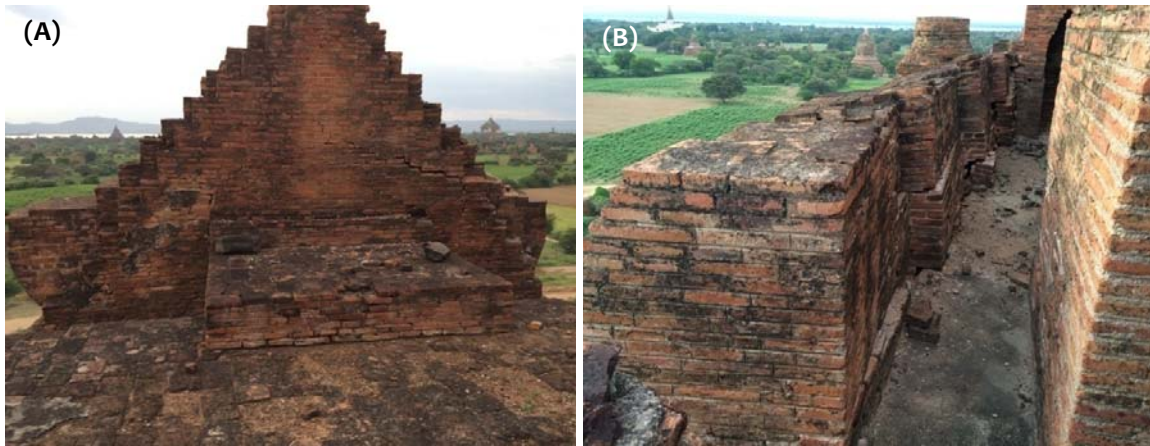
Figure 3.4: (A) Detachment and overturning of the free-standing pediment; (B) Detachment and overturning of parapet walls along the stairway

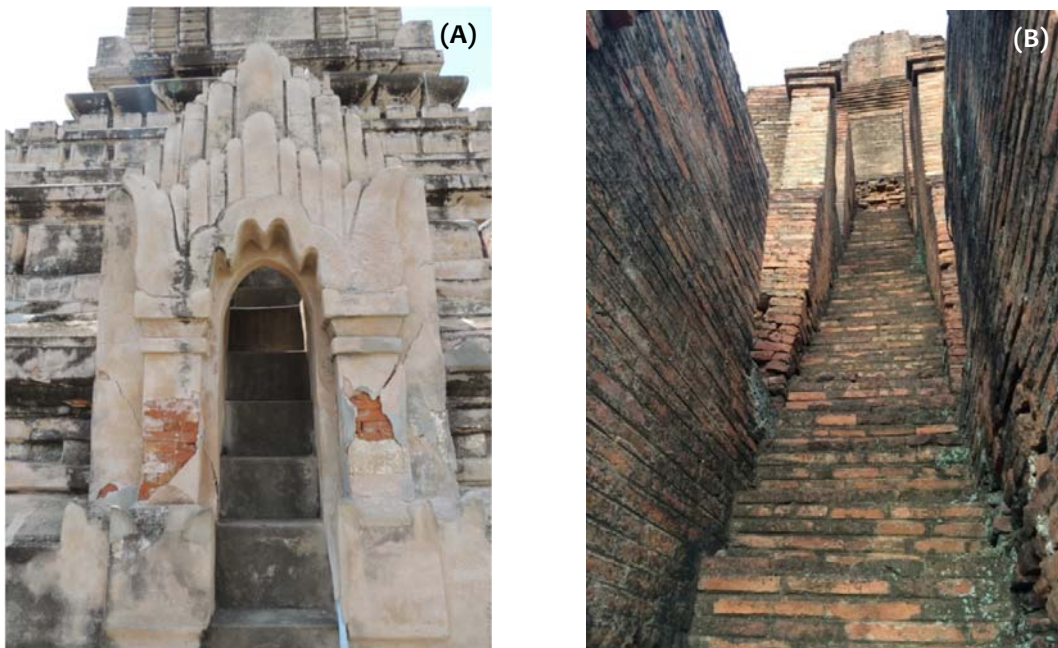
Figure 3.5: (A) Shear cracking at the supports of the entrance structure to the stairway; (B) Overturning of parapet walls along the stairway

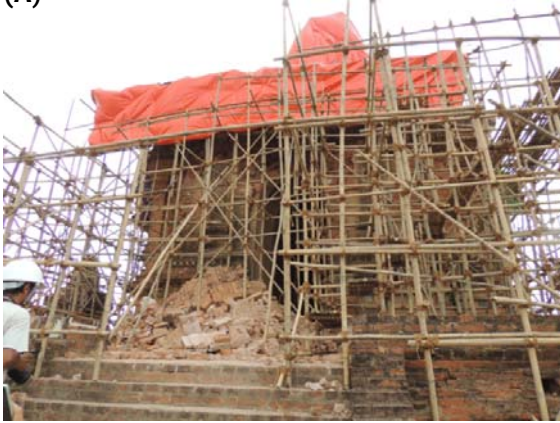
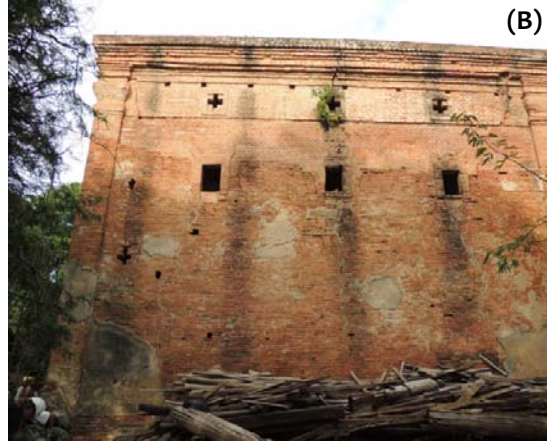
4. Figure 3.6: (A) Detachment and overturning of the facade; (B) Dilation of masonry walls and formation of vertical cracks

interconnections between the walls, leading to partial overturning and bulging of walls and formation of vertical cracks (see Fig. 3.6 B). In turn, such dilation of the masonry walls results in formation of separation in the true arch portion of the vaults, particularly when they are constructed in distinct layers without interlocking (see Fig. 3.7 A), and dislodgement of bricks (see Fig. 3.7 B and Fig. 3.8 A).

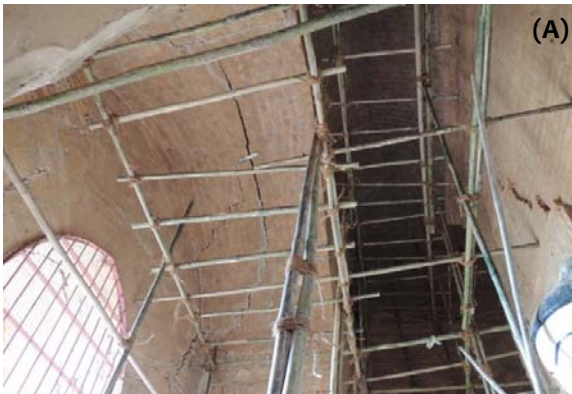
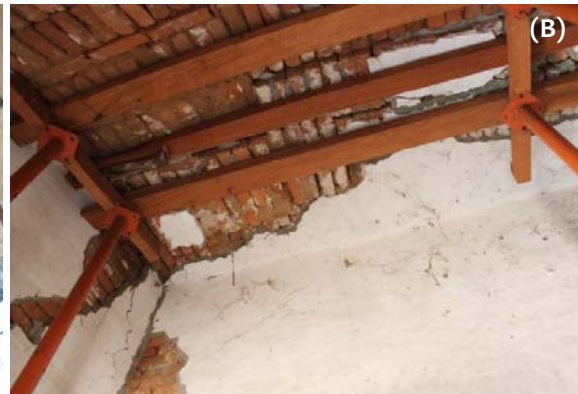
Figure 3.7: (A) Damage to vault due to dilation of masonry walls; (B) Deformation of brick masonry vault and dislodgement of bricks

2. **Damage to vaults:** Vaults are damaged either due to dilation of the masonry walls, leading to lateral movement of the supports of the vaults. Dislodgement of brick units or voussoirs in the true arch vaults is a direct result of the dilation of the walls (see Fig. 3.7 B and Fig. 3.8 A). Damage to vaults could also occur due to pounding (reversed cyclic vertical action) of the heavy spires on the supporting vaults. This is particularly expected when the structure does not have a solid core.
3. **Damage to solid core:** Shear damage to the solid core with the formation of diagonal cracks can compromise the vertical load carrying capacity of the core. Damage to the walls of the core could also occur due to pounding (reversed cyclic vertical action) of the heavy spires on the supporting solid core with bulging of the walls and formation of vertical cracks (see Fig. 3.8 B).

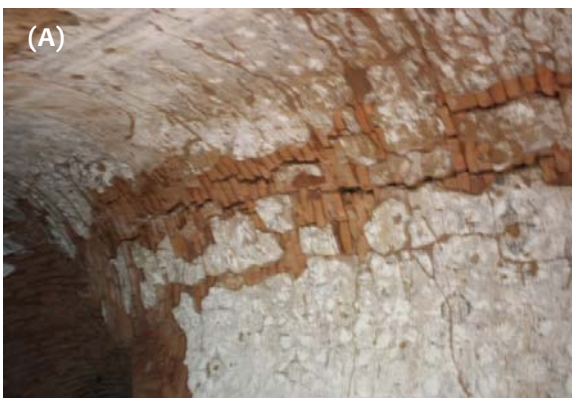
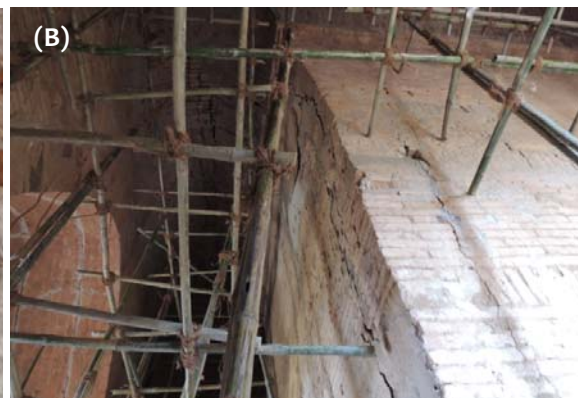
Figure 3.8: (A) Deformation of brick masonry vault and dislodgement of bricks; (B) Bulging and cracking in the solid core supporting the central spire

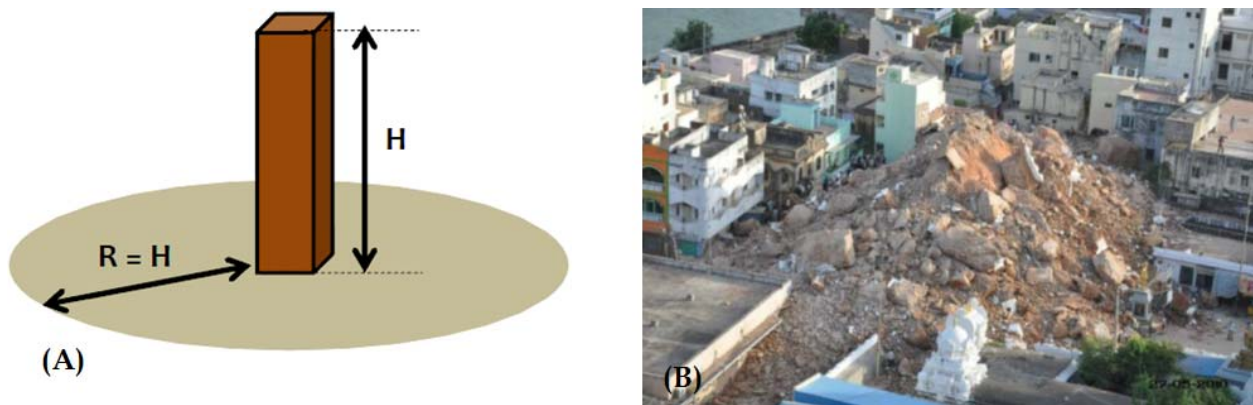
In case of imminent collapse, ensure that a circular area of radius equal to height of the structure, around the structure, be cordoned off from public access. This area is normally the extent of debris fall in ancient brittle masonry structures (see Fig. 6.3).

**Figure 6.3: (A) Circular Area with Radius Equal to Height of the Structure to be Cordoned off (B) 7-Storeyed Temple tower collapse in Srikalahasti, India**

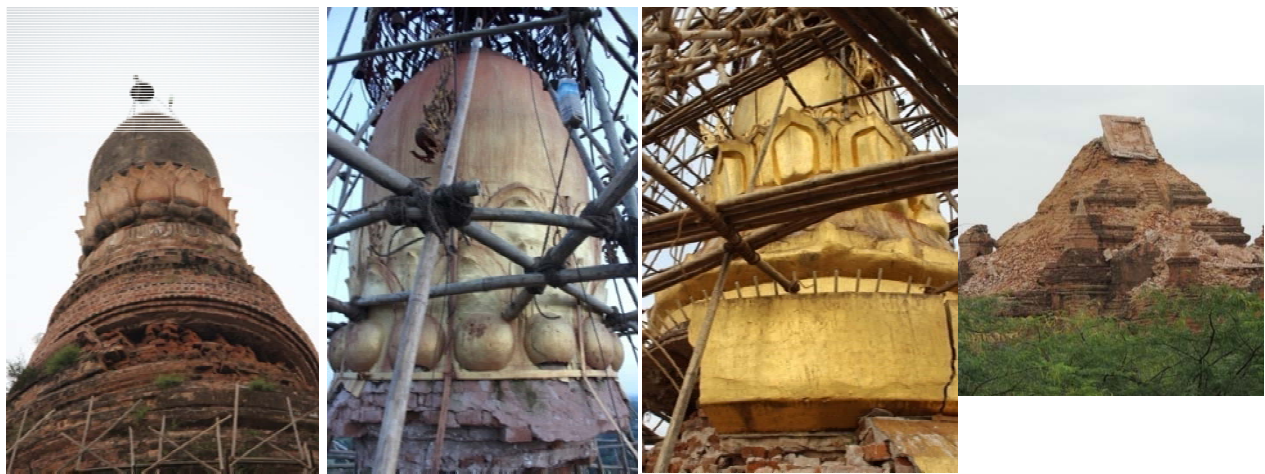
In several monuments, the situation of the monument after the earthquake was rendered highly precarious due to the falling hazard of endangered massive portions of the structure, mostly at its pinnacle. As shown in Fig. 8.1, in several cases of pinnacles in stupas, structural safety was compromised due to extensive damage to the base of the pinnacle portion. A similar situation was encountered at the base of central or subsidiary spires in temples.

Figure 8.1: Structures with Heavily Damaged Portions Requiring Careful Removal

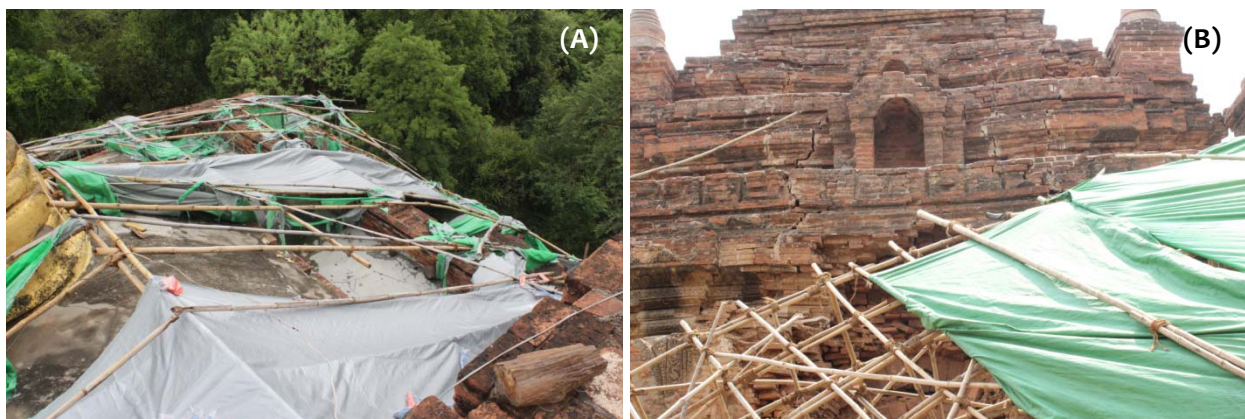
Figure 9.2: (A) Deterioration of Bamboo and Tarpaulin Sheets; (B) Wind Effect on Scaffolding

1. The connections between bamboo elements, typically in coir ropes, deteriorate rather rapidly, compromising the stability of the scaffolding. Hence, these need to be monitored and replaced from time to time. Nylon ropes could also be used, however, even nylon deteriorates rather quickly on continuous exposure to sunlight (and is less environmental friendly, vis-à-vis this indigenous scaffolding and weather protection system). Even the tarpaulin sheets are affected by sunlight, and strong winds (see Fig. 9.2 A). In this regard, a regular maintenance protocol must be in place in order to ensure that the system is effective throughout the wet period.

2. The scaffolding system, while it attempts to become airtight, is severely affected by strong winds, and in many instances blown away (see Fig. 9.2 B). The most efficient way of handling effects of wind is to provide the weather protection system with a sufficient number of air vents, which are in turn protected from ingress of rainwater (with necessary overhanging eaves). In this regard, the vernacular bamboo constructions for residences could be a model to be followed (see Fig. 9.3 A).

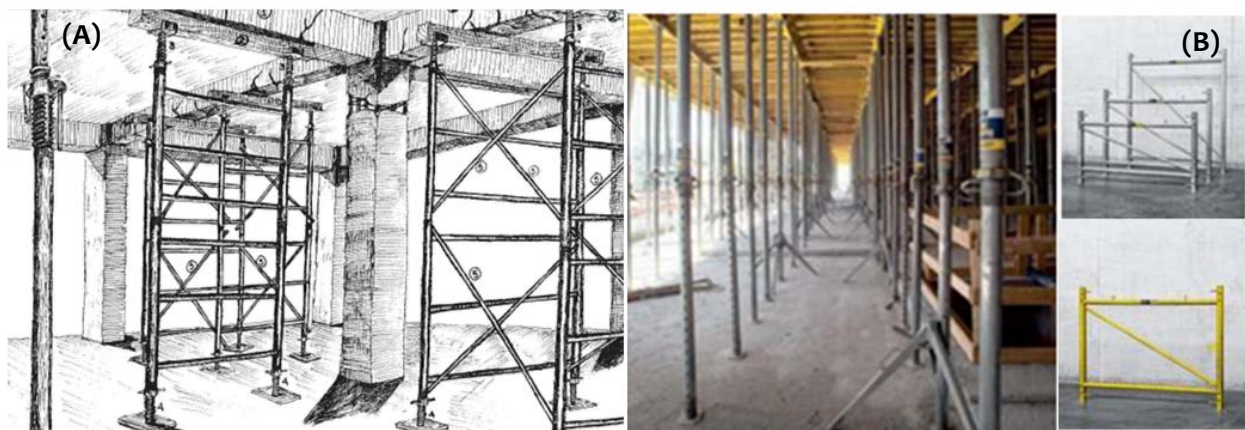
Industrial metal pipe scaffolding is used in order to bear light vertical loads but to a greater extent of area i.e. slab loads or relieving horizontal elements. Integrated vertical, horizontal and inclined (bracing) elements with adjustable heights, assembled by pairs into a tower using diagonal bars, and in combination with wooden beams are used as typical elements for propping mainly slabs, beams, etc. (see Fig. 10.2).

Figure 10.2: (A) Propping using Metal Industrial Scaffold (EPPO, 2000); (B) Larsen and Toubro's Doka Formwork System

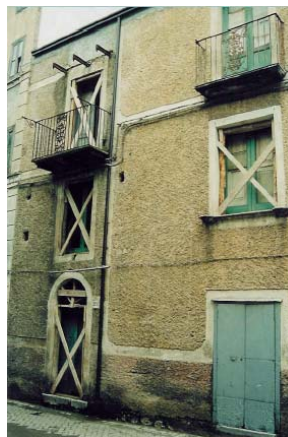
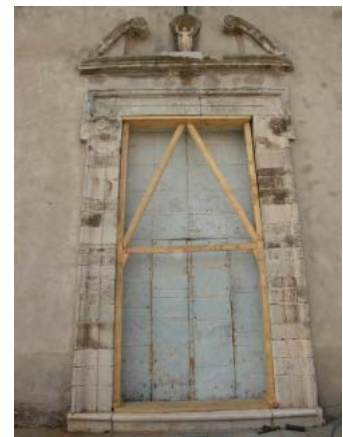
Since windows and doors are the weakest parts of a wall, structural movement occurs at or around their locations first. Placing bracing and shoring in the opening stabilizes this weak area. Diagonal bracing has been used successfully to prevent a structure from further deforming (see Fig. 10.8). Inclined elements are required for wedging.

Figure 10.8: Propping and bracing door and window openings (SSN-DPC, 2005)

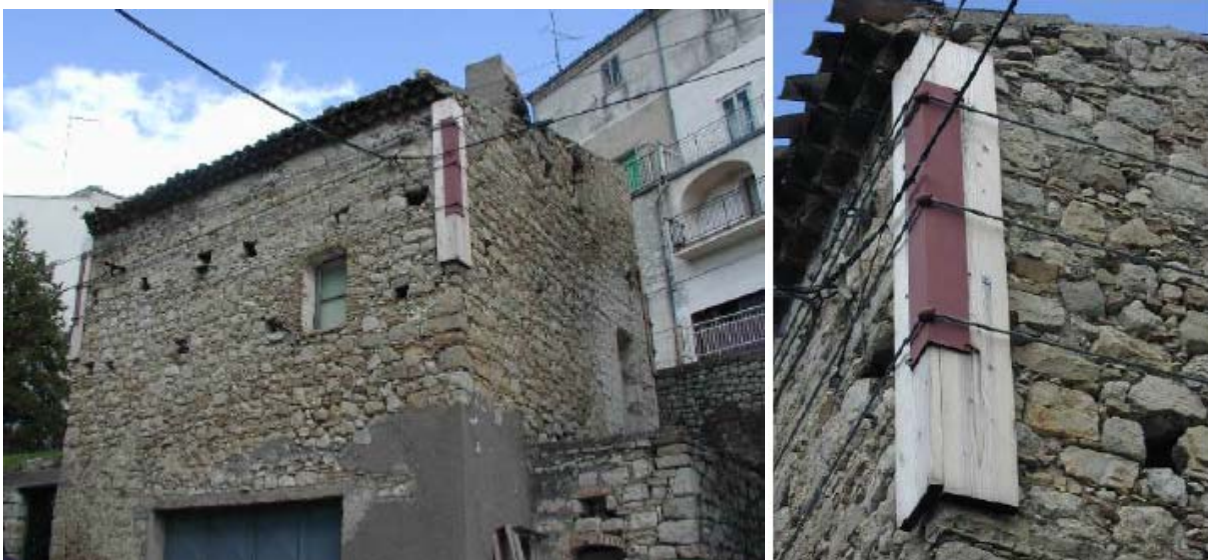
Figure 10.15: Connecting orthogonal walls using steel pre-stressing cables (DPC, Molise earthquake, 2002)

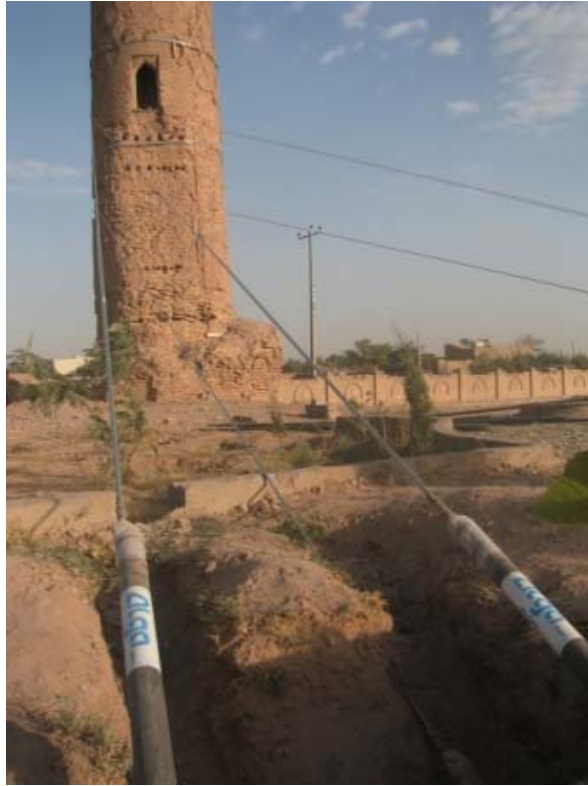
**Figure 10.18: Temporary stabilization of the Minaret of Herat, Afghanistan by means of steel cables, anchored to the floor in RC anchor block (Courtesy: Prof. Giorgio Macchi, University of Pavia, Italy).**

This procedure is also applied to situations where temporary structural stabilisation is required. An example of such an application for stabilising an inclined tower as a temporary removable measure is shown in Fig. 10.18.

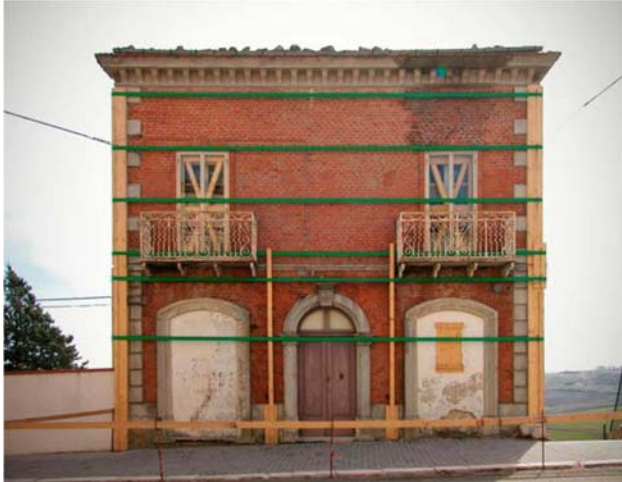
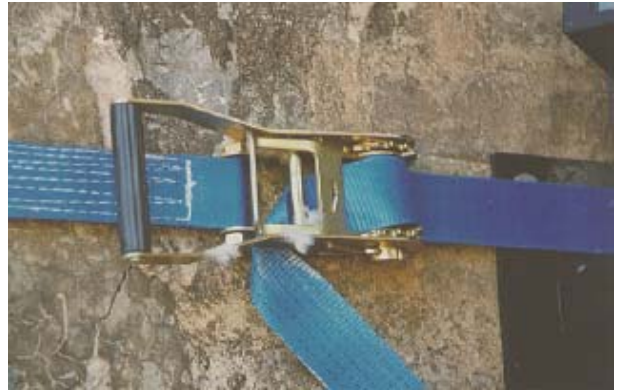
Ratchet lashing is carried out to connect orthogonal walls and ensure box action against lateral movement by means of synthetic (nylon or polypropylene) belts with buckles. These nylon lashings are available in different sizes and load ratings, and have been successfully used in a few of the earthquake-damaged monuments in the Bagan archaeological zone.

Figure 10.18: (A) Ratchet lashing to connect orthogonal walls (Langenbach, 2003); (B) Lashing and buckle

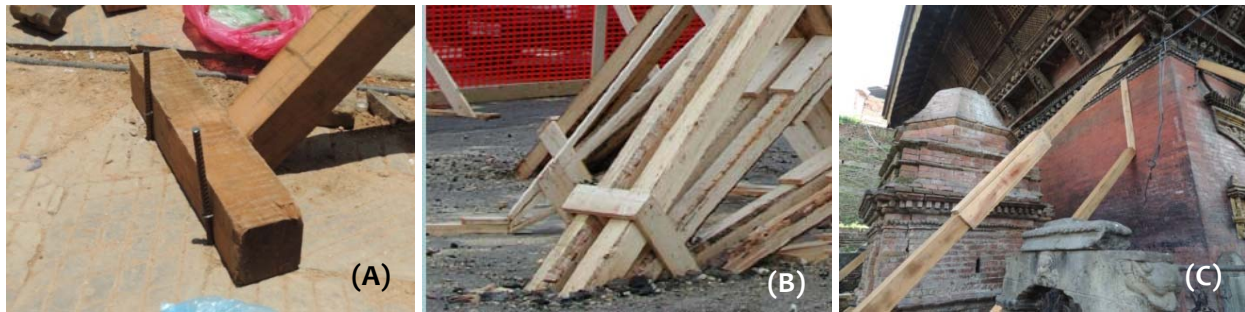
Figure 12.1: Anchoring by (A) Steel bars as horizontal restraint (B) Embedding into soil (C) Rake restrained from vertical sliding

The shoring members must be anchored by any of the following methods (also refer to details in Fig. 10.12 B and 10.13 B):

- Using embedded steel bars for horizontal restraint against sliding;
- Embedding members directly into the soil, where possible, for horizontal restraint against sliding; and
- Anchoring members to the wall for vertical restraint against sliding (this is essential when upright members are not present connected to the rake).

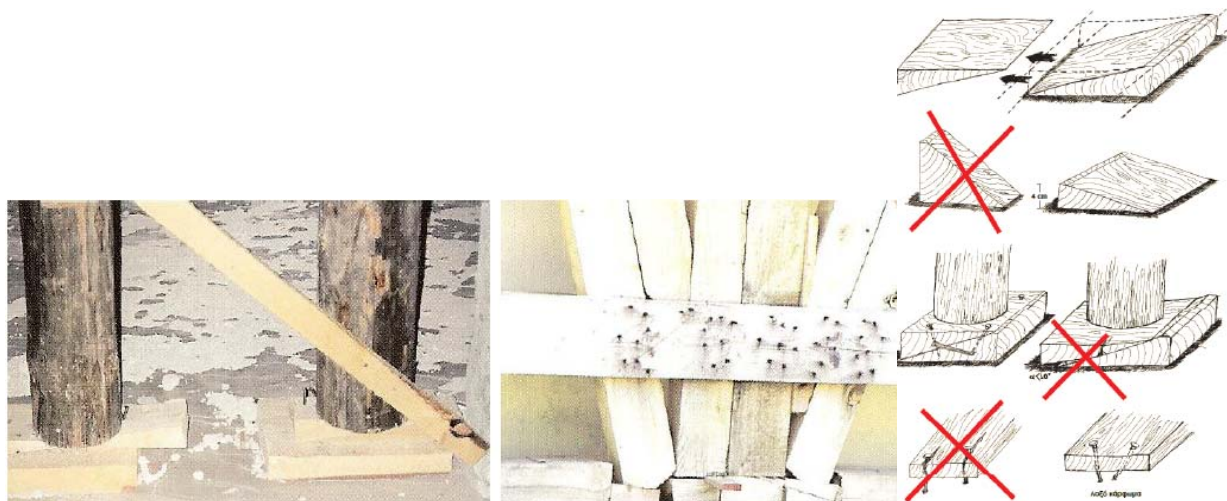
Figure 12.2: Wedging methods (EPPO, 2000)

The total or partial transfer of loads from the damaged element of the building to the shoring formation is successful when efficient wedging is done. This is achieved by wooden twin wedges or jacks (mechanical, hydraulic).

The wedges must be of dry timber, should not contain nodes and should be safe from sliding by oblique nails. The wedging must be applied slowly and carefully and the beam behaviour must be observed at the wedging position. Hydraulic or mechanical jacks are used for bearing heavy loads, ensuring homogeneous transfer of loads.

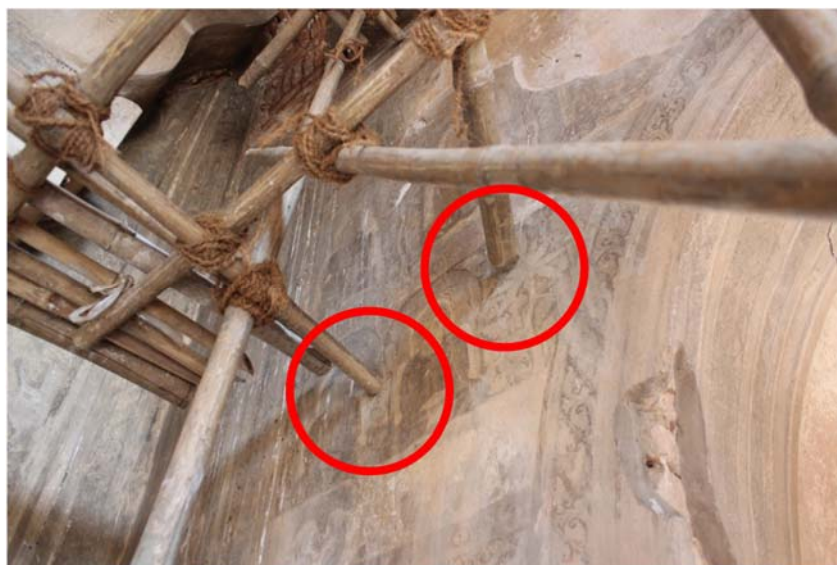
Figure 12.3: Ends of wooden structural members of the temporary stabilisation in direct contact with a wall with an ancient mural painting in Bagan

A large proportion of monuments in Bagan are endowed with valuable mural paintings in the interiors and with incised decorative plasters or glazed tiles on the exterior as part of the architectural renders. Any damage to these valuable pieces of art and sculpture will be irreplaceable. Temporary or permanent structural intervention on these monuments must take into account necessary techniques and protocols for the protection of these architectural features. As these elements are fragile, they will not be able to remain undamaged under bearing stresses introduced by structural members in contact with walls with murals or decorative plaster. A region of potential hazard to a mural painting is shown in Fig. 12.3.

Care must be taken to ensure that no **structural member** that constitutes a temporary stabilisation and strengthening intervention should ever come in **direct contact** with a location with a **mural, incised decorative plaster** or **glazed tiles**. Sufficient distance must be maintained between the end or edge of the steel or wooden structural member. Or in situations where contact is inevitable, sufficiently thick **cushioning material** (neoprene rubber pads or synthetic foam pads) must be introduced between them, with necessary detailing such that the cushioning material is held in position and does not slide down in case of potential structural movements (e.g. during an aftershock).

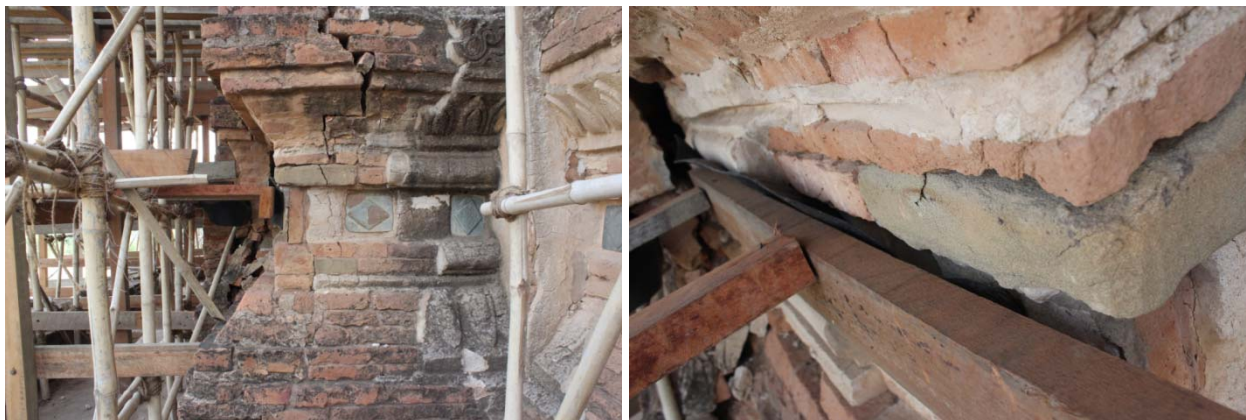
Figure 12.41: Potential hazard posed by wooden scaffolding and temporary propping members to glazed tiles

In case of mouldings on walls, glazed tiles, incised plaster work or murals that are present in niches or offset into a wall, necessary precaution to prevent any direct contact of temporary structural members (or even elements of scaffolding) must be taken. For instance, expanded polyethylene (EPE) foam sheets, available in different thicknesses, cut to size can be inserted into such niches to protect glazed tiles from bearing stresses that could be transferred from the horizontal wooden member seen in Fig. 12.4 and Fig. 12.5.

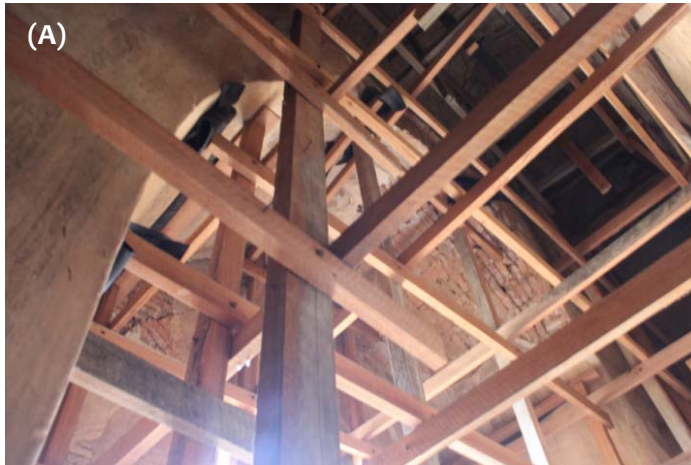
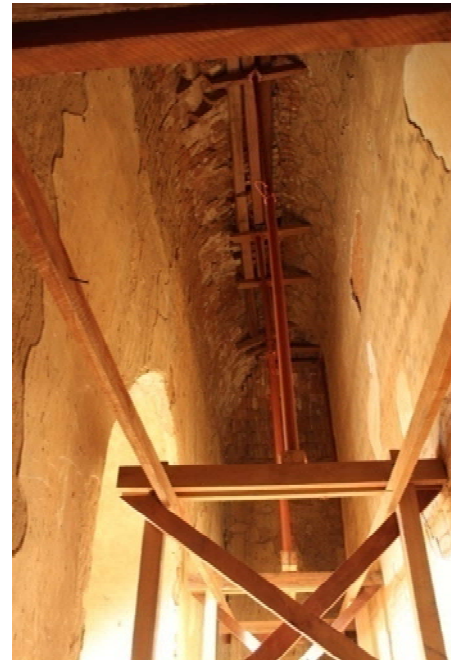
**Figure 12.74: (A) Congested temporary intervention; (B) Lean temporary intervention**

An aspect that needs to be taken into account while selecting and designing temporary stabilisation and strengthening schemes is the access to the damaged location after the implementation of the short-term measure for detailed assessment, for preparatory works for the execution of the final intervention and the execution of the latter itself. The problem becomes evident with the photographs in Fig. 12.7 A and B, and Fig. 12.8.

An attempt should be made to verify if a heavy intervention with several temporary structural members is really essential, and whether a leaner and more efficient system is possible. The latter requires an in depth understanding of the expected behaviour of the structure being protected. The latter approach will also adequate lesser hindrances during the detailed assessment and execution phase of final interventions. In this regard, where applicable, methods based on tying and anchorage (section 10.8) can be advantageous over props and rakes (sections 10.1-10.7).

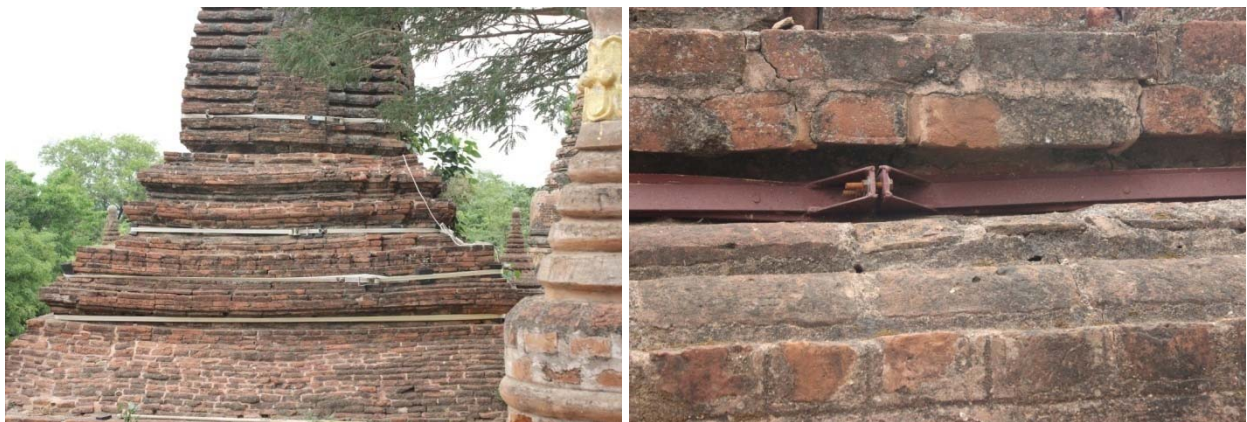
**Figure 12.96: Monitoring time to time if tautness of synthetic belts and metal straps used for tying and confinement**

It is essential to ensure that elements such as synthetic belts and metallic straps meant to serve for circumferential post-tensioning or confinement are always snug fit and taut (see Fig. 12.9). Otherwise, they will cease to be effective in their intended action, with disastrous consequences in the event of significant aftershocks. The same holds true for post-tensioning tendons used for circumferential post-tensioning (see Fig. 12.10), which should never become slack. To achieve their intended effectiveness, all such sites must be regularly inspected and the effectiveness of the intervention verified.

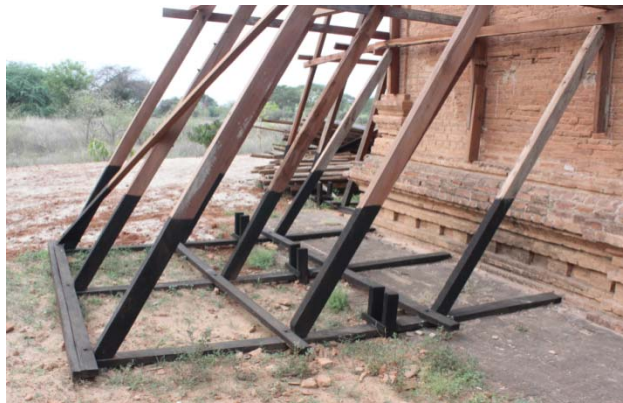
**Figure 12.118: Termite treatment of timber structural members in contact with soil**

Termite treatment of timber structural elements, which form part of a temporary stabilisation system, and which are in direct contact with the soil is a good practice (see Fig. 12.11).

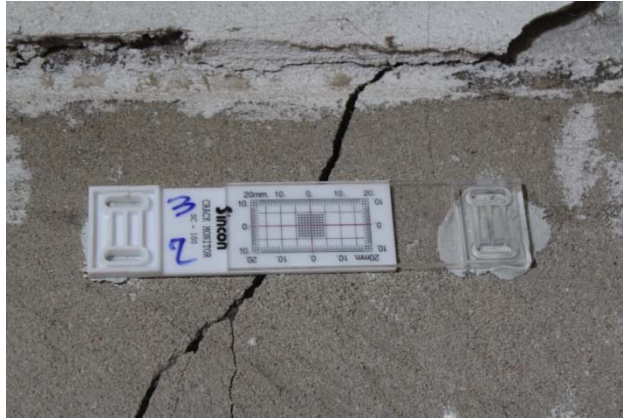
Figure 12.129: Quantitative monitoring of damaged locations with crack-width gauge

Instrumentation of damaged locations with simple measuring devices such as crack width gauges, tiltmeters or load cells, wherever feasible, will provide crucial information on effectiveness of a temporary intervention (see crack-width gauge installed at cracked location in a structural member). Such measures can potentially provide valuable information for decision making in the detailed assessment phase, which could extend from a few months to a even a few years in the context of historical monuments.

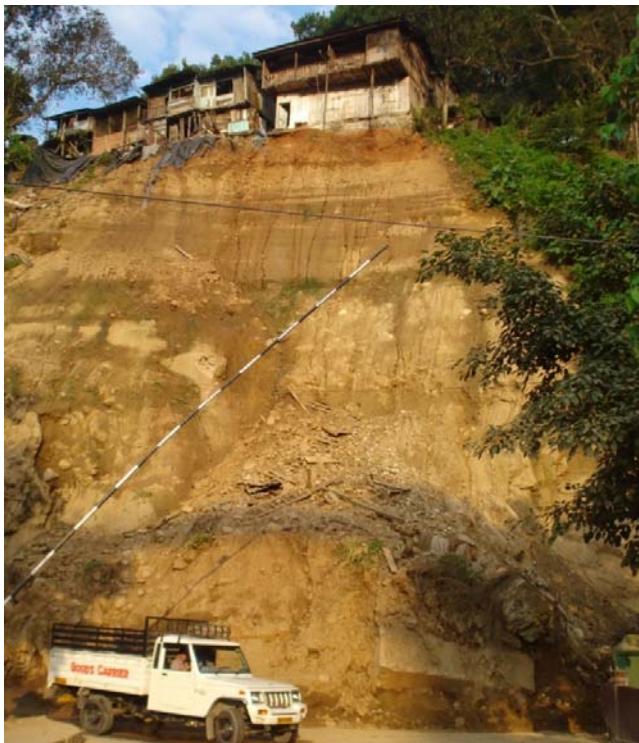
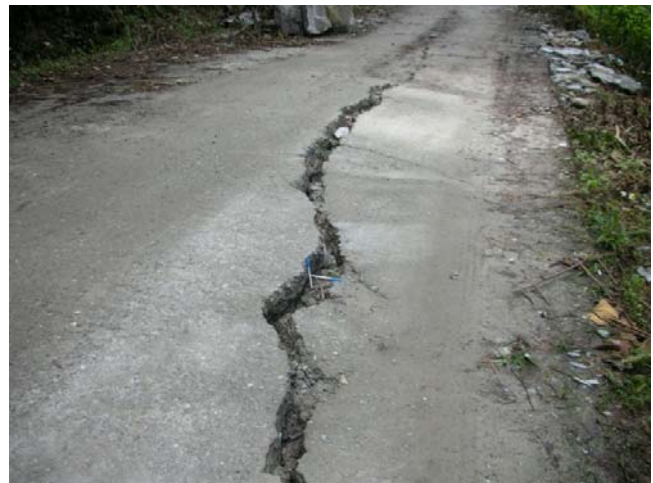
Features such as formation of fissures on the ground due to surface manifestation of fault rupture or due to ground displacements, or landslides and failure of hill slopes, in the vicinity of the structure, render the structure susceptible to further damage or collapse, hence potentially unsafe.

**Figure 10: (A) Buildings precariously placed in landslide affected areas; (B) Ground fissures due to loss of slope stability in hill slopes or surface rupture due to fault movement**

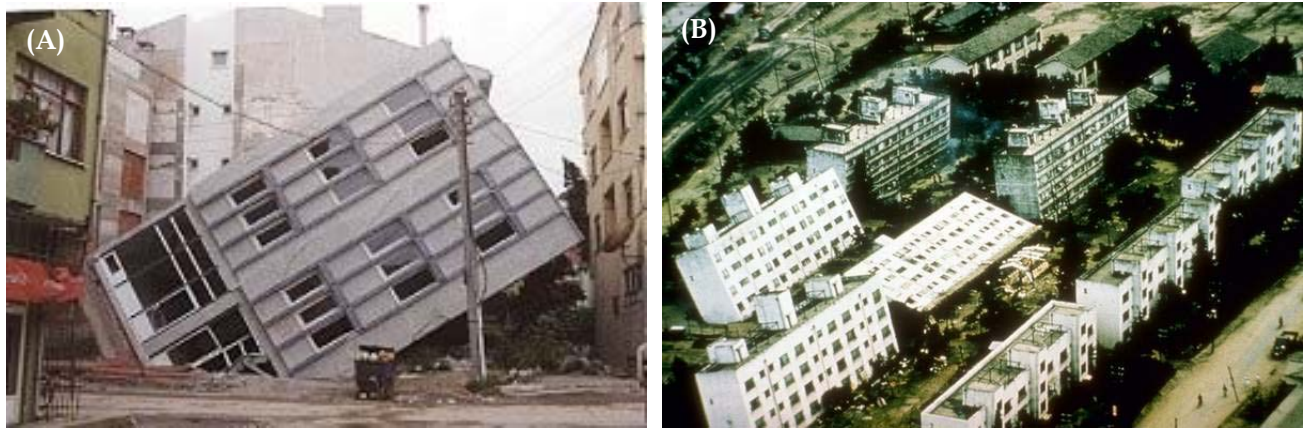
When the phenomenon of liquefaction is observed at the site of a building, wherein saturated or partially saturated loose or cohesionless soils significantly lose their bearing capacity under earthquake groundmotion, then the building situated on such soils should be tagged red.

**Figure 11: (A) Tilting of building due to liquefaction in the Kocaeli earthquake of August 1999; (B) Tilting of buildings due to liquefaction in the Nigata earthquake Japan, 1964**

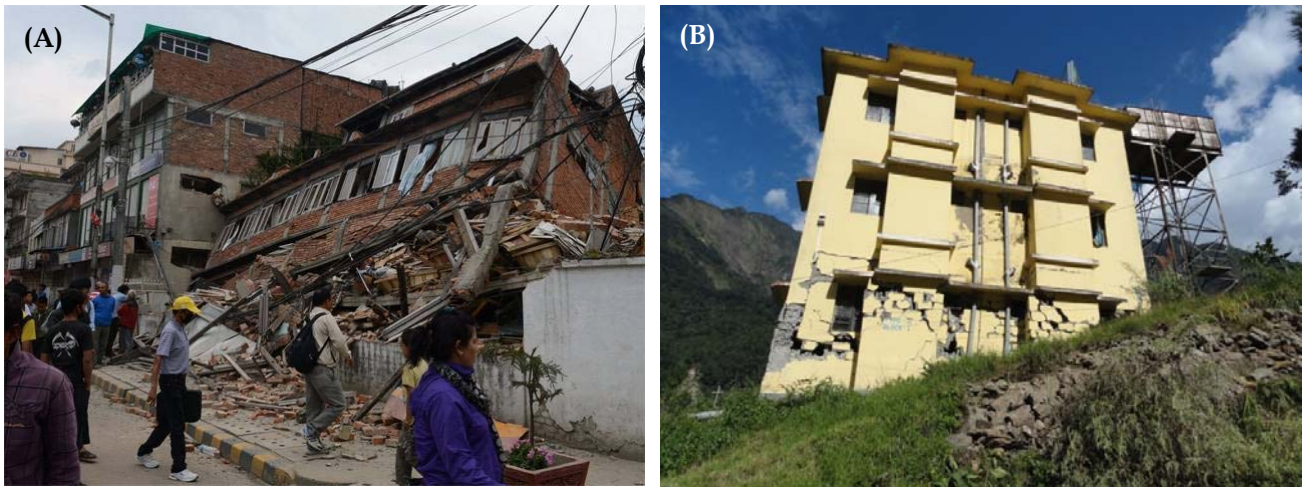
Any building that is sitting either adjoining one that has collapsed or heavily damaged or below one that is uphill and has collapsed or heavily damaged is vulnerable to structural damage in the event of any further movement or collapse of the adjoining or uphill building.

**Figure 13: (A) Life safety hazard to building due to collapsed adjoining structure; (B) Life safety hazard to buildings downslope due potential sliding or collapse of heavily damaged uphill building**

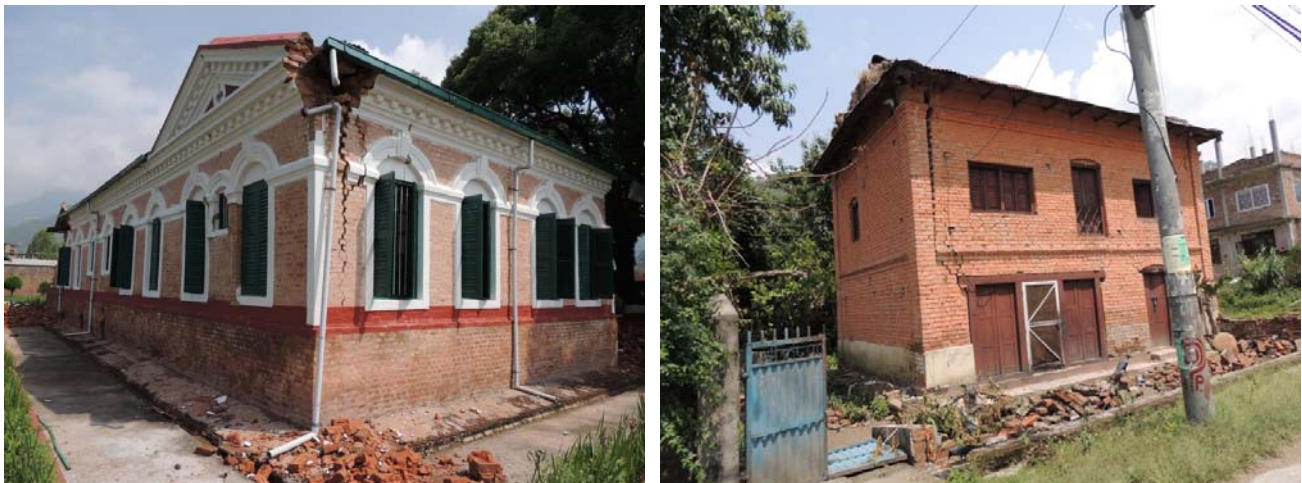
Out-of-plane mechanisms are typically observed at the uppermost portions of a structure, where the overturning resistance is the least due to decreasing gravity loads coming from self-weight. Separation of masonry walls at the junctions of walls or corners of walls is due to poor interconnections between walls. Box action in the masonry structure is lost as a result, and the free-standing walls are vulnerable to further movement out-of-plane and collapse. The roof or floor slab is no longer being supported uniformly by the walls and poses a serious threat.

**Figure 14: Buildings showing separation at the corners of perpendicular walls and out-of-plumb walls**

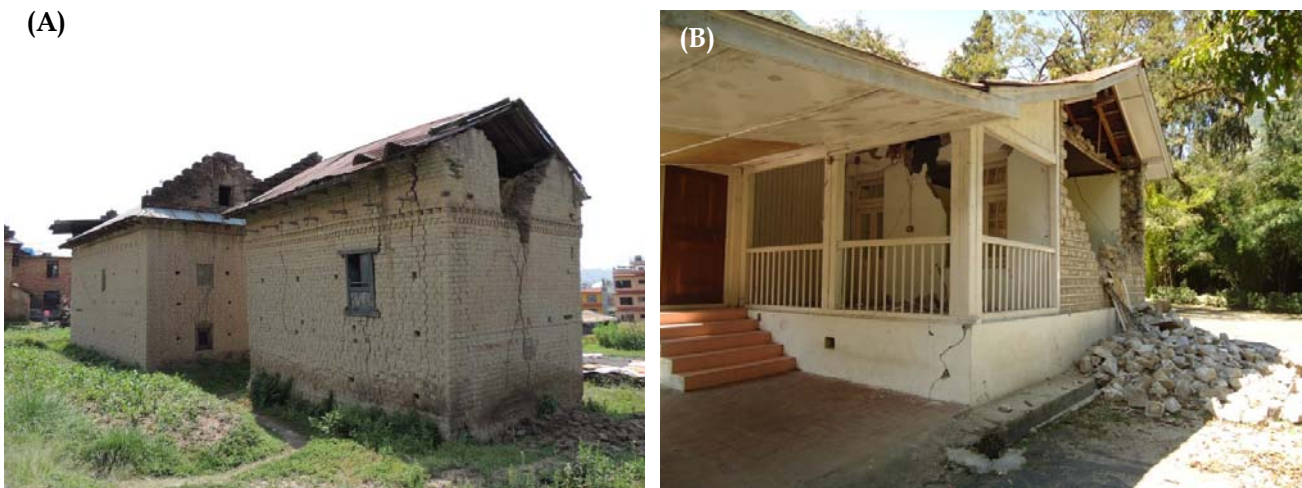
The tall free-standing masonry gable walls, typically at the ends of a building with sloped roof are susceptible to out-of-plane movement and severe damage or collapse due to poor interconnections with the perpendicular return walls and the roof or floor slab system. Such a damage or collapse implies loss of box action of the masonry and non-uniformly supported roof or slab systems.

Figure 16: (A) Building showing a gable wall that has partially collapsed inwards with heavy debris loading the floor and posing a threat to the structure; (B) A building showing outwards collapse of the gable wall, leaving the supported roof system and return walls further vulnerable

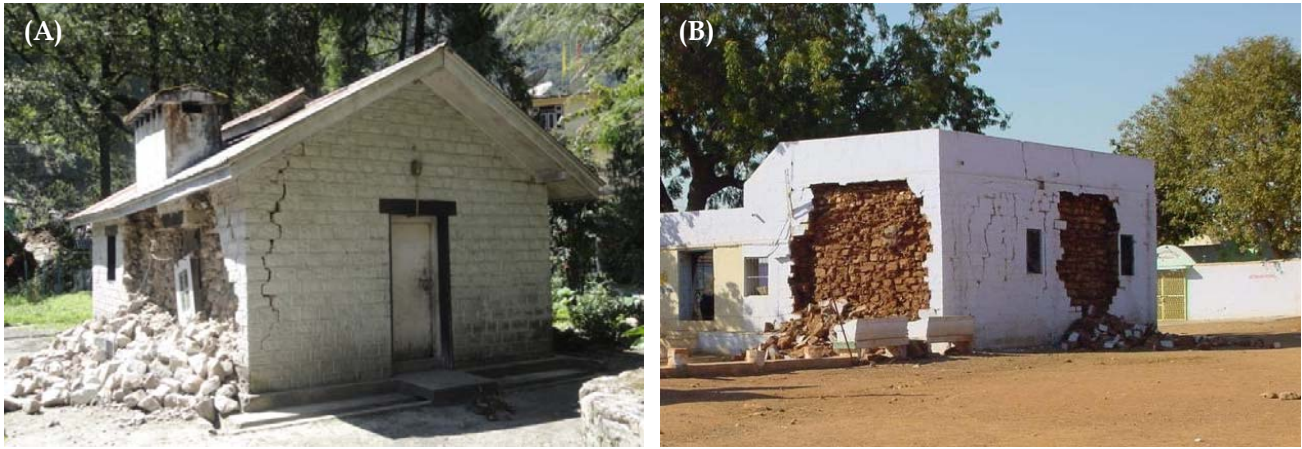
When multi-wythe (or multi-leaf) walls are subjected to out-of-plane shaking there could be collapse of the exterior wythe. This is primarily due to the poor quality of masonry walls. The out wythe collapses because the floor or roof slab system is typically supported on the inner wythe and not along the full thickness of a wall. Hence, restraint against lateral translation and rotation is offered to the inner wythe and not the external wythe, thereby causing it to fail out-of-plane. Such collapse of the external wythe results in an increase in the slenderness ratio (height to thickness ratio) with potential buckling of the wall and loss of support to the floor or roof system.

Figure 17: Separation and collapse of the external wythe of the multi-wythe wall

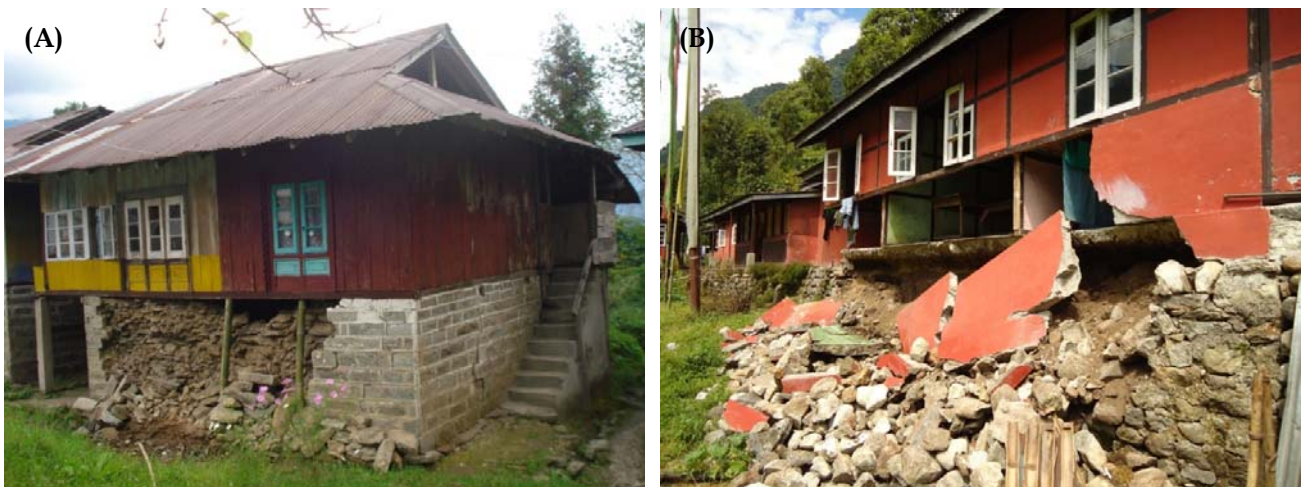
Partial or complete collapse of the plinth of the masonry structure (typically made in random rubble masonry), renders the structure unsafe, due to the significant disturbance of the supporting base of the structure.

Figure 18: (A) Tilted structure due to partial collapse of RR masonry plinth; (B) Partial collapse of the structure due to disintegration of the RR masonry plinth of the structure

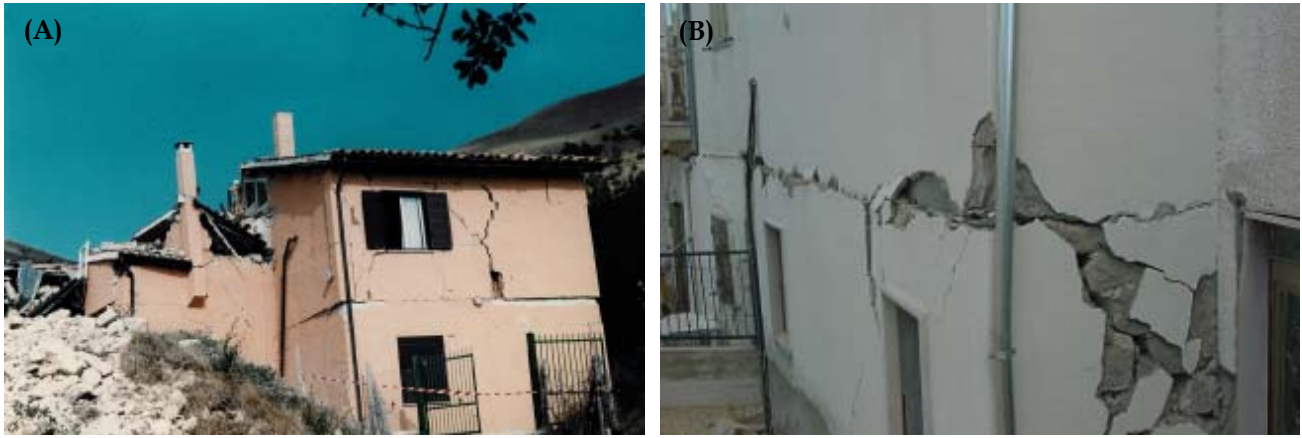
When interconnections between walls and between walls and roof/floor system are adequate, the in-plane shear resisting capacity of the masonry walls can be garnered. Horizontal sliding resulting in relative displacement between walls at any storey indicates that the in-plane shear capacity of the structure has been exceeded and the in-plane walls have failed in shear. The vertical load-carrying capacity is compromised after shear failure in the in-plane walls, which typically support the roof or floor system.

Figure 19: (A) Shear-sliding of the upper storey relative to the lower one; (B) Sliding-shear cracks noticed at the wall base or at the junction of the wall with the floor slab
