# GUIDELINES FOR POST-EARTHQUAKE TEMPORARY STRUCTURAL STABILISATION OF MONUMENTS OF BAGAN

Prepared by Dr Arun Menon  
Associate Professor, Structural Engineering Laboratory,  
Dept. of Civil Engineering, IIT Madras, Chennai, INDIA  
National Centre for Safety of Heritage Structures (NCSHS)

within support from the UNESCO Heritage Emergency Fund and within the framework  
of the UNESCO Projects

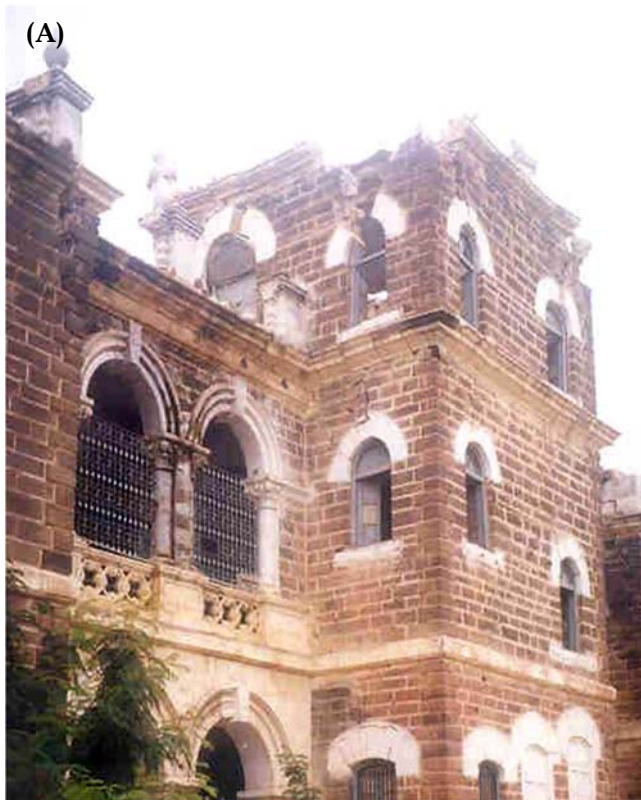
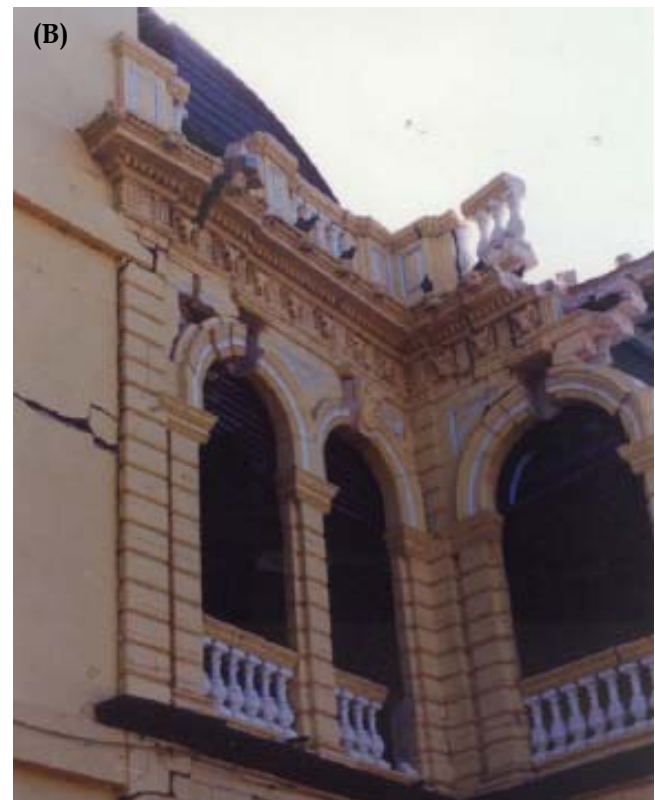
Load-bearing arches in masonry structures are either built out of stone units with a key stone at the crown or with brick units and binding lime mortar. Arches are very sensitive to relative lateral movement of the supporting piers or walls of the arch, leading to a loss of compression action in the arch, which is the load carrying mechanism in an arch. Dislocation or collapse of the keystone at the crown of an arch in stone masonry or wide cracks running to the full depth in a brick masonry arch at the crown, render the arch ineffective against the gravity loads they are meant to carry. This also leads to loss of box action of the masonry structure, due to the dilation of the walls and opening of the arches.

Figure 22: Dislocation and collapse of the keystone (at the crown) and voisseurs (other units) of the arch

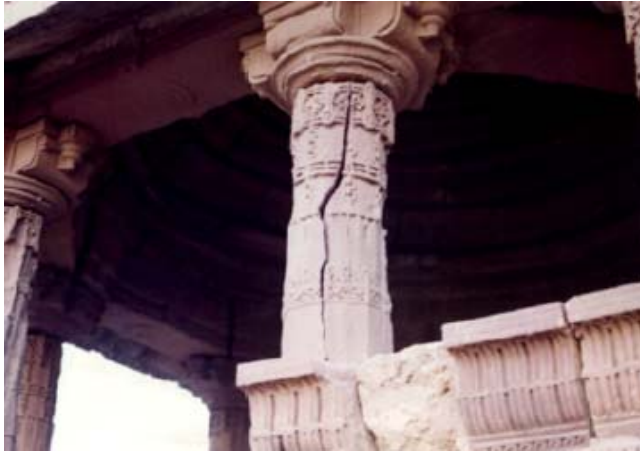
Splitting cracks or crushing at the base of masonry load-bearing columns, and/or loss of alignment of the columns results in eccentric loading of the columns and potential for collapse, rendering the supported elements susceptible to collapse.

Figure 23: Splitting crack in the stone column and crushing at the base

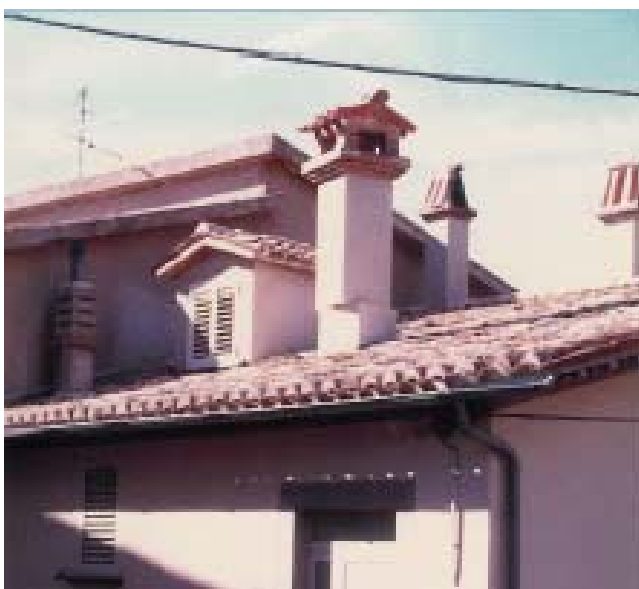
Non-structural damage and collapse of elements such as parapet walls at the uppermost level of buildings is a recurrent feature. They pose a serious falling hazard that can cause death or injury. A structure can be made accessible after such falling hazards have been secured or removed. Hence, the building is YELLOW-tagged when such damage is noticed.

Figure 24: Damage to the chimney (a non-structural component) of the building, posing a serious falling hazard

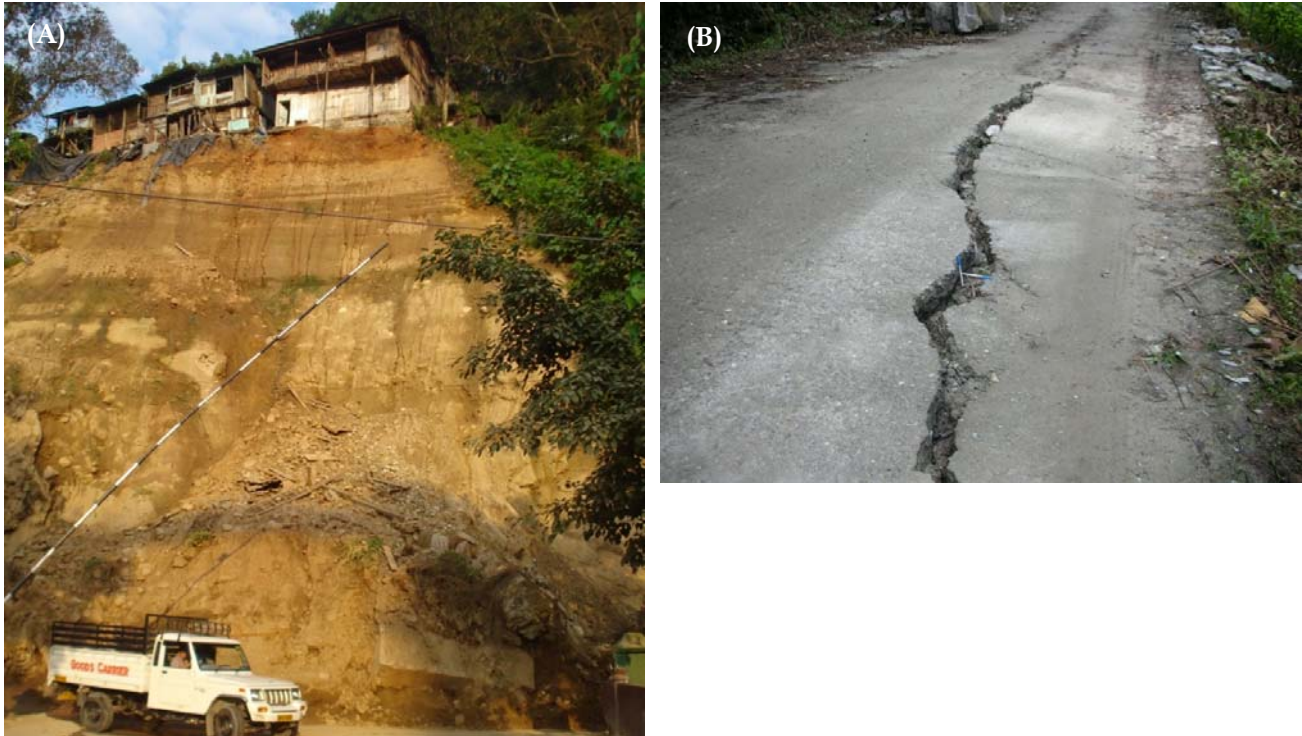
Features such as formation of fissures on the ground due to surface manifestation of fault rupture or due to ground displacements, or landslides and failure of hill slopes, in the vicinity of the structure, render the structure susceptible to further damage or collapse, hence potentially unsafe.

Figure 26: (A) Buildings precariously placed in landslide affected areas; (B) Ground fissures due to loss of slope stability in hill slopes or surface rupture due to fault movement

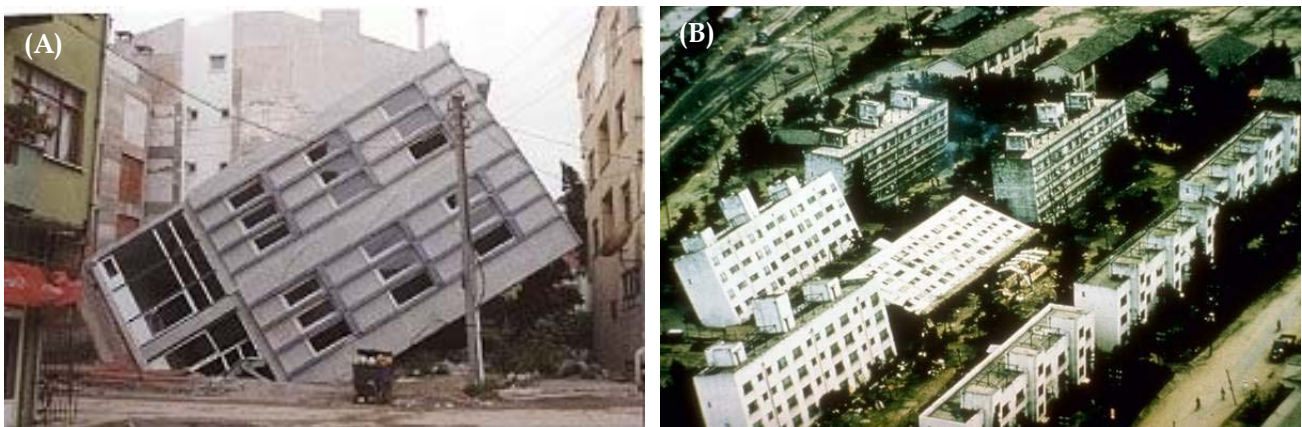
When the phenomenon of liquefaction is observed at the site of a building, wherein saturated or partially saturated loose or cohesionless soils significantly lose their bearing capacity under earthquake groundmotion, then the building situated on such soils should be tagged red.

Figure 27: (A) Tilting of building due to liquefaction in the Kocaeli earthquake of August 1999; (B) Tilting of buildings due to liquefaction in the Niigata earthquake Japan, 1964

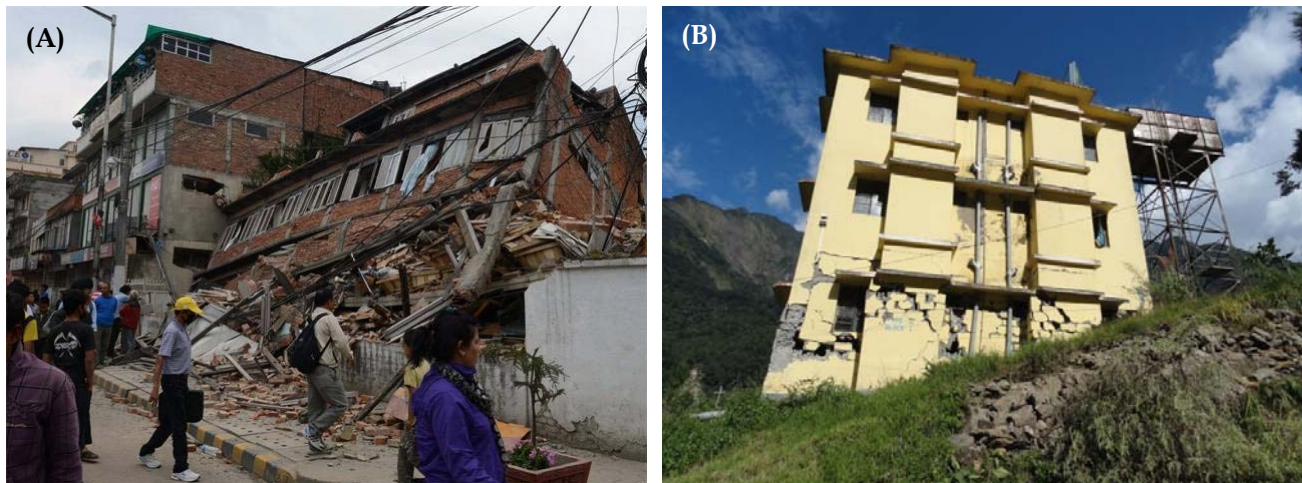
Any building that is sitting either adjoining one that has collapsed or heavily damaged or below one that is uphill and has collapsed or heavily damaged is vulnerable to structural damage in the event of any further movement or collapse of the adjoining or uphill building.

Figure 29: (A) Life safety hazard to building due to collapsed adjoining structure; (B) Life safety hazard to buildings downslope due potential sliding or collapse of heavily damaged uphill building

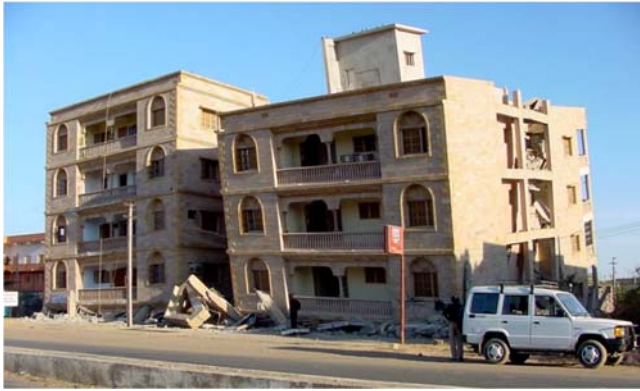
Presence of an open ground storey in an RC frame building results in irregular distribution of strength and stiffness along the height of the structure, and a ground storey with lower strength and stiffness relative to the rest of the structure. The open ground storey is then highly susceptible to structural failure, bringing the entire structure down. If the building being surveyed is an open ground storey building with shear failure (as discussed in point 3.1, and shown in Figure 26), then the building must be RED-tagged.

Figure 30: Failure of ground storey columns in an open ground storey building

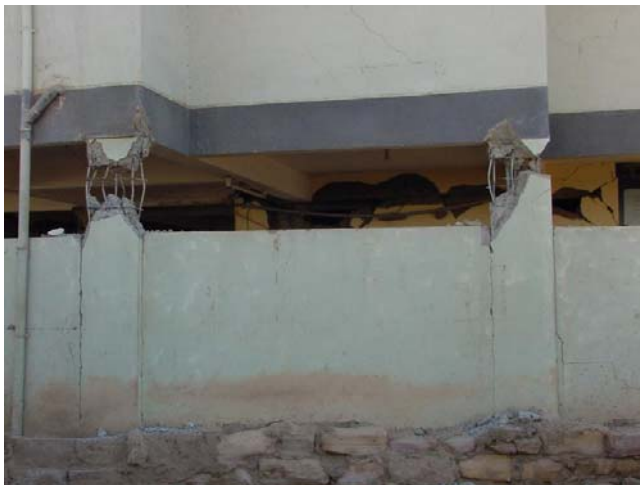
When RC frames are provided with partial height infill masonry panels, then the abutting partial height panel reduces the effective length of the columns and leads to a short-column effect with shear damage or failure in the column, unless the column is designed for the increased shear demand. If the building being surveyed has short columns with shear failure (as discussed in point 3.1, and shown in Figure 26), then the building must be RED-tagged.

**Figure 32: Shear failure in RC short columns, created due to the partial height infill panels in the RC frame**

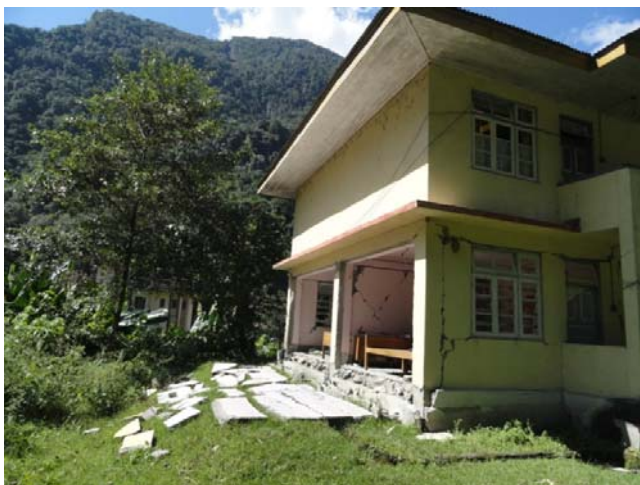
Due to RC frame and infill masonry interaction during an earthquake, there is propensity for separation at the junction of the frame and infill. In case the infill panel is heavily damaged and/or collapses out of its plane, then the building should be RED-tagged.

**Figure 33: Extensive cracking in the infill masonry panels and out-of-plane collapse of some infill panels in an RC structure**

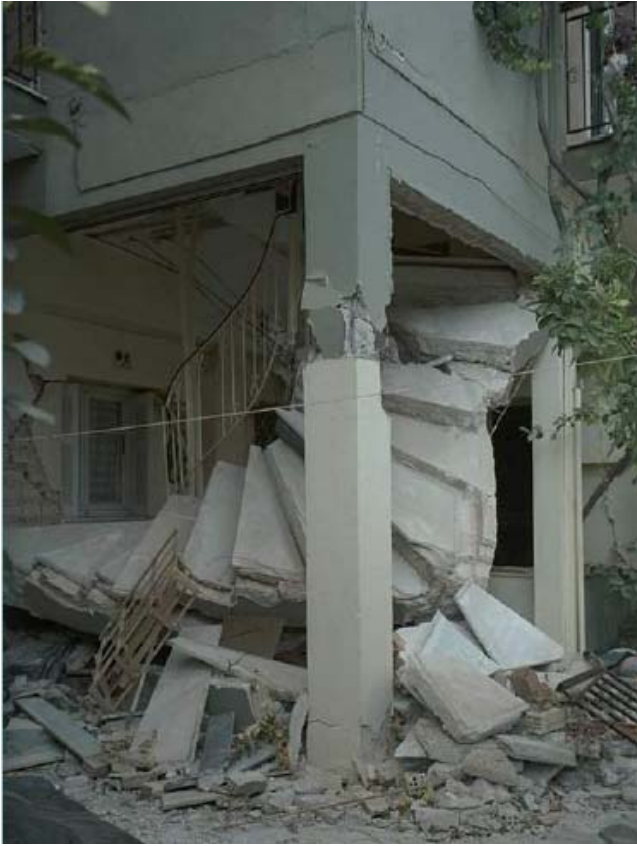
The staircase core of an RC frame is typically the stiffest location and element of the structure, attracting significant share of the shear demand during an earthquake. Collapse of the staircase or damage in the structural elements of the staircase, or any blockade of the staircase due to fallen debris renders the building inaccessible, and hence must be RED-tagged.

Figure 34: Collapse of the staircase of an RC frame structure with shear damage to the columns

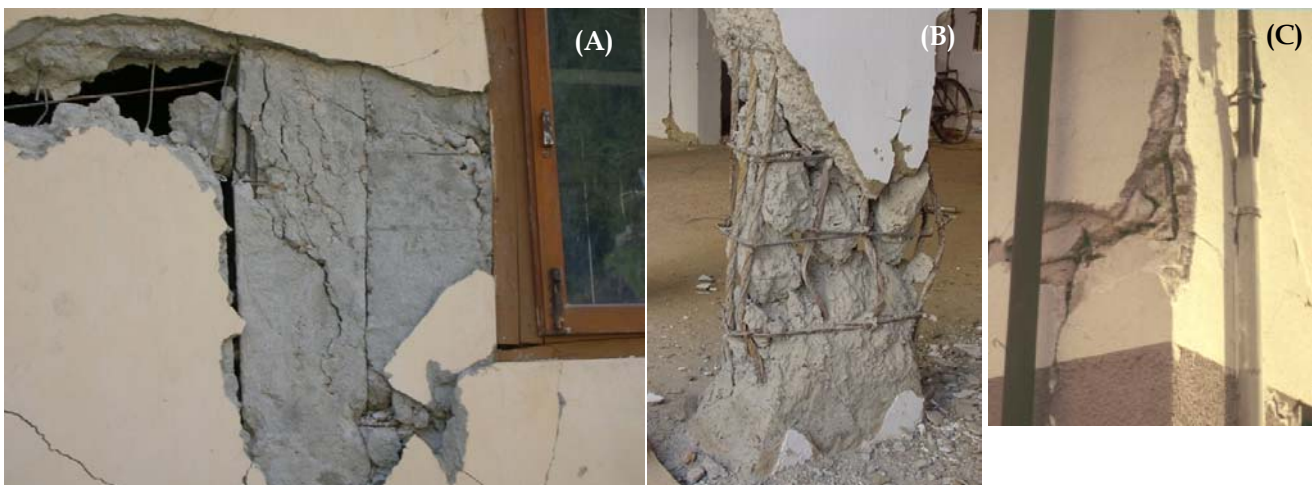
Shear failure of RC columns is the most undesirable behaviour in an RC frame structure. Shear cracking and failure is associated with inclined structural cracks in the concrete, spalling of cover concrete, snapping of steel ties (which may have only 90° hooks) and buckling of longitudinal steel. Shear failure of columns jeopardises the gravity load carrying capacity of the frame, and hence the building must be red-tagged.

Figure 35: (A) Inclined cracks and spalling of cover concrete; (B) Inclined failure plane with spalling of concrete, crushing of core concrete, snapping of ties (note 90° hooks in stirrups) and buckling of longitudinal bars, (C) Inclined failure plane with spalling of concrete, crushing of core concrete and buckling of longitudinal bars

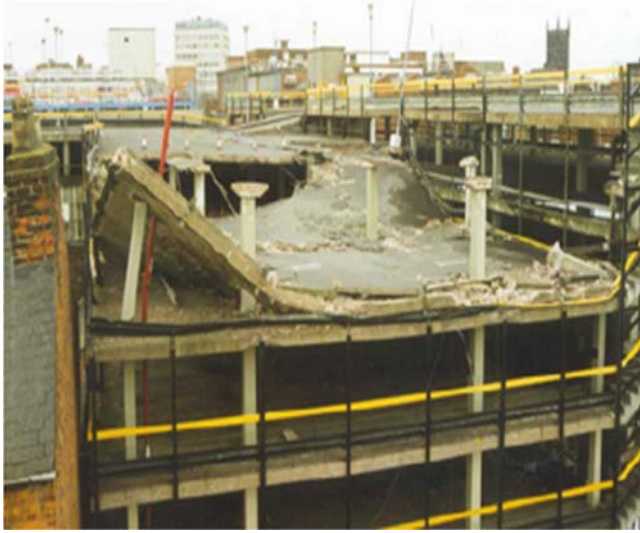
RC structures with flat slab construction are susceptible to punching shear failure, where the column punches through the RC slab, if the slab is not designed adequately to account for additional shear forces.

Figure 36: (A) Tilting of building due to structural damage at lower stories; (B) Tilting of building due to soil settlement

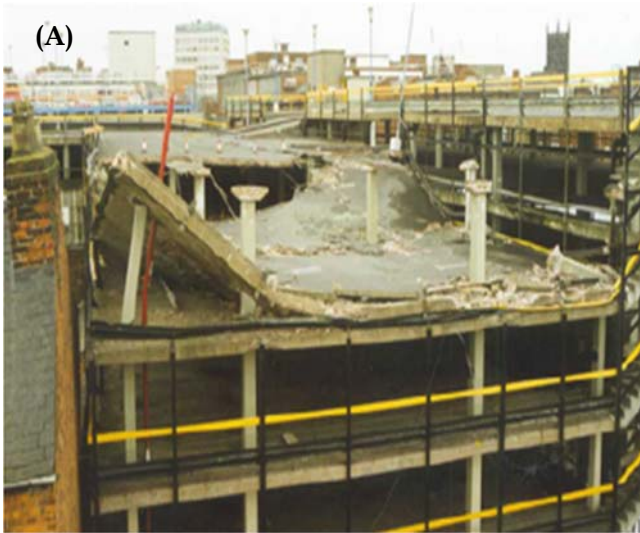
If inclined shear cracks are noticed in the beams with and without spalling in the cover concrete and damage to infill panels, the structure should be tagged yellow.

Figure 37: (A) Building showing punching shear failure in the flat slab; (B) Formation of punching shear damage at the interface of column and flat slab

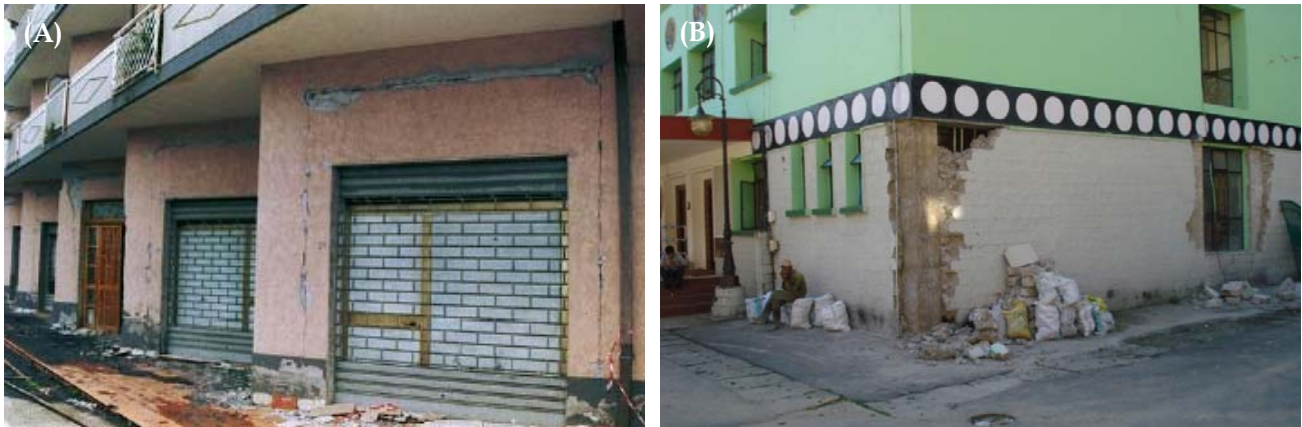
Due to RC frame and infill masonry interaction during an earthquake, there is propensity for separation at the junction of the frame and infill. In case the infill panel is separated from the frame

and there are no structural cracks in the frame, then the building can be yellow-tagged and accessible after necessary interventions are carried out to address the free-standing infills.

Figure 38: (A) Infill-frame separation in an RC frame; (B) Infill damage alone

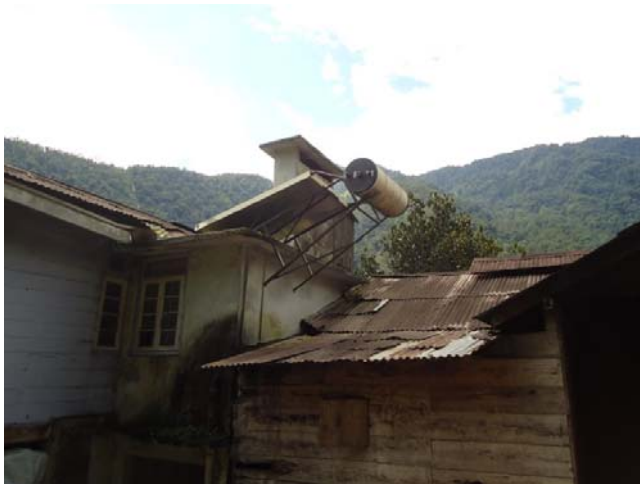
Non-structural damage and collapse of elements such as water tanks and structural damage involving dislodging or sliding of machine room, at the uppermost level of buildings, is a recurrent feature. They pose a serious falling hazard that can cause death or injury. A structure can be made accessible after such falling hazards have been secured or removed. Hence, the building is YELLOW-tagged when such damage is noticed.

Figure 39: Overturning or dislodging of overhead water tank
