HERITAGE FOR MYANMAR

Earthquake, Heritage and Conservation

Assessment of Earthquake-Damaged Heritage

Prepared by HFM

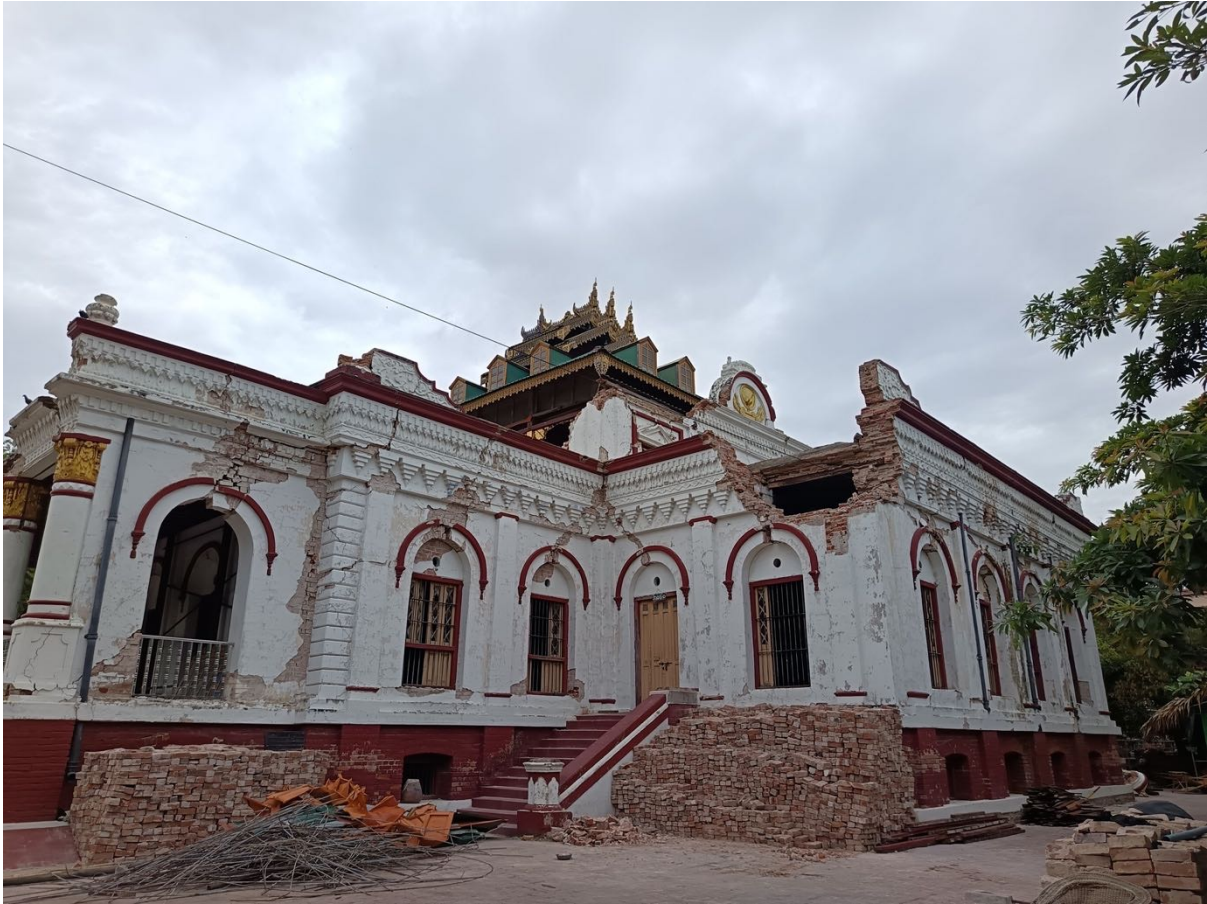
Figure 5 – Myinwun Monastery, Mandalay (8 July 2025)

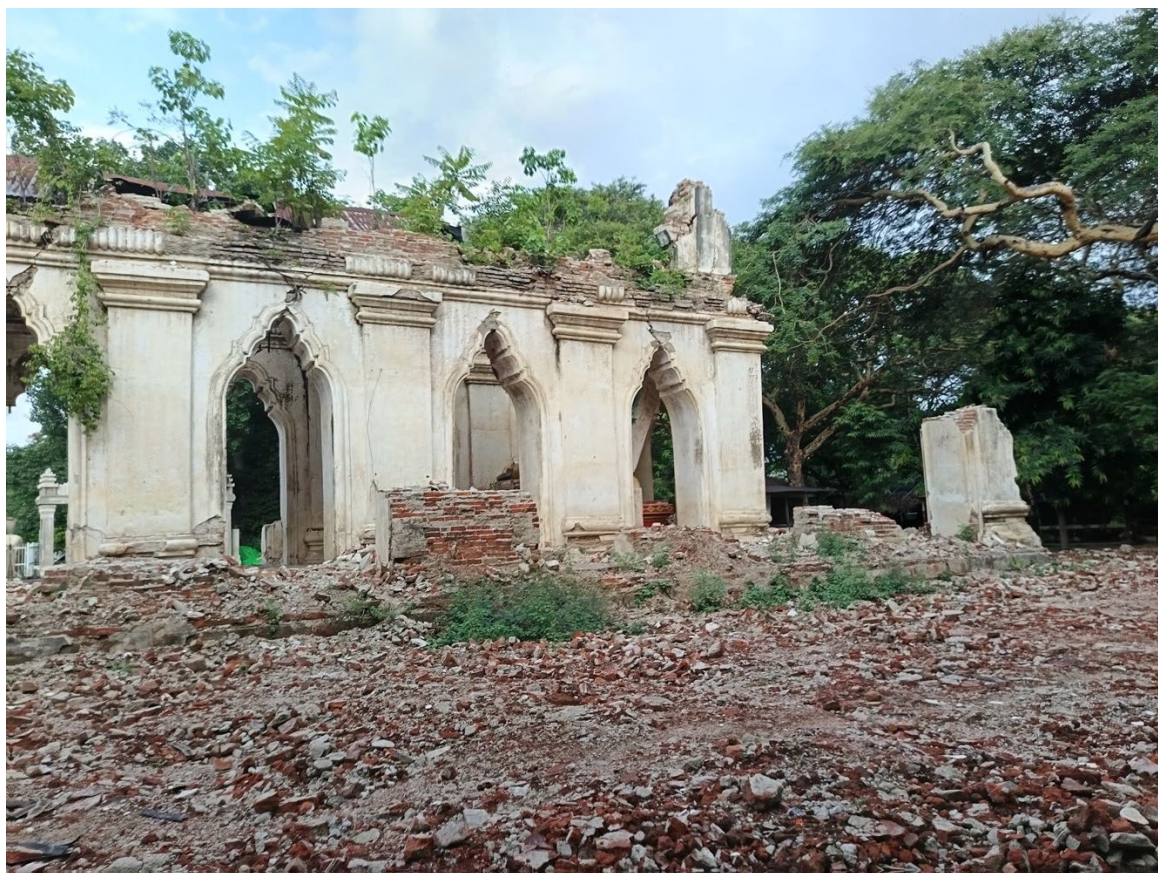
Figure 5 – Yadanapon Pitaka Taik, Amarapura (15 July 2025)

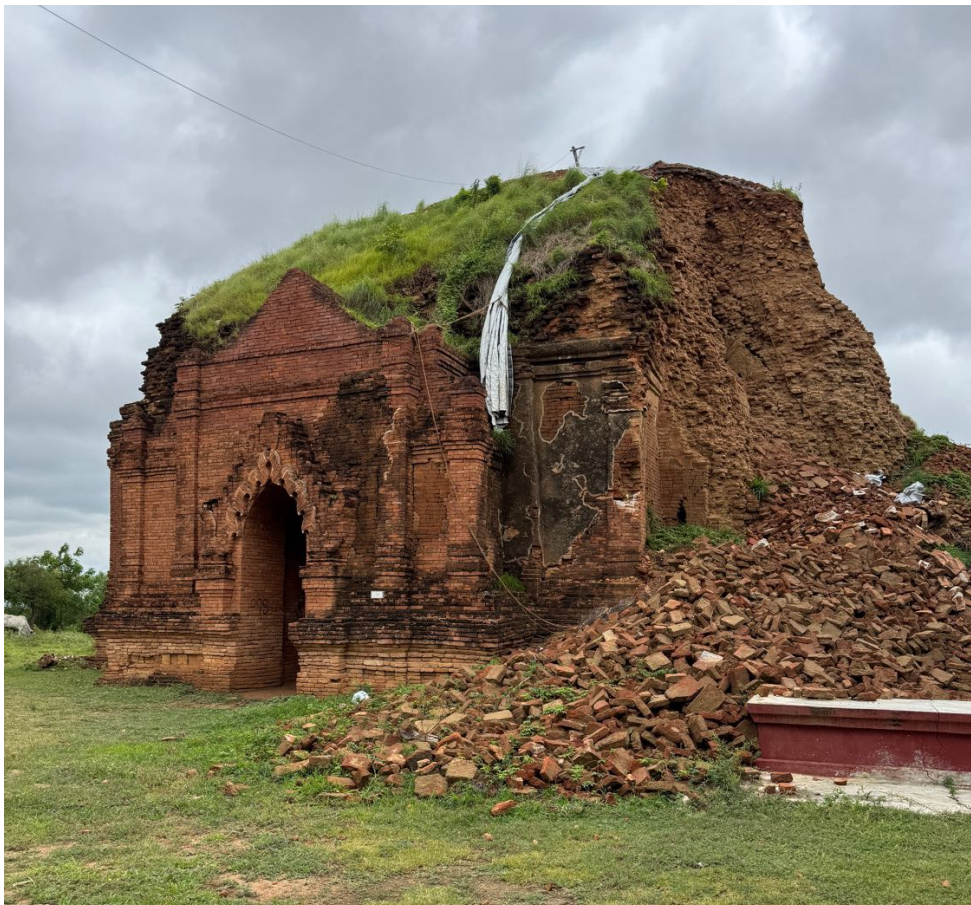
Based on the survey data, the number of buildings with Major Damage combined with those that suffered Total Collapse reached a total of 203 (Figure 6-7), accounting for 38.4% of the overall results. Furthermore, 158 buildings (29.9%) sustained Moderate Damage (Figure 8). These figures together reveal that 68% of the heritage sites suffered significant structural impact, ranging from notable damage to total collapse. According to the survey data, only 39 buildings (7.2%) were found to have been unaffected by the earthquake.

Figure 7 – Gugyi Thone Lone (three temples), Pinya (18 July 2025)

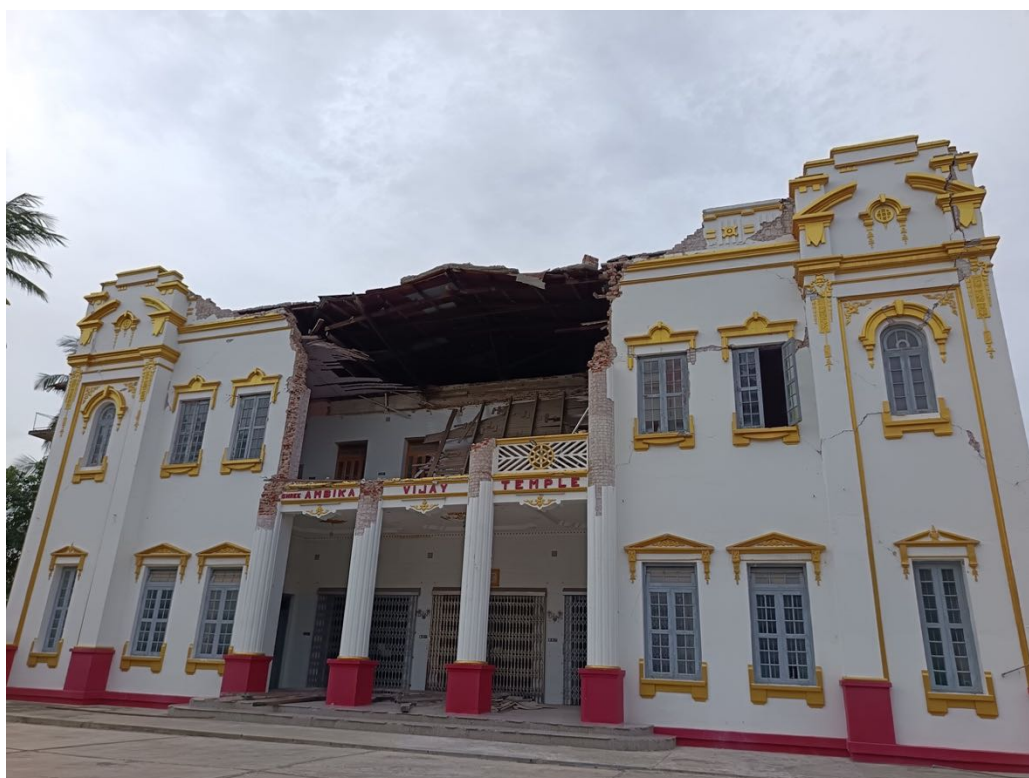
Figure 8 – Ambika Vijay temple, Mandalay (9 July 2025)

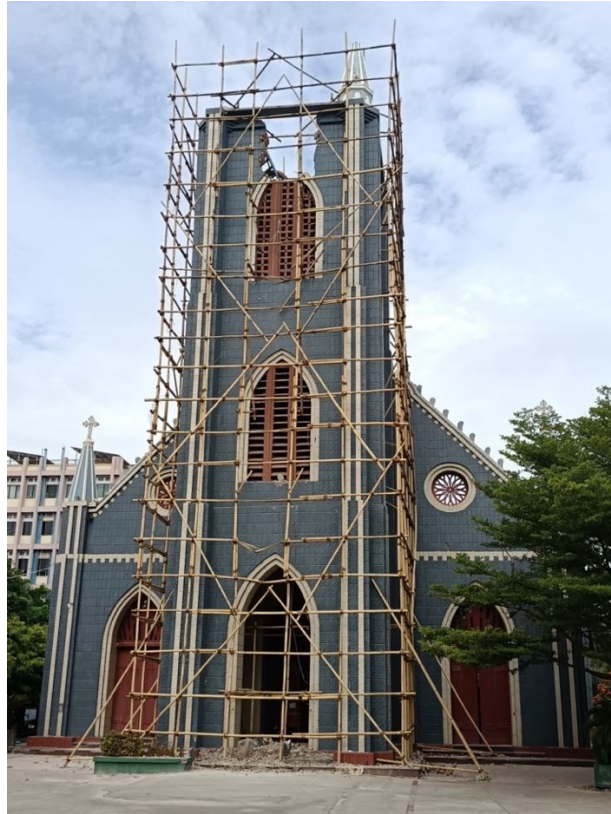
Figure 9 – Sacred Heart church, Mandalay (9 July 2025)

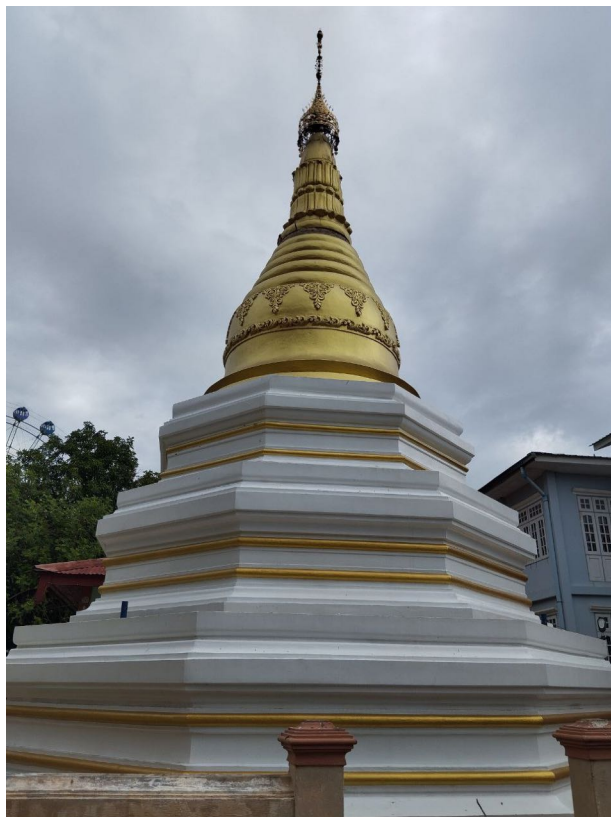
Figure 10 – Tawagu Thein Zedi, Mandalay (31 May 2025)

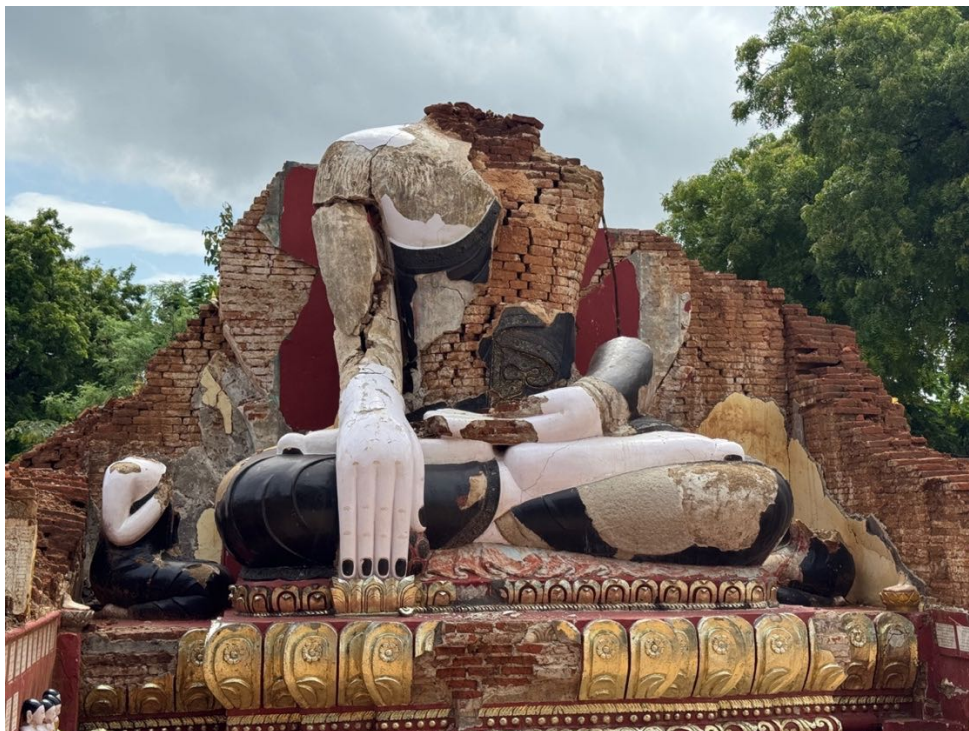
Figure 20 – Buddha image, Shwegugyi monastery, Amarapura (17 July 2025)

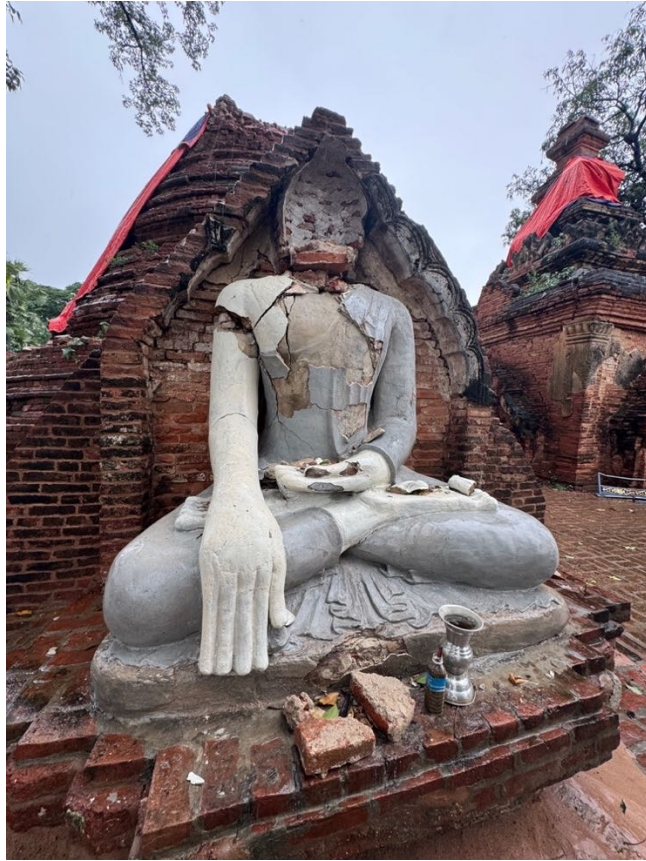
Figure 21 – Buddha image, Yadana Semi complex, Inwa (16 July 2025)

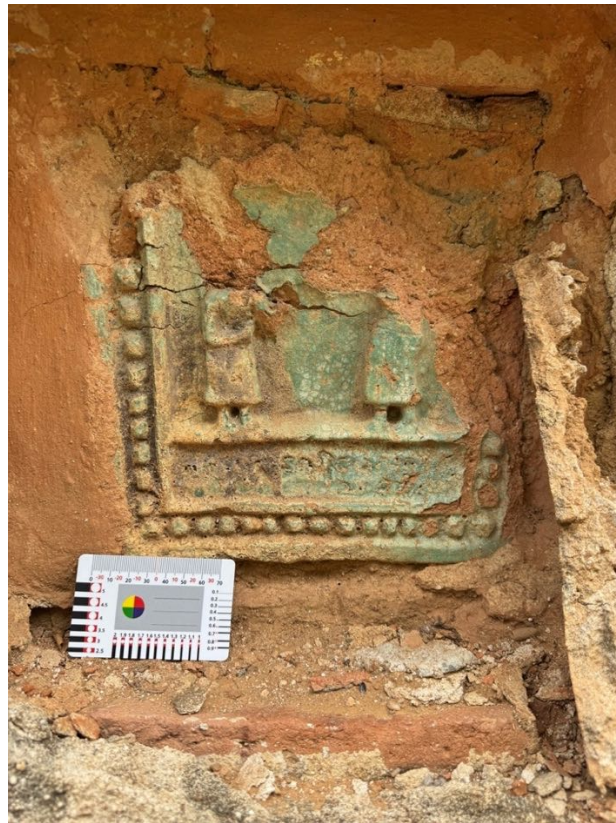
Figure 22- 550 glazed Jataka plaque, Aungzigon, Pinya (3 August 2025)

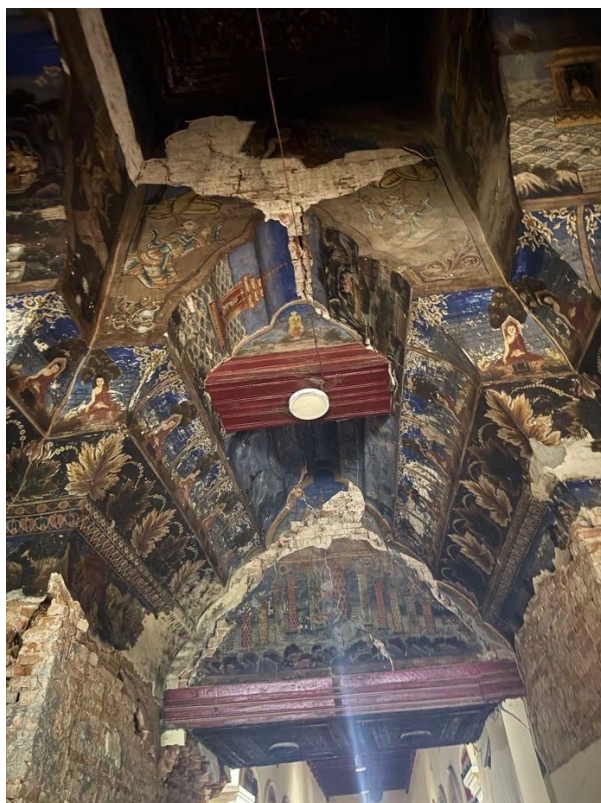
Figure 23 – Mural paintings, Mahamuni temple, Mandalay (5 August 2025)

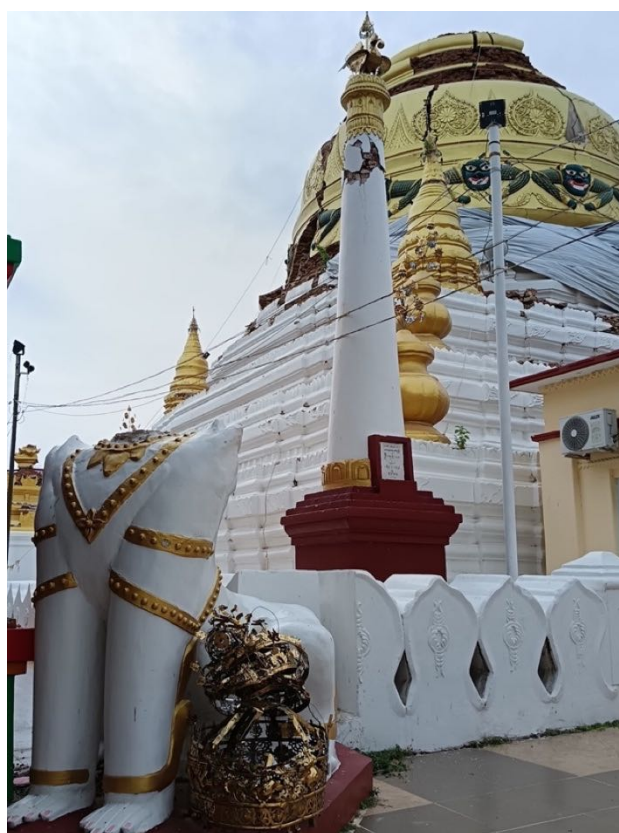
Figure 24 – Manusiha figurine, Phayani, Mandalay (9 July 2025)
